BIOLOGICAL TECHNICAL REPORT

Biological Technical Report for the Campo Verde Solar Project

First Solar

Heritage Environmental Consultants

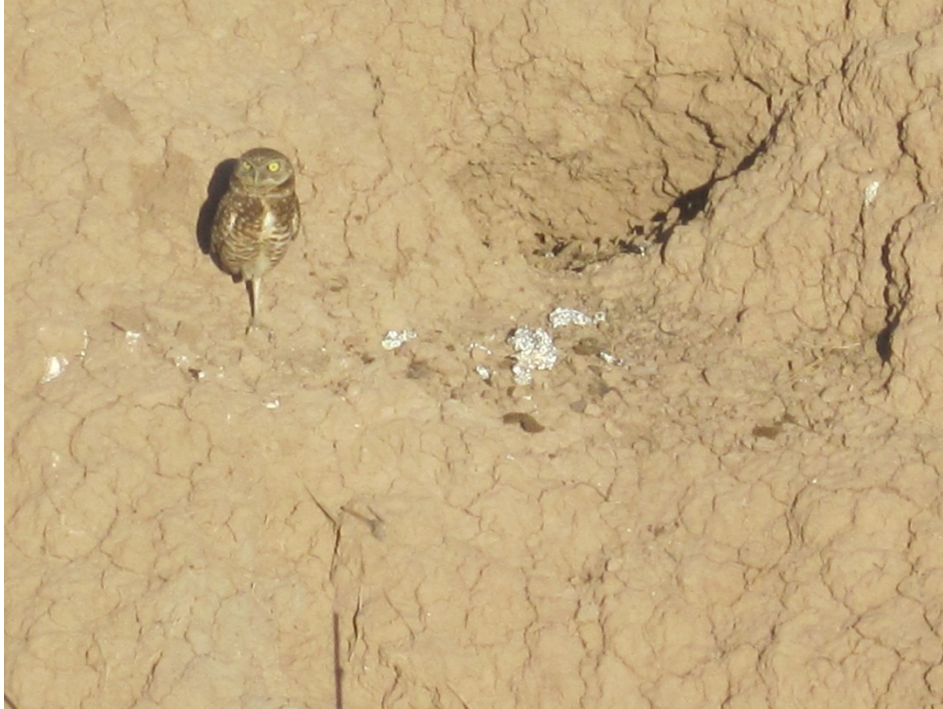
Adult Burrowing Owl and representative active burrow with pellets, whitewash, and other debris.

Burrows that had the potential to be used by Burrowing Owls were marked using a handheld global positioning system (GPS) unit. Photos were taken of representative potential burrows and owl observations were noted. “Burrow Clusters” were recorded in areas that supported high densities of burrow entrances that were either (1) multiple entrances associated with a single burrow; or (2) separate burrows that were located too close together to support more than one breeding pair of owls (burrows within 5 meters of each other).

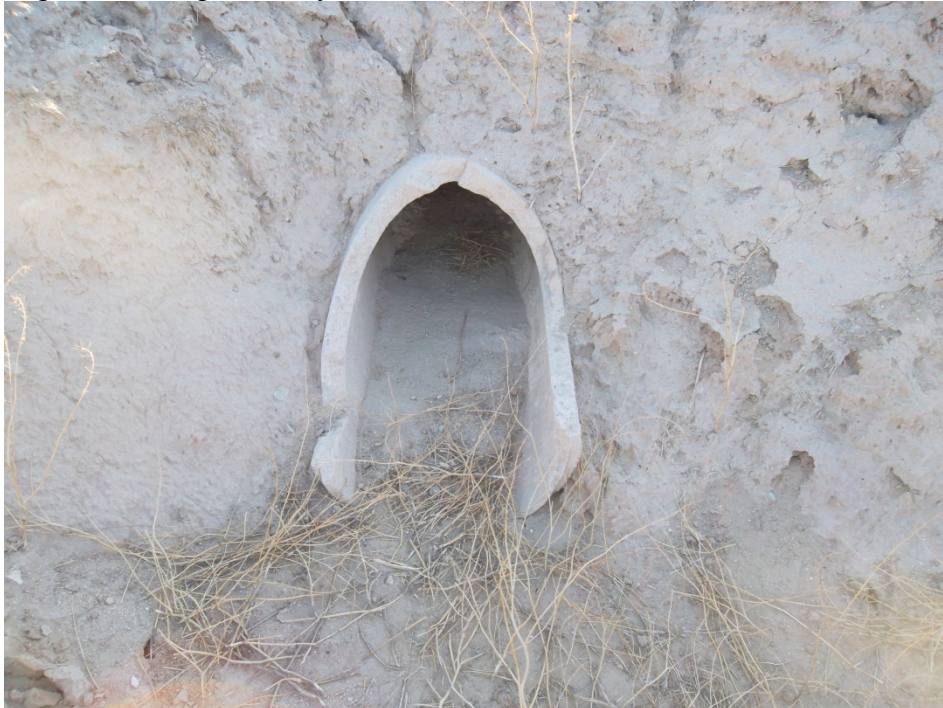
Representative potentially suitable man-made burrow (Eastern BLM Gen-tie Corridor).

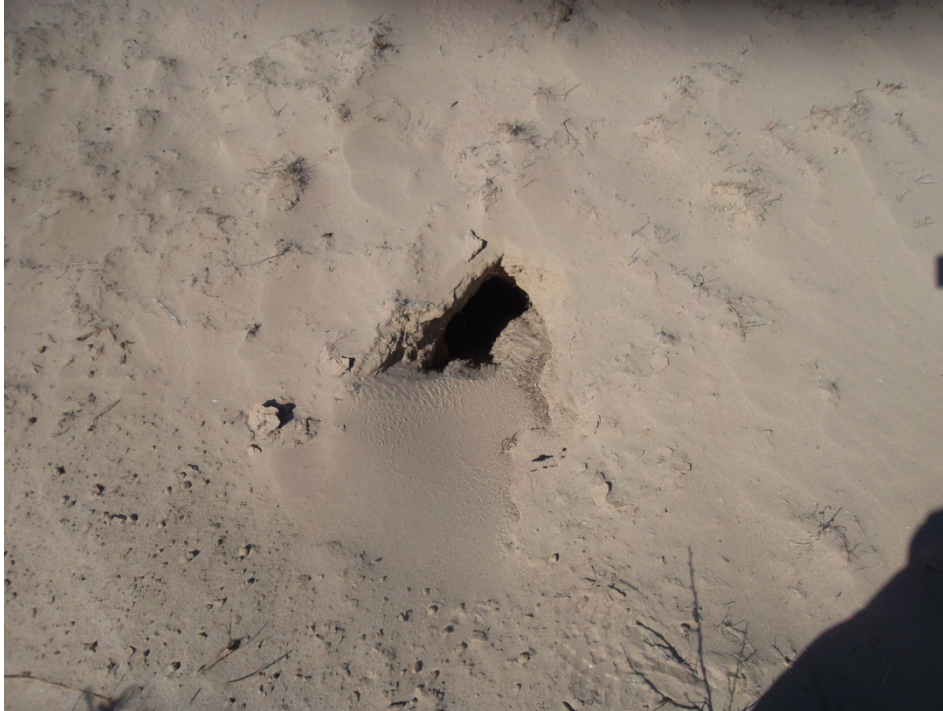
Representative potentially suitable natural burrow (Western BLM Gen-tie Corridor).

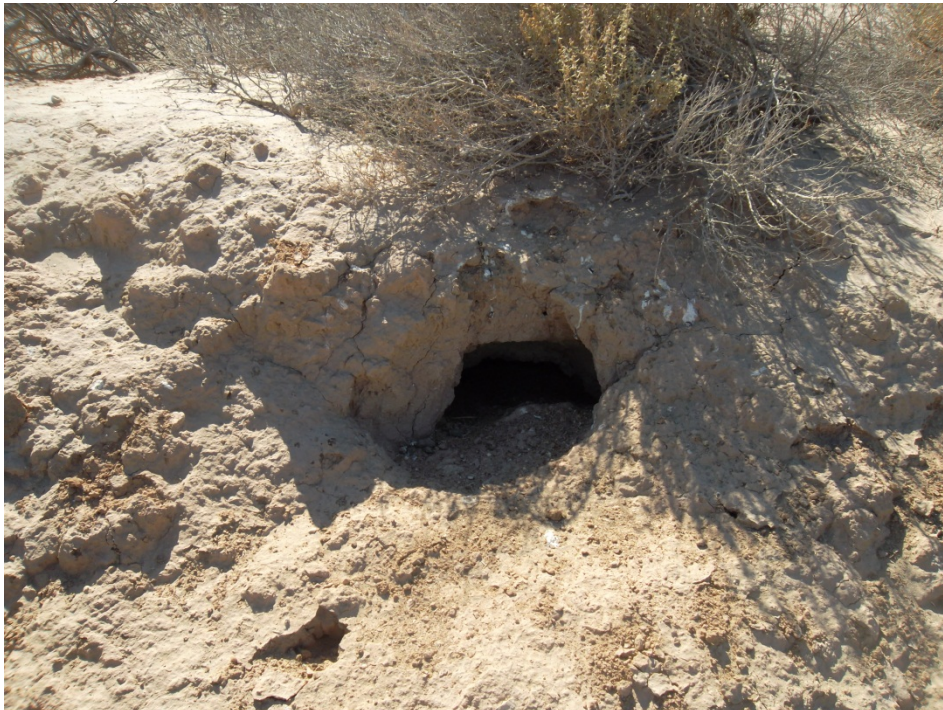
Representative potentially suitable natural burrow with sign (whitewash)(Western BLM Gen-tie Corridor).
