**CULTURAL RESOURCE SURVEY  
FOR A PORTION OF THE  
CENTINELA SOLAR ENERGY, LLC PROJECT AREA  
IMPERIAL COUNTY, CALIFORNIA**

June 2011

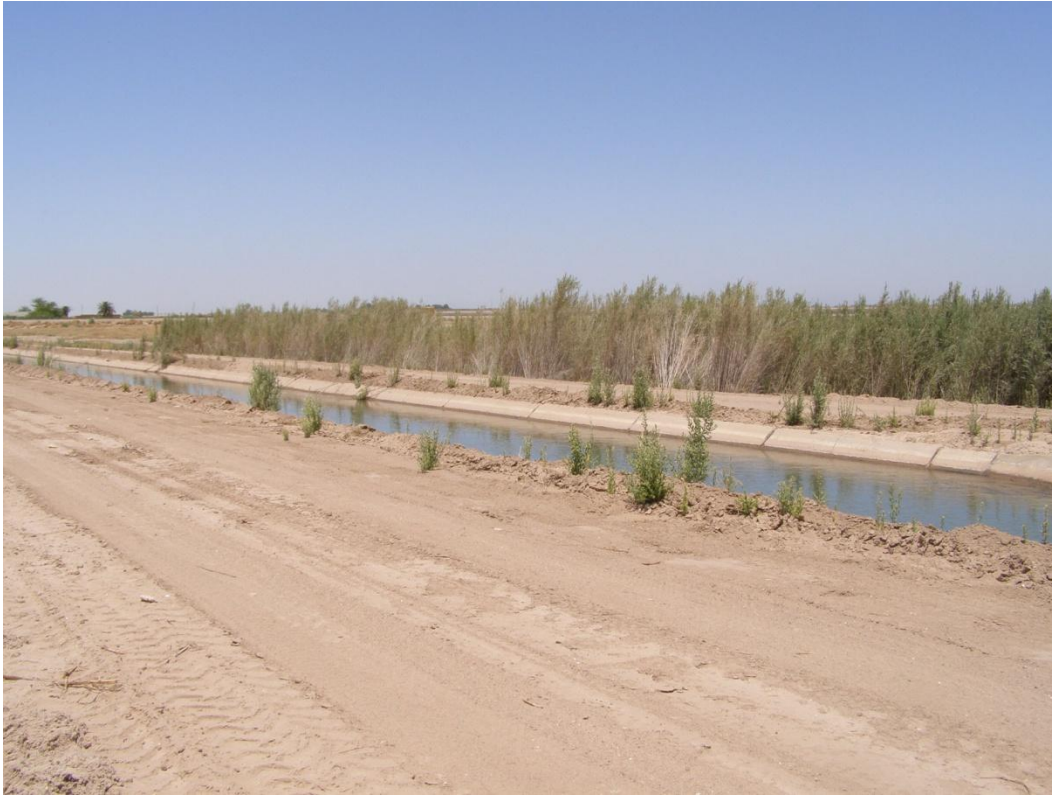
Figure 5. Westside Main Canal.

Westside Main Canal was constructed ca. 1907 as part of the earliest irrigation system in the Imperial Valley. It was later connected to the All-American Canal which runs east-west north of the U.S.-Mexico border, as one of three main canals that receive water from the All-American Canal. The segment of the Westside Main Canal within the Project APE is approximately two mi. long, with 0.75 mi. of canal extending north from its intersection with Hwy. 98, and 1.25 mi. of canal extending south of the highway (Figure 5). The canal is approximately eight ft. deep and approximately 40 ft. wide. Numerous laterals extend from the canal into the Project area.

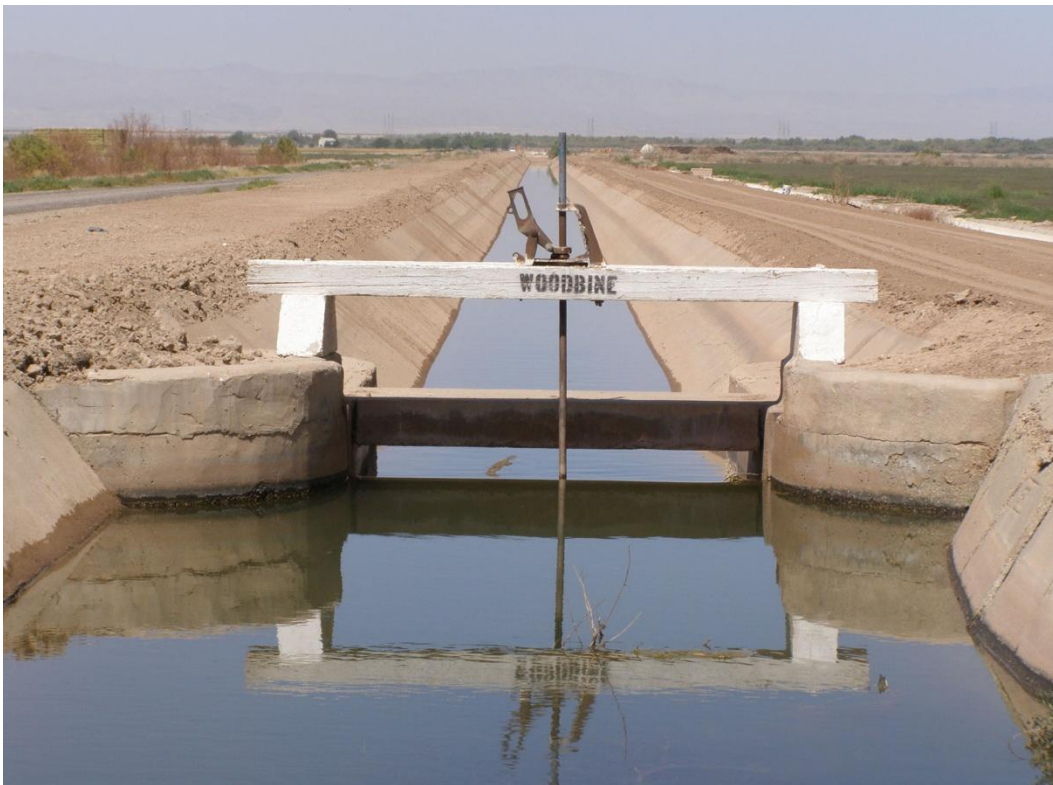
Figure 7. Woodbine Canal.

The Woodbine Canal is an irrigation canal constructed ca. 1915 and modified in the 1950s and 1960s. It is located east of the Westside Main Canal and flows east and south for approximately three miles in total length (Figure 7). The canal is approximately 10 ft. wide and six ft. deep and is accessible from Old Highway 80, State Route 98, and Interstate 8.

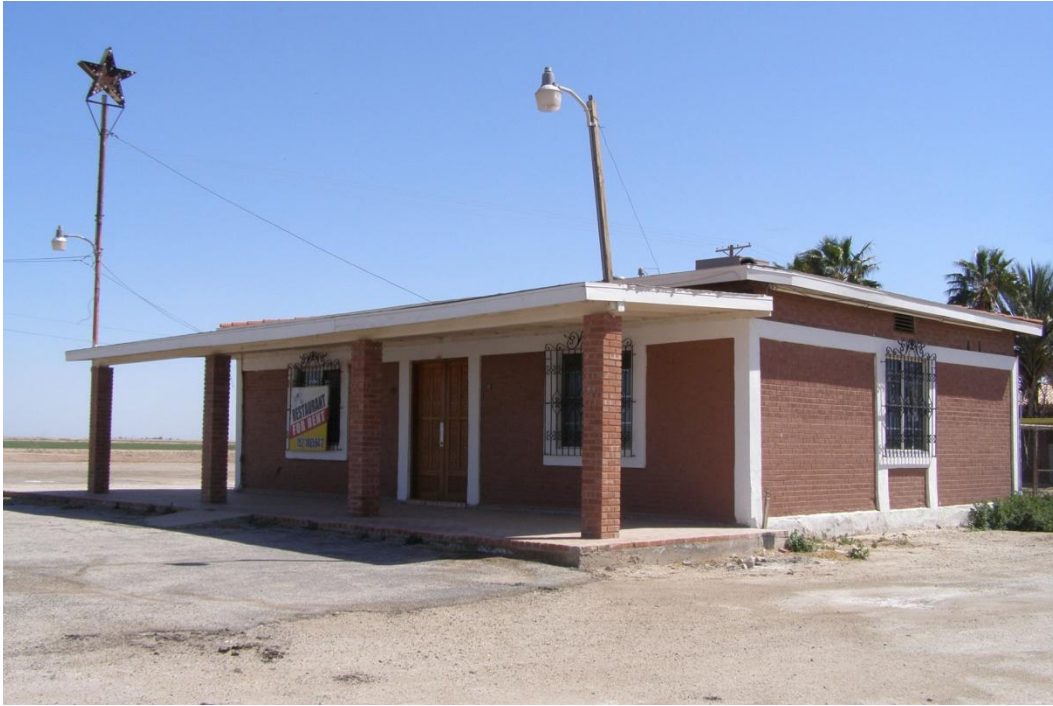
Figure 8. Mount Signal, Building 1.

The building at 1201 W. State Highway 98 was constructed as a commercial building ca. 1965. It is a one-story vernacular building located on the southeast side of the intersection of State Highway 98 and Brockman Road. The commercial building is wooden frame and rectangular in plan, with a concrete foundation. The exterior is clad in brick siding. The roof is a low-pitched shed roof with wide eaves and clad in asphalt shingles and red clay tiles. On the north elevation, a concrete ramp leads to a full-width porch with a flat roof. The porch is supported by brick columns. The primary entrance is located within the porch and consists of two doors. The windows consist of aluminum sash windows. There appear to be no modifications to the building. Some features include a sign that reads, “Mt. Signal Café” on the west side of the restaurant and a neon-light star is situated on the northeast corner of the building. Landscape features include a gravel parking lot surrounding the property (Figure 8).

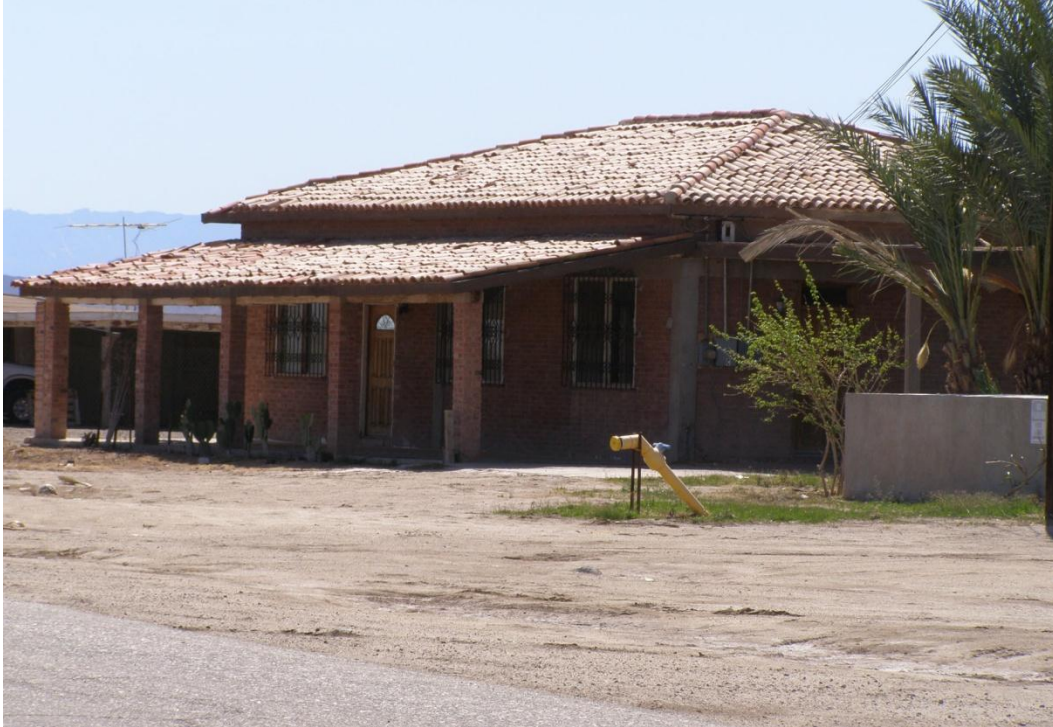
Figure 10. Mount Signal, Building 3.

Building 3 was constructed as a single family residence ca. 1965. It is a one-story vernacular building located on the west side of Brockman Road. The building is wood-framed and rectangular in plan, with a concrete foundation. The exterior is clad in brick siding. The roof is a low-pitched hipped roof with moderate eaves and clad in red clay tiles. On the east elevation, a concrete pathway leads to a full-width porch with a shed roof. The porch is supported by brick columns. The primary entrance is located within the porch and consists of a partially glazed wood door. The windows consist of vinyl casement windows obscured by metal security

bars. Modifications to the building include the replacement door. Landscape features include a dirt yard (Figure 10).

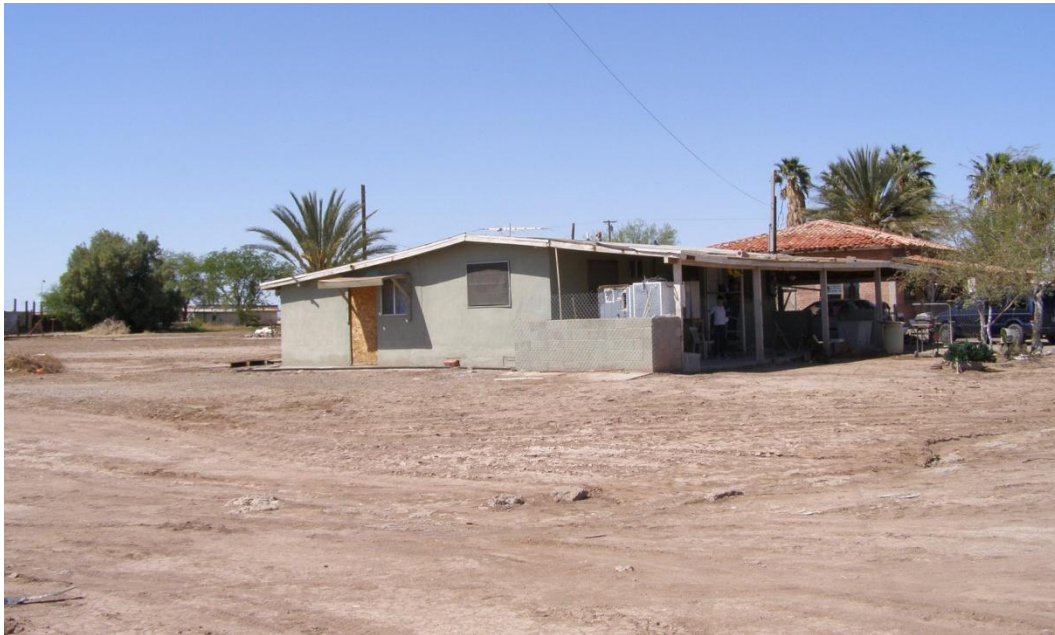
Figure 11. Mount Signal, Building 4.

Building 4 was constructed as a single family residence ca. 1948. It is a one-story vernacular building located on the west side of Brockman Road. The residence is wood-framed and rectangular in plan, with a concrete foundation. The exterior is clad in stucco siding. The roof is a low-pitched side gable roof. The recessed porch is supported by wood posts. A low concrete block wall is located on either side of the porch. The primary entrance is located within the porch. The windows are primarily aluminum sliders. There appear to be no additions to the building. Modifications to the building include a boarded-over door on the south elevation. Landscape features include a dirt yard (Figure 11).

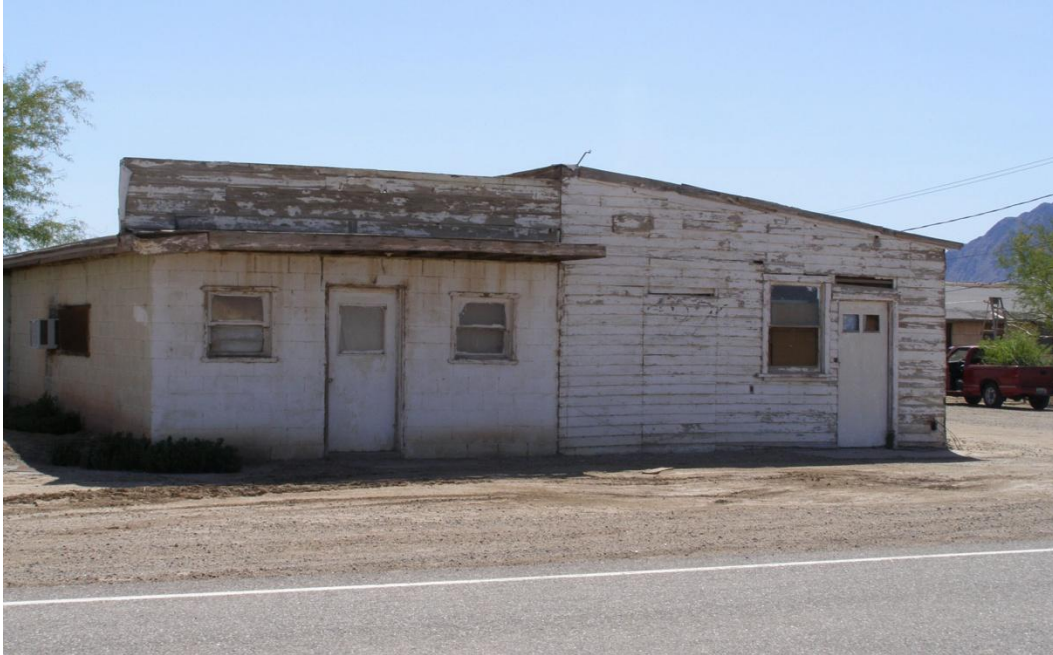
Figure 12. Mount Signal, Building 5.

Building 5 was constructed as a commercial building ca. 1940. It is a one-story building exhibiting elements of the Western False Front style and located on the south side of W. State Highway 98. The commercial building has two components, both of which are wooden-framed and rectangular in plan, with concrete foundation. The exteriors are clad in concrete block and wood clapboard siding. The component on the east side has a Western False Front parapet made of wood boards. The roof of this component is flat. It also has wood sash windows and a primary door located on the north elevation. The second component to the east has a shed roof, wood sash windows, and a door located on the north elevation. Modifications to the building include the change in fenestration on the shed-roof building and door replacements (Figure 12).

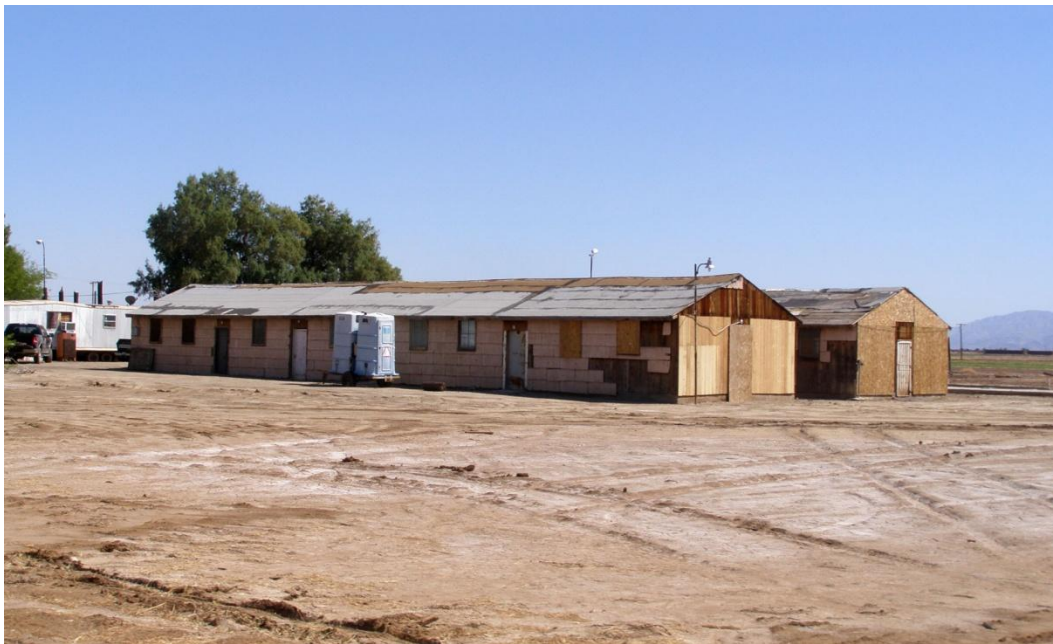
Figure 13. Mount Signal, Building 6a and 6b.

Buildings 6a and 6b were constructed as a two-building industrial complex ca. 1940. The vernacular buildings are located on the south side of State Highway 98. The buildings are similar in shape and size, wooden-framed and rectangular in plan with concrete foundations. The exteriors are clad in asbestos shingle siding. The roofs are moderately pitched front gable roofs with asphalt sheets. The windows are primarily casements or boarded over. Modifications to the building include the boarding over of windows and doors. Landscape features include a dirt-and-gravel drive (Figure 13).

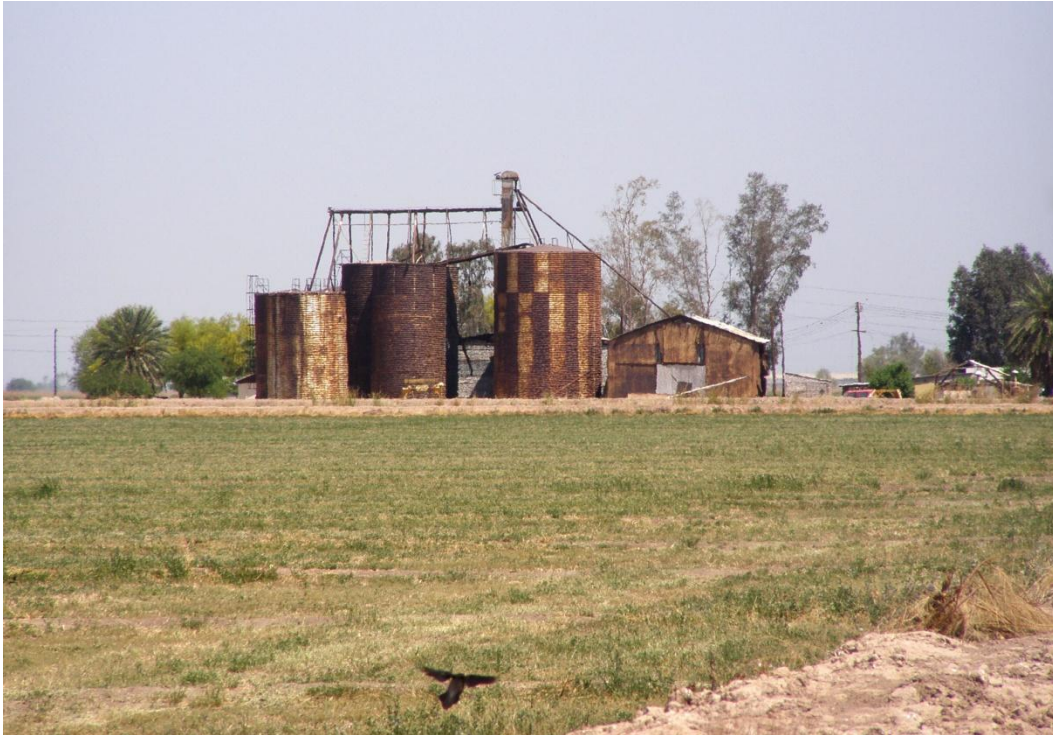
Figure 14. Brockman Ranch, Building 1 & Granary.

Building 1 and the granary silos are located on the south side of the property. They appear to be the oldest structures constructed on the property, constructed circa 1920. The building is a two-story barn building with a wood frame and metal sheet siding. The roof is clad in metal sheets as well (Figure 14).

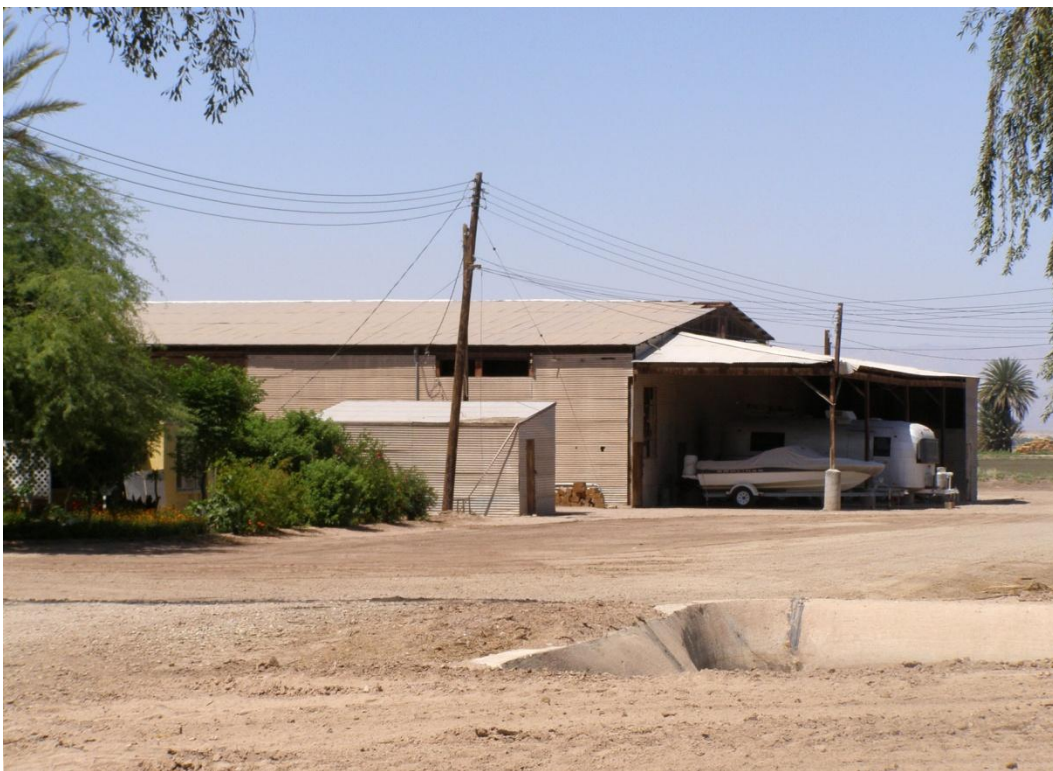
Figure 15. Brockman Ranch, Building 2.

Building 2 is located on the south side of the property lot north of Building 1 and the granary. It is a two-story barn building with a wood frame and clad in corrugated metal sheet siding. Corrugated metal sheets also clad the side gable roof. An attached carport structure is located on the north elevation (Figure 15).

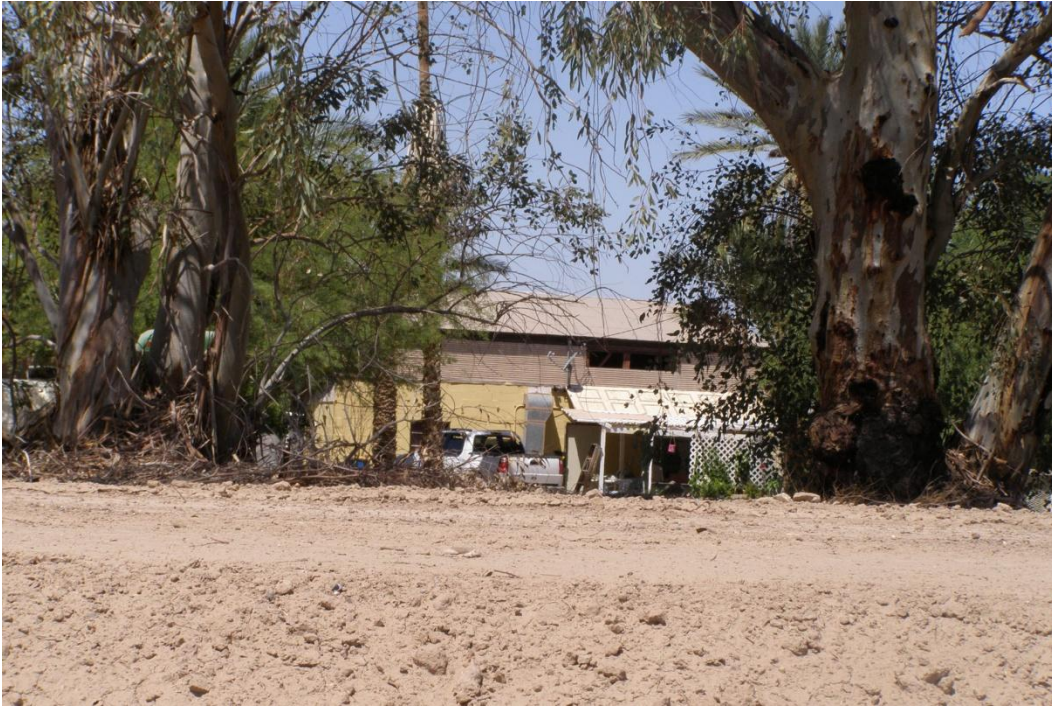
Figure 16. Brockman Ranch, Building 3.

Building 3 is located on the south side of the property lot west of Brockman Road and east of Building 2. The building has one story and appears to be a secondary residence. It has a flat roof and concrete block siding. There is a porch on the east elevation, with a shed roof and latticework. No other details could be seen from the road (Figure 16).

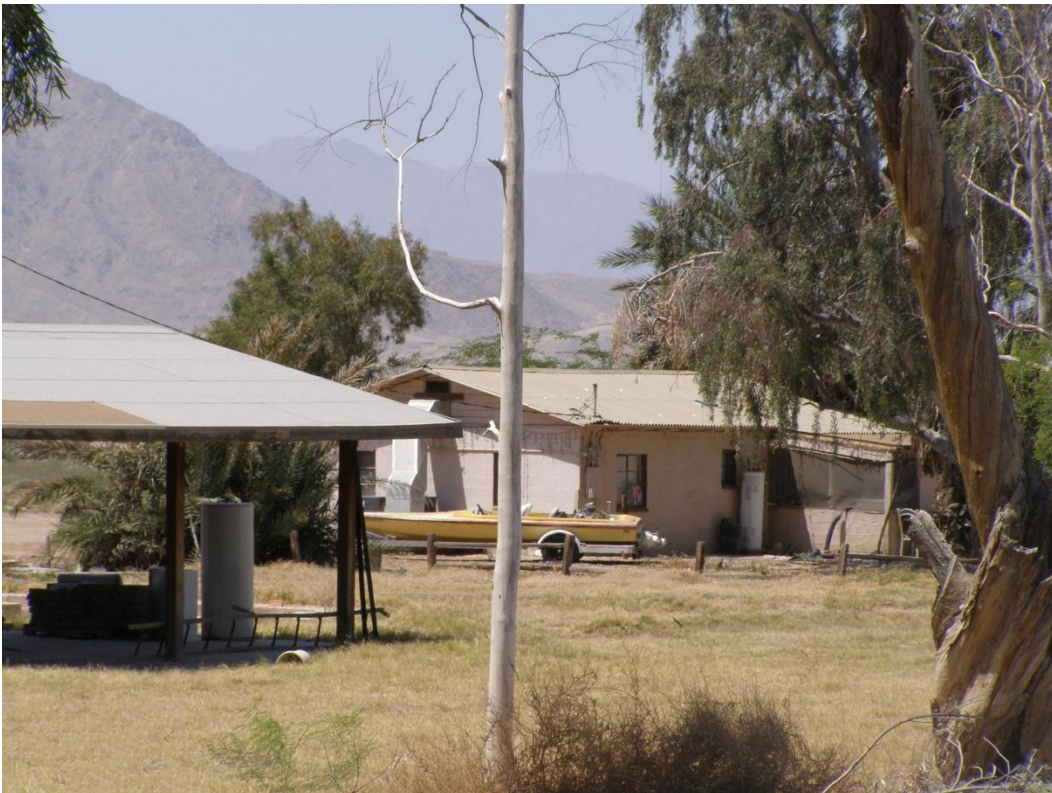
Figure 17. Brockman Ranch, Building 4 (background) and Building 7 (foreground).

Building 4 is located on the west side of the property lot. It has a front gable roof clad in corrugated metal sheets. The windows are triple hung sash aluminum windows. The building is a single family residence and has concrete block siding and wood siding underneath the gable ends. There is also a shed-roofed, enclosed porch on the north elevation (Figure 17).

Building 7 is a one-story front-gable storage shed with no walls. The roof is supported by wood beams (see Figures 17 and 18).

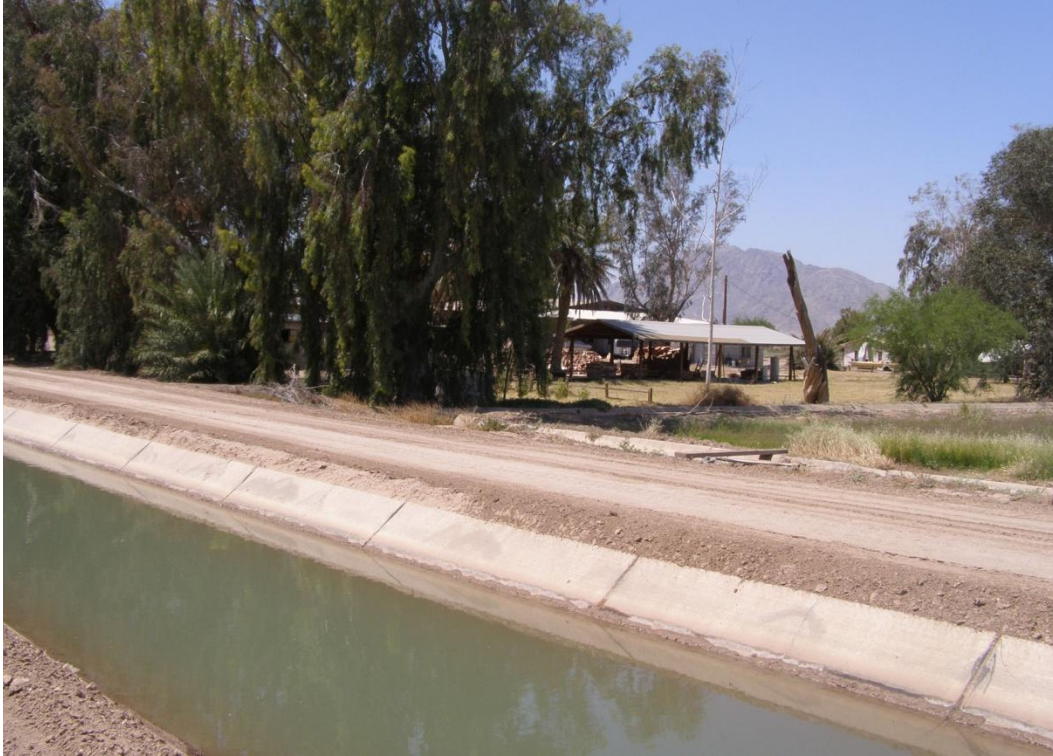
Figure 18. Brockman Ranch, Building 6 (background) and Building 7 (foreground).

Building 6 is a one-story shed-roof ancillary building. It has a door made of corrugated metal sheet siding. The building is clad in flat metal sheet siding (Figures 18 and 19).

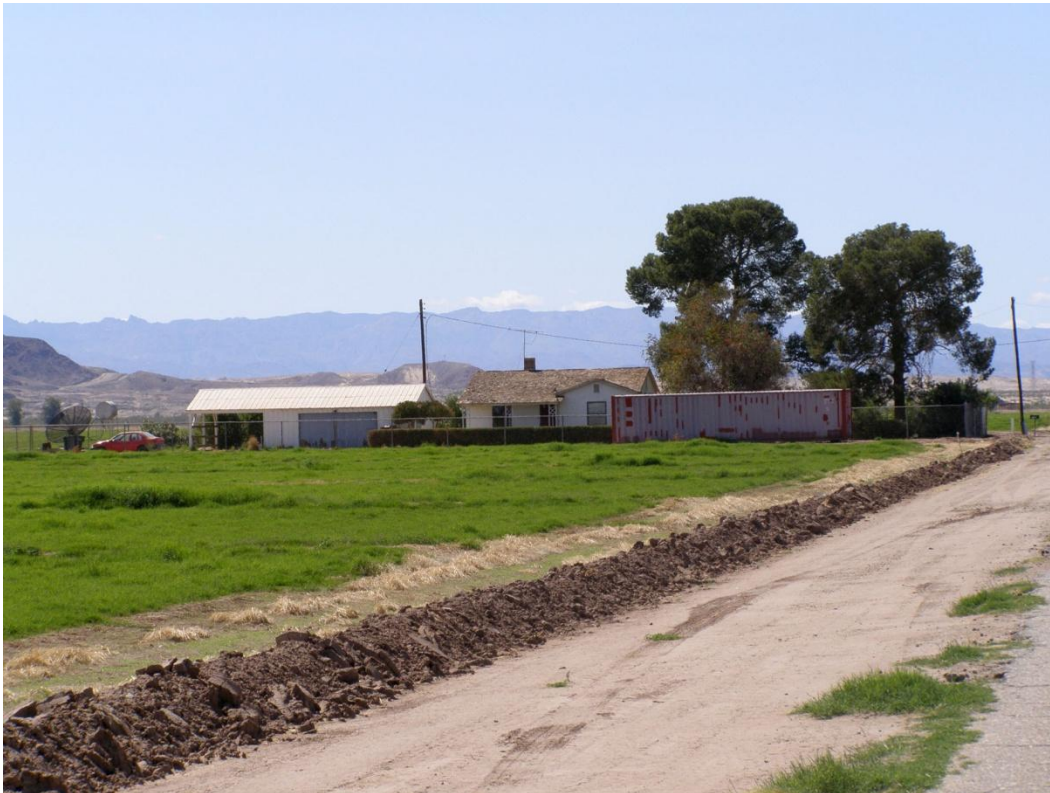
Figure 20. 1249 Anza Road, view looking west

The building at 1249 Anza Road was constructed as a single family residence ca. 1950. The one-and-one-half-story vernacular building is located on the south side of Anza Road. The building is wood-framed and rectangular in plan, with a concrete foundation. The exterior is clad in stucco siding. The roof is a moderately pitched front-gable roof with shallow eaves and clad in wood shingles. The main entryway could not be seen from the street at the time of the survey. The windows consist of double hung wood sash windows. There is a chimney located within the roofline. Additions could not be seen at the time of the survey. There is a garage located to the south of the main building. Landscape features include a chain-link fence, mature trees, and a lawn (Figure 20).

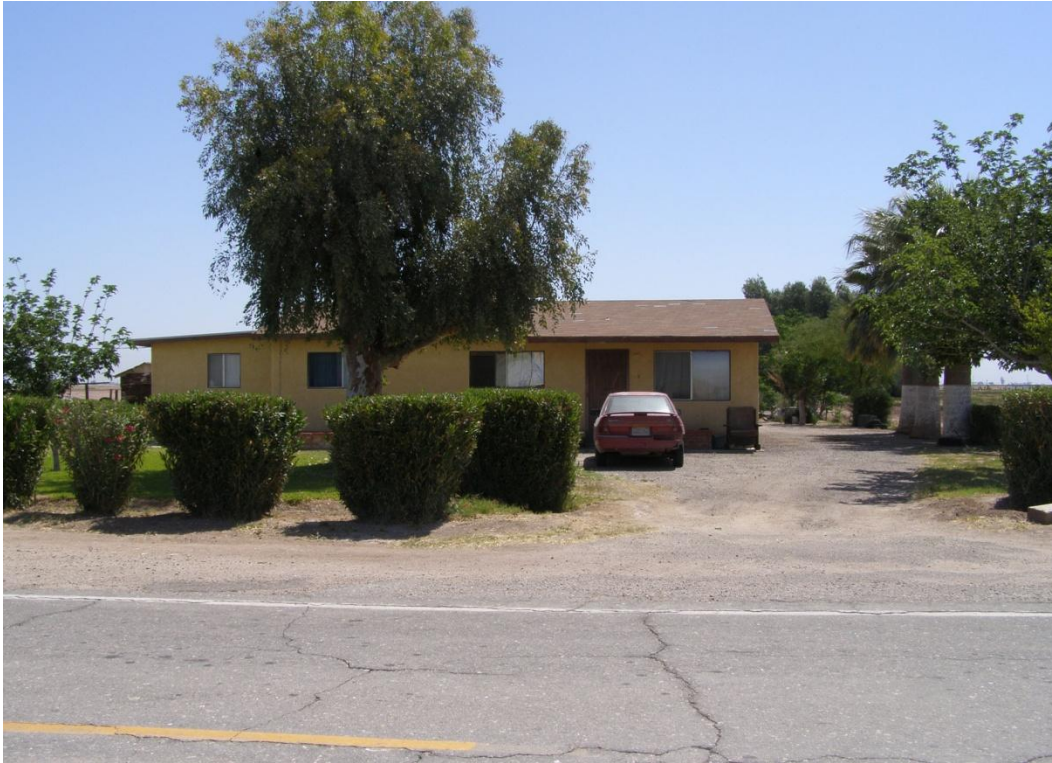
Figure 21. 640 Brockman Road.

The building at 640 Brockman Road was constructed as a single-family residence ca. 1965. The one-story vernacular building is located on the east side of Brockman Road. The building is wood-framed and rectangular in plan, with a concrete foundation. The exterior is clad in stucco and brick siding. The roof is a low-pitched side-gable roof with moderate eaves and clad in an asphalt roll. On the west elevation, a gravel driveway leads to the primary entrance and consists of a single door that is obscured by a metal security door. The windows consist of aluminum sliding windows. Additions include a shed roof extension on the north elevation. There appear to be no modifications to the building. Landscape features include trees, bushes, and a grass lawn (Figure 21).

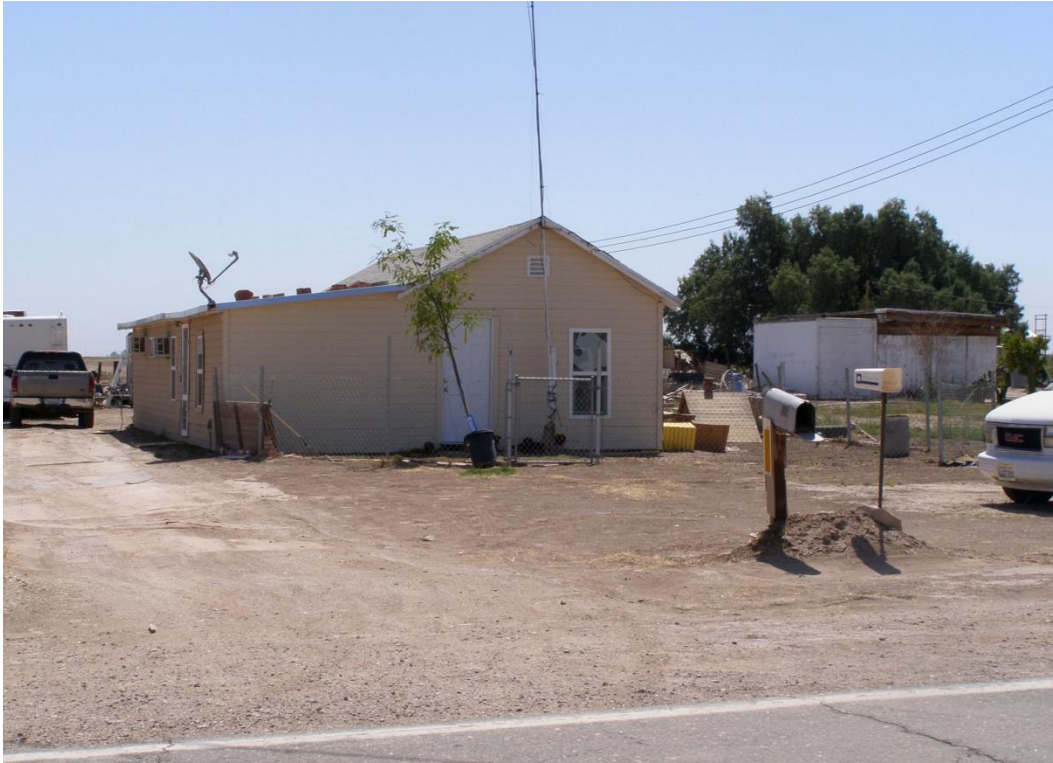
Figure 22. 644 Brockman Road.

The building at 644 Brockman Road was constructed as a single-family residence ca. 1940. The one-story vernacular building is located on the east side of Brockman Road. The building is wood-framed and rectangular in plan, with a concrete foundation. The exterior is clad in vinyl siding. The roof is a moderately pitched front-gable roof with shallow eaves and clad in asphalt. On the west elevation, a short concrete walkway leads to the primary entrance, which consists of a vinyl door. The windows consist of double hung vinyl sliding windows. Additions include a shed-roof extension on the north elevation. Modifications to the building include the replacement windows, doors, and siding. Landscape features include a chain-link fence and a dirt yard (Figure 22).

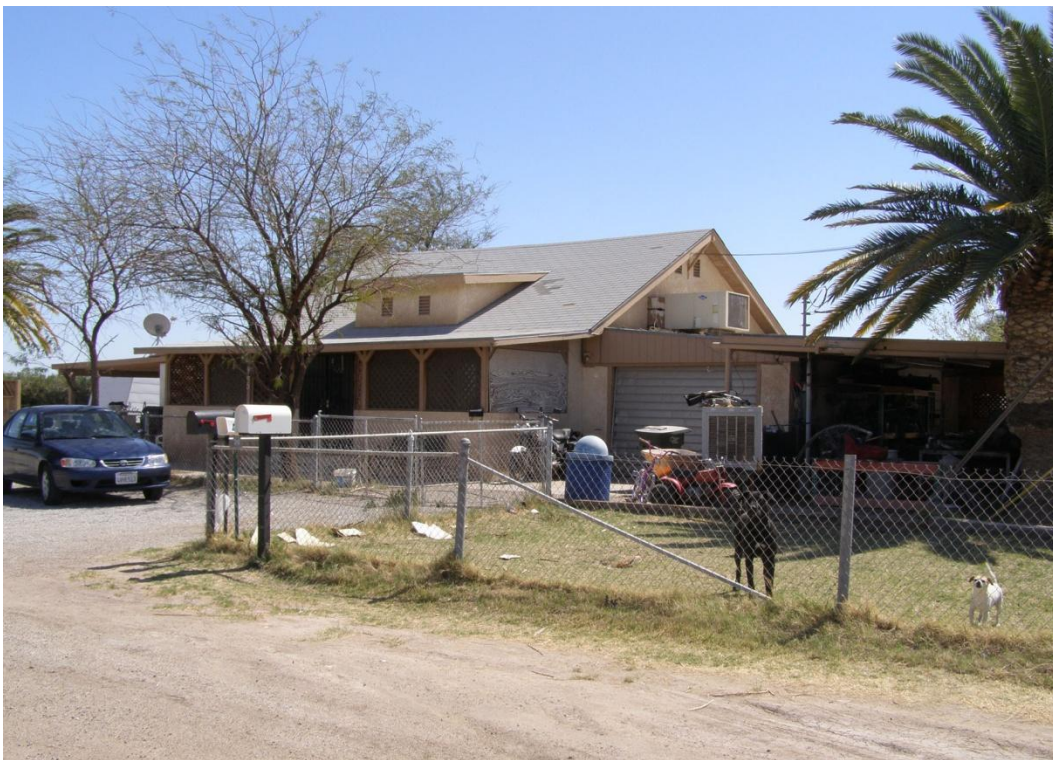
Figure 23. 405 Drew Road.

There is a shed roof dormer window that has two vent openings. Additions include two shed roof extensions on either side of the main facade. Modifications to the building include the non-original siding, as well as the attached garage extension. Landscape features include the chain-link fence that surrounds the perimeter of the property (Figure 23).

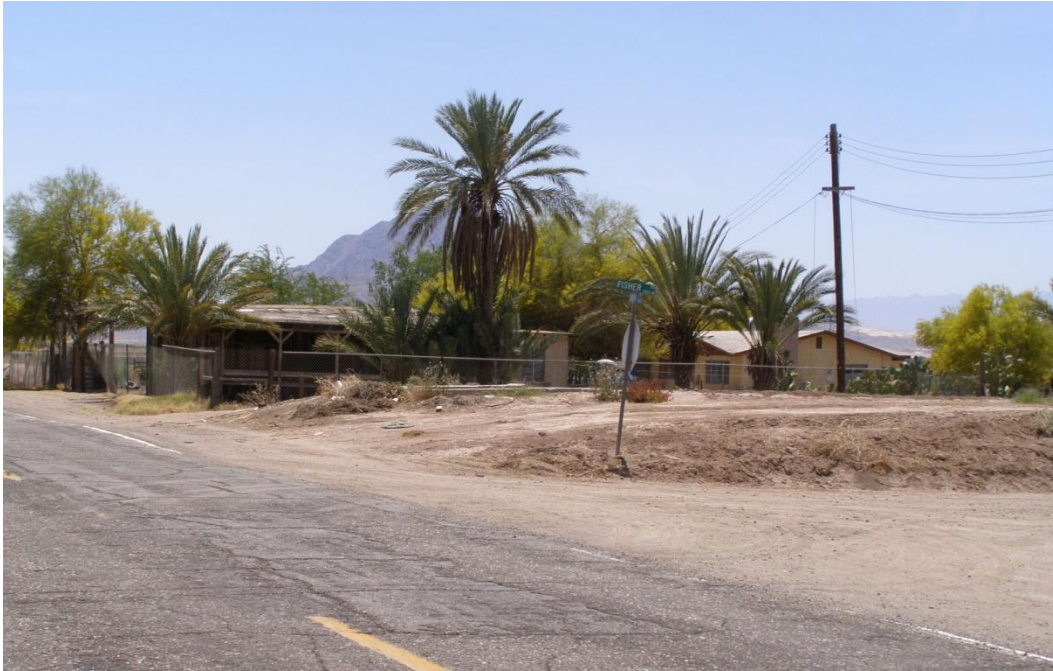
Figure 24. 695 Drew Road, Building 1.

Building 1 was constructed as a single-family residence ca. 1960. The one-story building is wooden-framed and rests on a concrete foundation. The roof has a widely pitched cross gable. The siding is stucco with wood siding underneath the gable ends. The primary entrance is located on the east elevation. The windows are primarily vinyl. There is a chimney on the north elevation. No other features of the building could be seen from the road at the time of the survey (Figure 24).

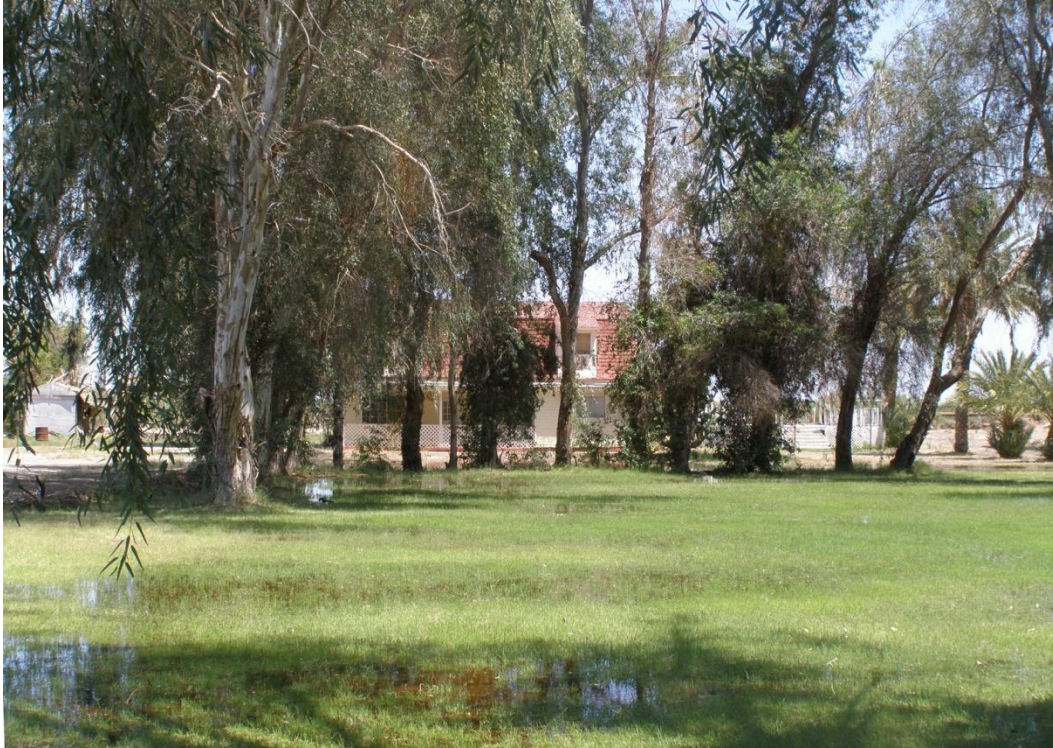
Figure 26. 705 Drew Road.

The building at 706 Drew Road was constructed as a single-family residence ca. 1958. The two-story Colonial Revival-style building is located on the east side of Drew Road. The building is wood-framed and rectangular in plan, with a concrete foundation. The exterior is clad in wood siding. The roof is a gambrel roof with split wood shingles and has two dormer windows. On the west elevation, a walkway and steps lead to a full-width porch with a shed roof and lined with latticework. The primary entrance is located within the porch and consists of a glazed door. The windows consist of vinyl sliders and vinyl fixed windows. Additions could not be seen from the street at the time of the survey. Modifications to the building include the carport extension on the north elevation. Landscape features include mature trees surrounding the property (Figure 26).

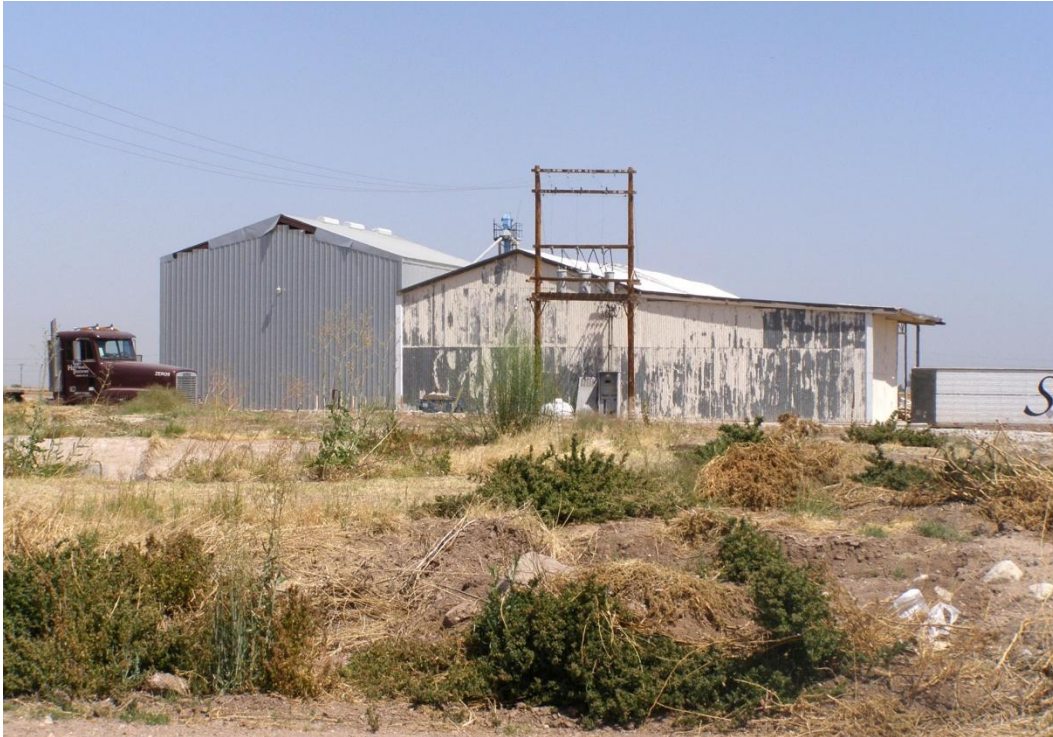
Figure 27. 1160 Kubler Road

The building at 1160 Kubler Road was constructed as an ancillary agricultural building ca. 1920. The two-story vernacular building is located on the north side of Kubler Road and is part of a larger agricultural ranch complex. The barn is wood-framed and rectangular in plan, with a concrete foundation. The exterior is clad in corrugated metal sheet siding. The roof is a low-pitched front-gable roof with exposed rafter tails and clad in standing seam metal. Additions include a shed-roof extension located on the east side of the building. There appear to be no modifications to the building. Other buildings within this complex include a mobile home, a modern barn, and shed and storage buildings (Figure 27).

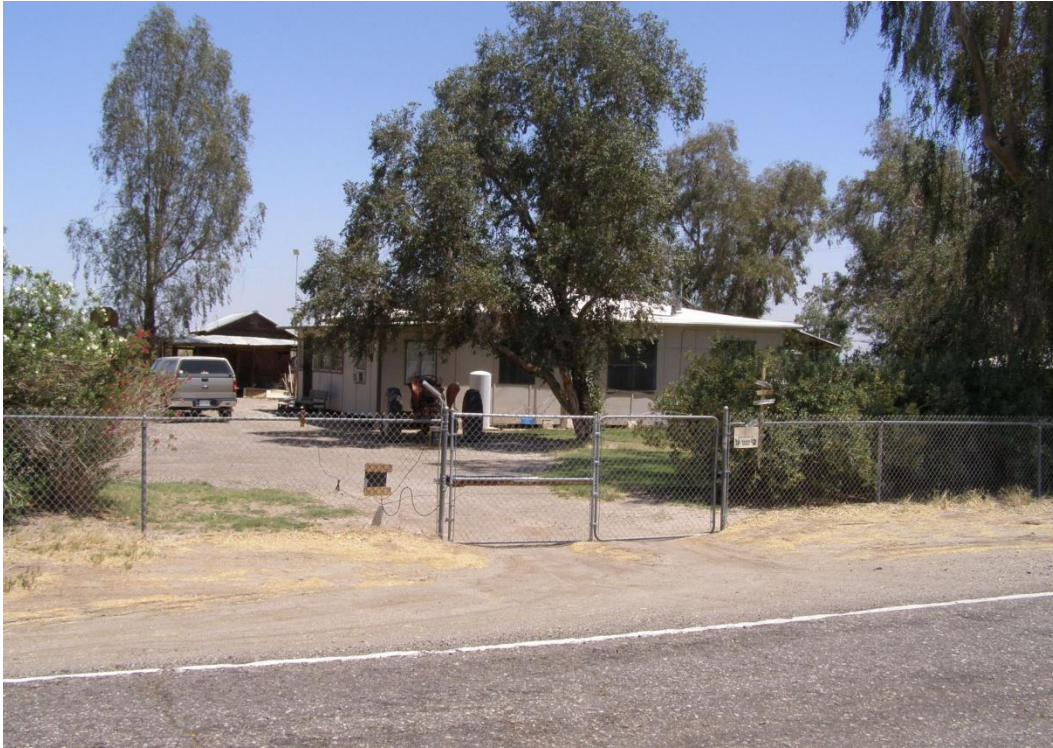
Figure 28. 1596 Fisher Road, Buildings 1 and 3c.

Building 1 is a single-family residence constructed ca. 1940. It is a one-story vernacular building with a concrete pier foundation. The building has a low-pitched hipped roof with wide eaves. The siding is a wood composite sheet siding with decorative wood strips. The windows are primarily vinyl sash and sliders. The main entrance is located on the south elevation and could not be seen at the time of the survey. There is an addition on the north elevation of the building. Modifications include the replacement windows and additions. There is also a gazebo located southwest of the main residence on the southwest corner of the property lot (Figure 28).

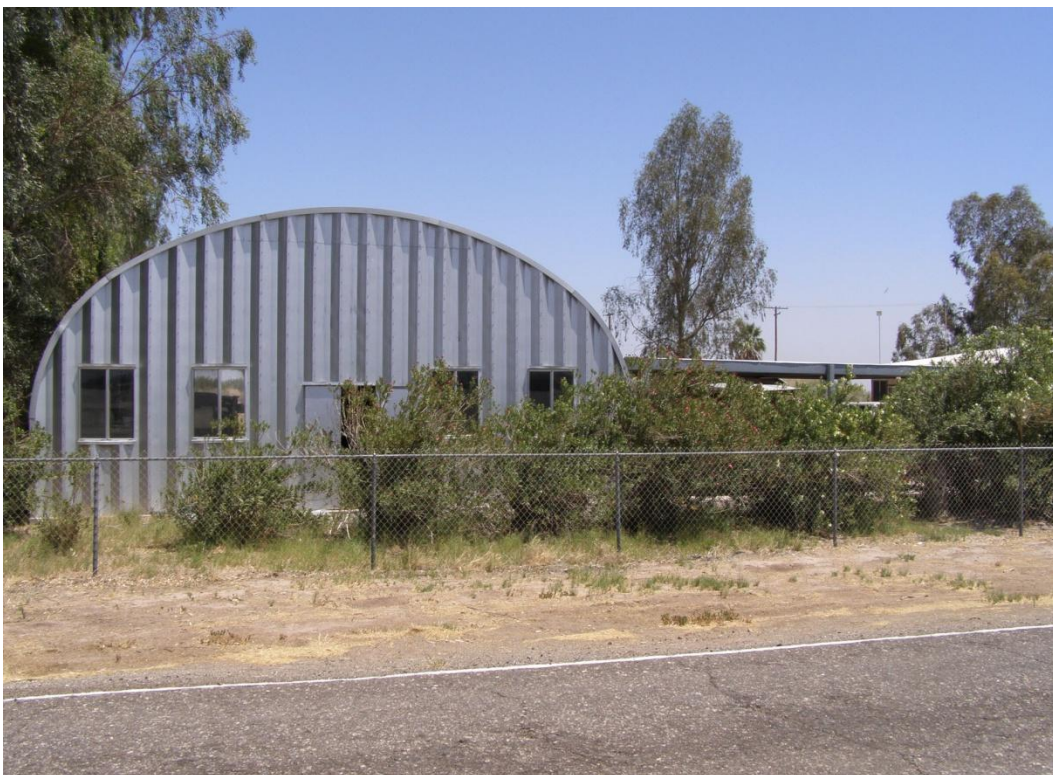
Figure 29. 1596 Fisher Road, Building 2.

Building 2 is an ancillary building located on the northeastern section of the property lot. The building is comprised of metal siding and has a barrel-shaped roof. The windows are primarily aluminum sliding windows. There is a primary entrance on the west elevation that consists of two metal-hinged doors. There is also a metal carport extension located on the south side of this building (Figure 29).

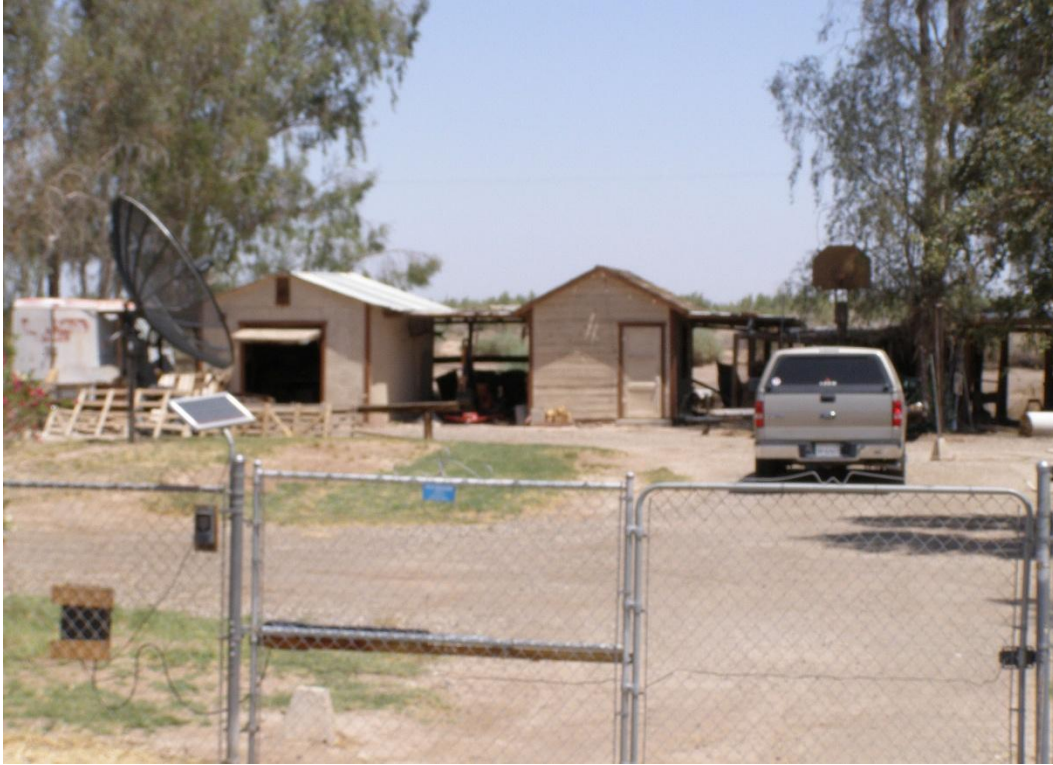
Figure 30. 1596 Fisher Road, Building 3a and 3b.

Building 3a is one of three connected sheds located to the rear of the main residence. Building 3a is located at the northwestern part of the property lot. It is a front-gable, wood-sided building with a hinged awning garage door located on the west elevation. The building has a standing seam metal roof. To the south of this building is a flat roof extension that connects it to Building 3b (Figure 30).

Building 3b is located to the south of Building 3a and is also a front-gable shed with wood siding and an asphalt roof. There is one paneled door located on the west elevation. A flat roof extension is located on the south elevation of the building which connects the building to a covered walkway/shop area that is not enclosed and is north of Building 3c (see Figure 30 and Figure 31).

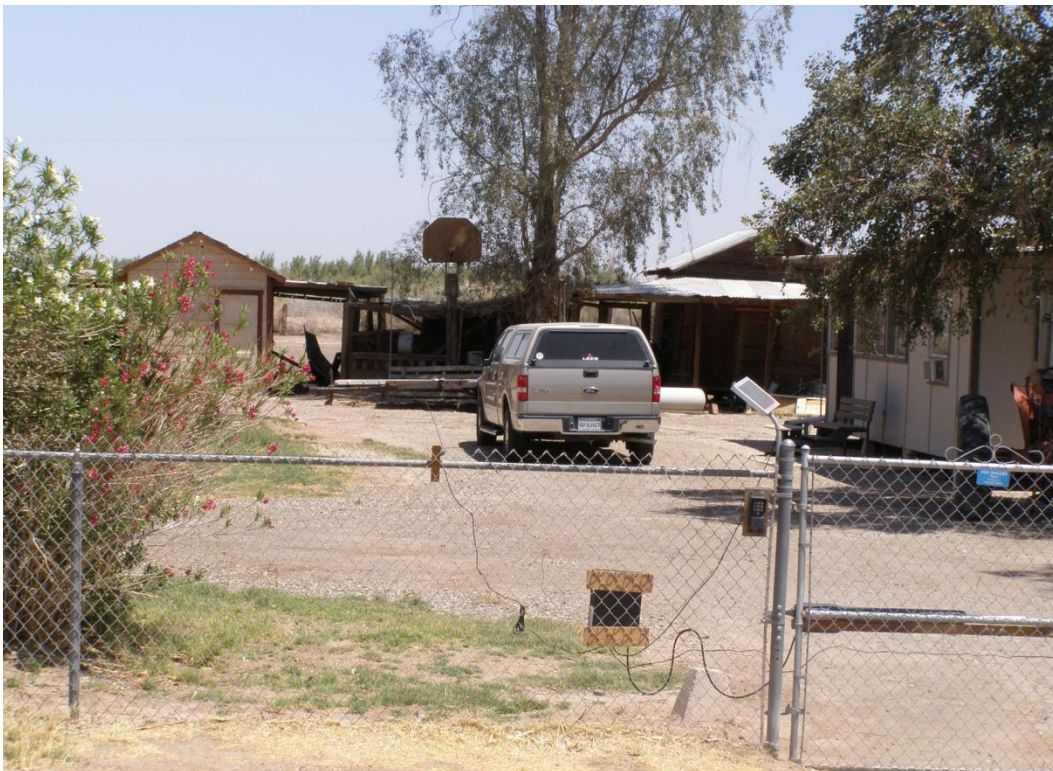
Figure 31. 1596 Fisher Road, Buildings 3b, 3c and 1.

Building 3c is located to the south of Building 3b and is a front-gable ancillary building with wood siding and a corrugated metal sheet roof. There is a hipped porch roof extension that wraps around the north and west elevations of the building. This porch area is enclosed by screens and wood posts. No other features could be seen of this building from the street at the time of the survey (Figure 31).
