**CULTURAL RESOURCE SURVEY  
FOR A PORTION OF THE  
CENTINELA SOLAR ENERGY, LLC PROJECT AREA  
IMPERIAL COUNTY, CALIFORNIA**

June 2011

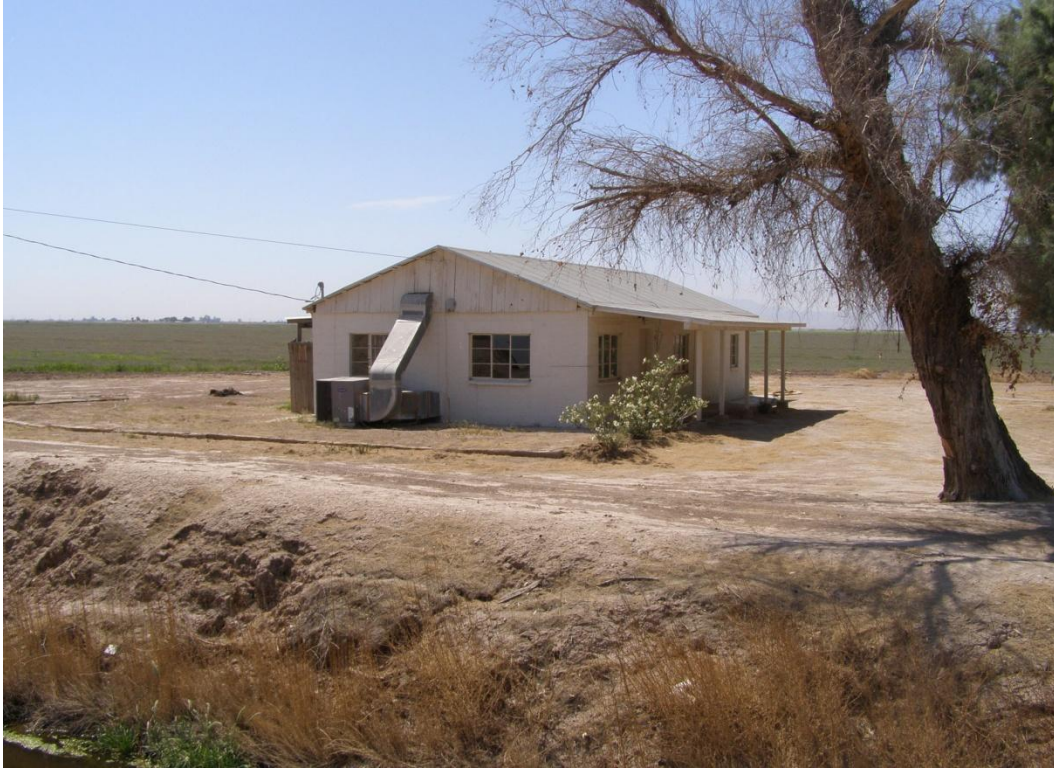
Figure 32. 596 Pulliam Road.

The building at 596 Pulliam Road was constructed as a single-family residence ca. 1950. It is a one-story vernacular building located on the southeastern side of Pulliam and Kubler roads. The building is wood-framed and rectangular in plan, with a concrete foundation. The exterior is clad in a concrete block siding and vertical wood siding underneath the gable ends. The roof is a low-pitched side-gable roof with shallow eaves and clad in standing seam metal. On the west elevation, the main entrance is situated within a nearly full-width porch with a shed roof. Squared wooden posts support the porch roof. The windows consist of 9-light windows. There appear to be no modifications to the building. Landscape features include mature trees and a dirt yard (Figure 32).

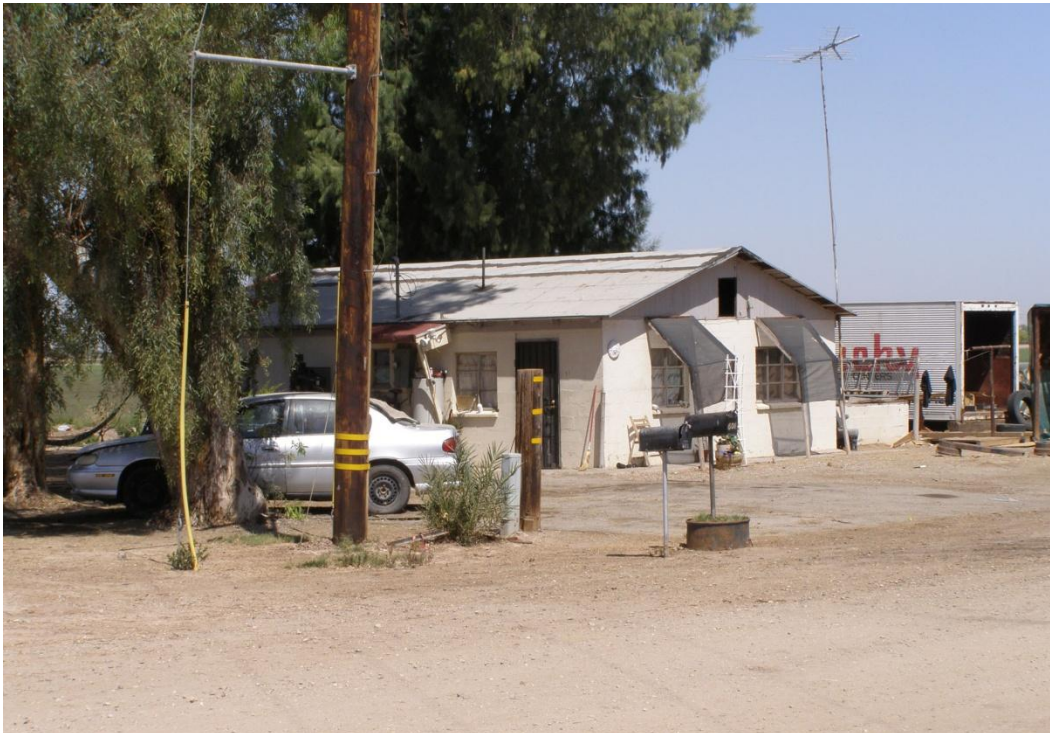
Figure 33. 605 Pulliam Road.

The building at 605 Pulliam Road was constructed as a single-family residence ca. 1950. It is a one-story vernacular building located on the northwest side of Pulliam and Kubler roads. The building is wood-framed and rectangular in plan, with a concrete foundation. The exterior is clad in concrete block siding. The roof is a low-pitched side-gable roof with shallow eaves and clad in asphalt sheets. The primary entrance is located on the south elevation and consists of a wood door obscured by a metal security door. The windows consist of wood sash and casement windows. Modifications to the building include the screen awnings. Landscape features include mature trees and a dirt yard (Figure 33).

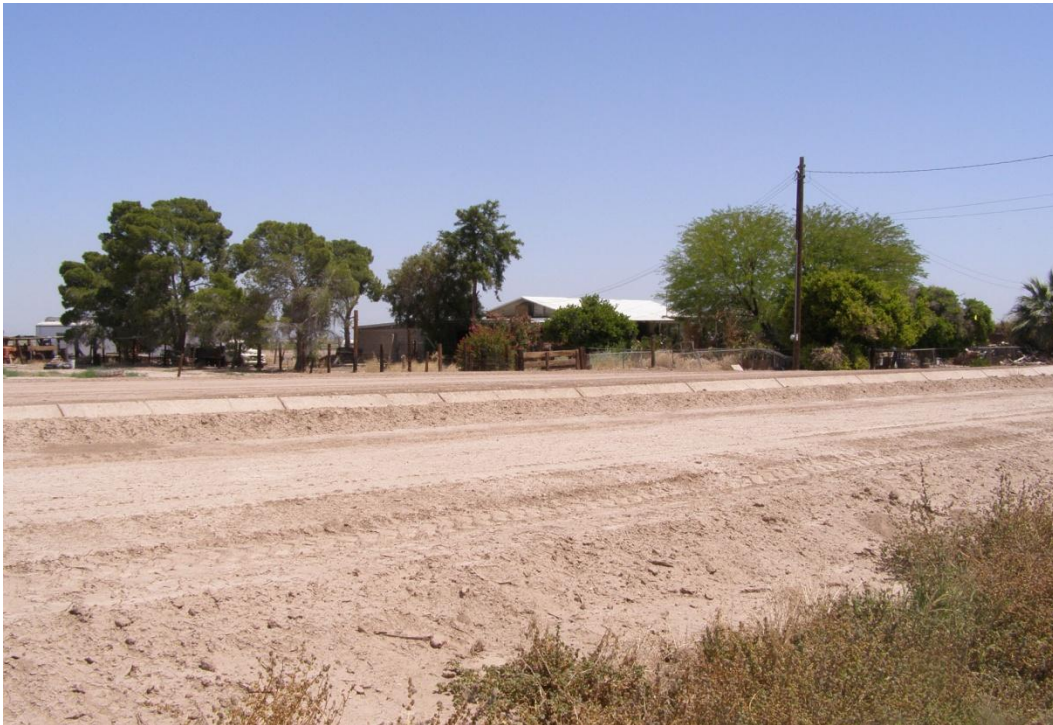
Figure 34. 904 State Highway 98.

The building at 904 State Hwy 98 was constructed as single-family residence ca. 1920. It is a one-and-one-half-story Craftsman-influenced building located on the north side of State Highway 98. The building is wood-framed and rectangular in plan, with a concrete foundation. The exterior is clad in wood clapboard siding. The roof is a low-pitched side-gable roof with exposed rafter tails and clad in corrugated metal sheets. On the south elevation, the primary entrance is located within the partial-width porch. The porch is covered by a shed roof extension of the main roof surface that is supported by wood posts. The windows could not be seen from the street at the time of the survey. Additions include a shed roof extension of the west elevation. Modifications to the building include replacement patch siding. Landscape features include trees and a wood and chain-link fence surrounding the property. There are other ancillary buildings on the property located to the rear of the main building that could not be seen from the street at the time of the survey (Figure 34).
