Vega SES LLC Solar Project El Centro, California Added Parcel (APN 051-390-012) Preliminary Jurisdictional Waters/Wetlands Delineation Report

Prepared for: Vega SES LLC 604 Sutter Street, Suite 250 Folsom, California 95630

Prepared by: Stantec Consulting Services Inc. 290 Conejo Ridge Avenue Thousand Oaks, California 91361

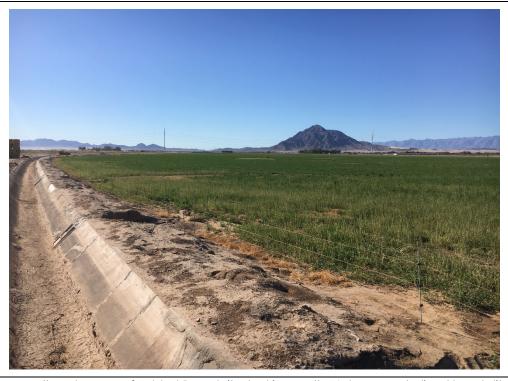
Photo 1: October 23, 2017

From northeast corner of Added Parcel site, looking south. Note concrete-lined head ditch along the left side of the photograph – a non-jurisdictional drainage.

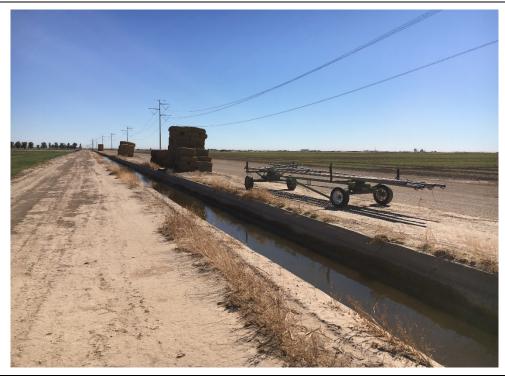
Photo 2: October 23, 2017

From southeast corner of Added Parcel site, looking north. Note Wormwood Lateral 4 canal – generally carries water year round and would be considered a jurisdictional resource.

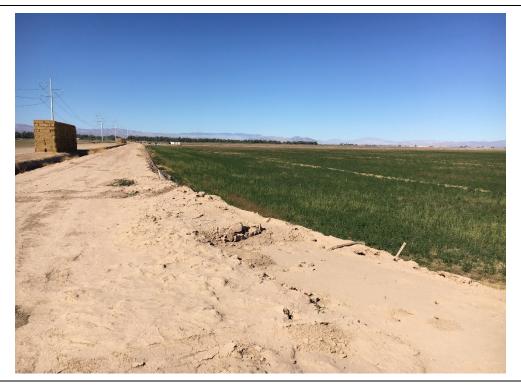
Photo 3: October 23, 2017

From southeast corner of Added Parcel Site, looking west.

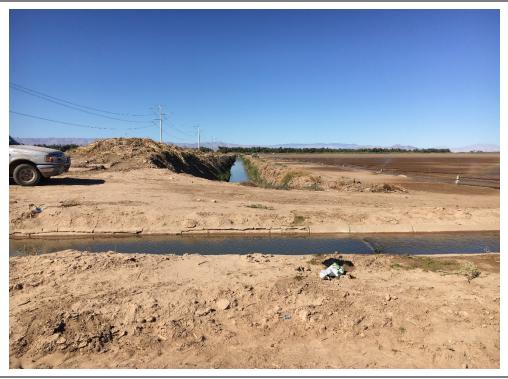
Photo 4: October 23, 2017

From southwest corner of site, looking west toward Fig Drain No. 1B. Note, concrete lined channel in the foreground is a head ditch that periodically conveys flow for irrigation – a nonjurisdictional drainage.
