Jurisdictional Features

Table 1 - Summary of Potential Federally Jurisdictional Waters

Photographs

Campo Verde Solar Project Drainage Mapbook

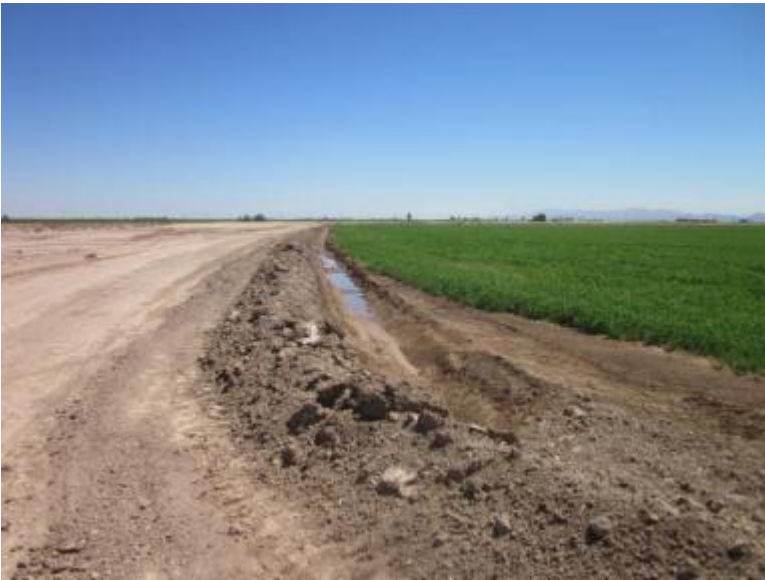
Drainage #18 – Photo 23

Mapbook Pages: E-1
Photographs: 23
ACOE Jurisdiction: Not Jurisdictional

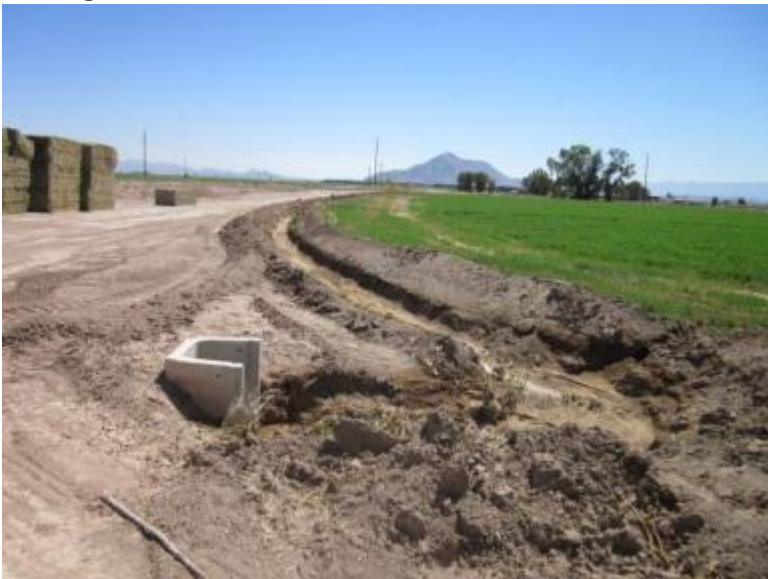
Drainage #22 – Photo 40

Mapbook Pages: D-2, E-1, E-2
 Photographs: 40, 41
 ACOE Jurisdiction: Potentially Jurisdictional
 CDFG Jurisdiction: Potentially Jurisdictional
 Feature Type: Canal
 Riparian Vegetation: None
 Substrate: Concrete

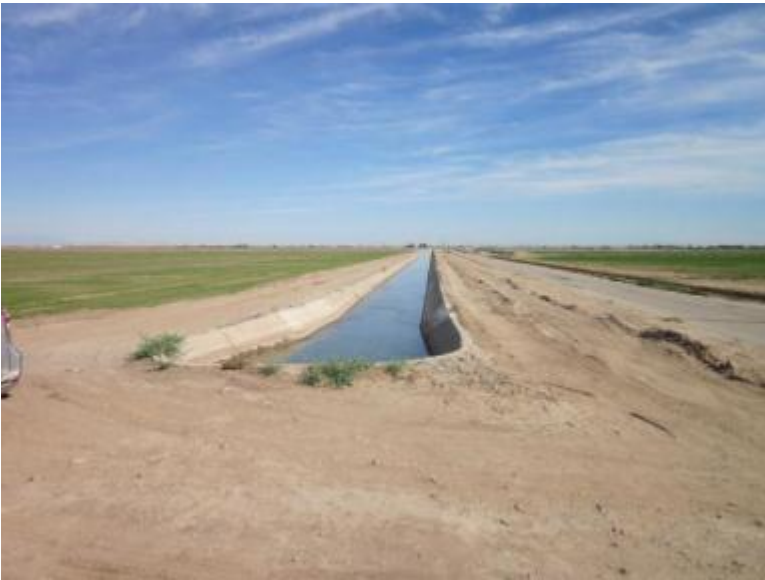
Drainage #23 – Photo 42

Mapbook Pages: E-2
 Photographs: 42
 ACOE Jurisdiction: Not Jurisdictional
 CDFG Jurisdiction: Not Jurisdictional
 Feature Type: Head Ditch
 Riparian Vegetation: None
 Substrate: Concrete

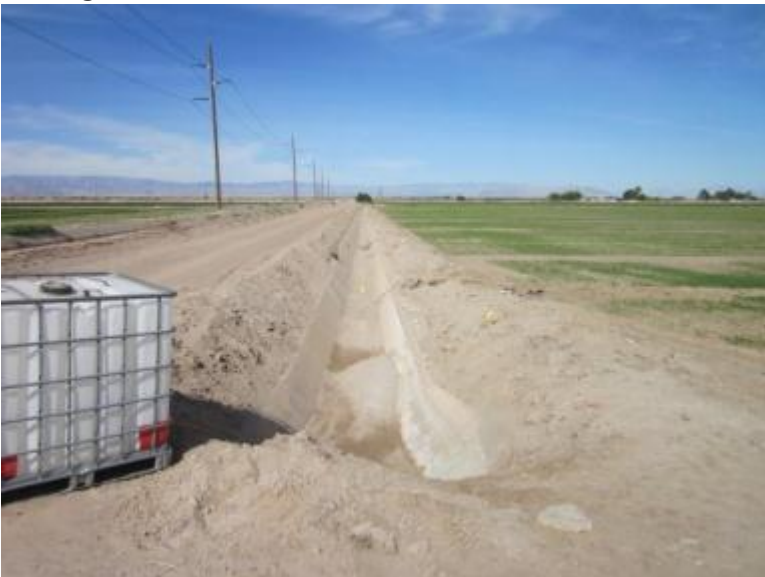
Drainage #24 – Photo 43

Mapbook Pages: E-2
 Photographs: 43
 ACOE Jurisdiction: Not Jurisdictional
 CDFG Jurisdiction: Not Jurisdictional
 Feature Type: Tail Ditch
 Riparian Vegetation: None
 Substrate: Earthen

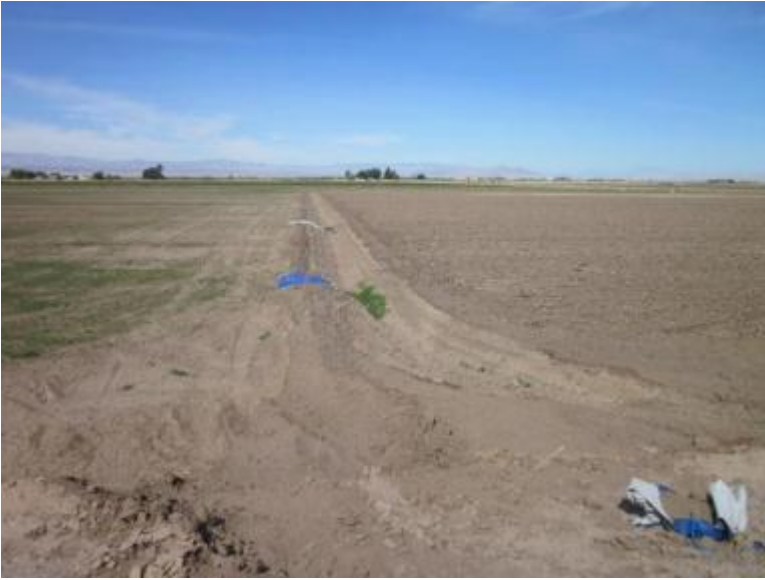
Drainage #25 – Photo 44

Mapbook Pages: D-2, E-2
 Photographs: 44
 ACOE Jurisdiction: Not Jurisdictional
 CDFG Jurisdiction: Not Jurisdictional
 Feature Type: Head Ditch
 Riparian Vegetation: None
 Substrate: Concrete

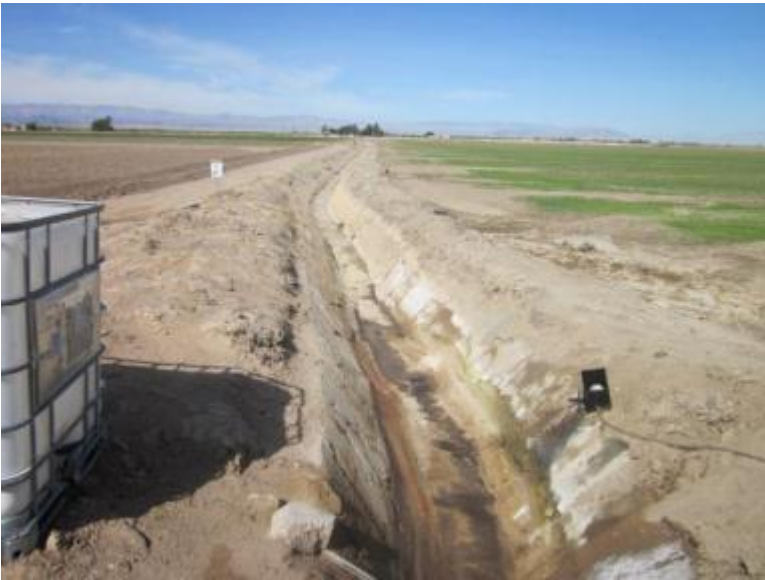
Drainage #26 – Photo 45

Mapbook Pages: D-2, E-2
 Photographs: 45
 ACOE Jurisdiction: Not Jurisdictional
 CDFG Jurisdiction: Not Jurisdictional
 Feature Type: Tail Ditch
 Riparian Vegetation: None
 Substrate: Earthen

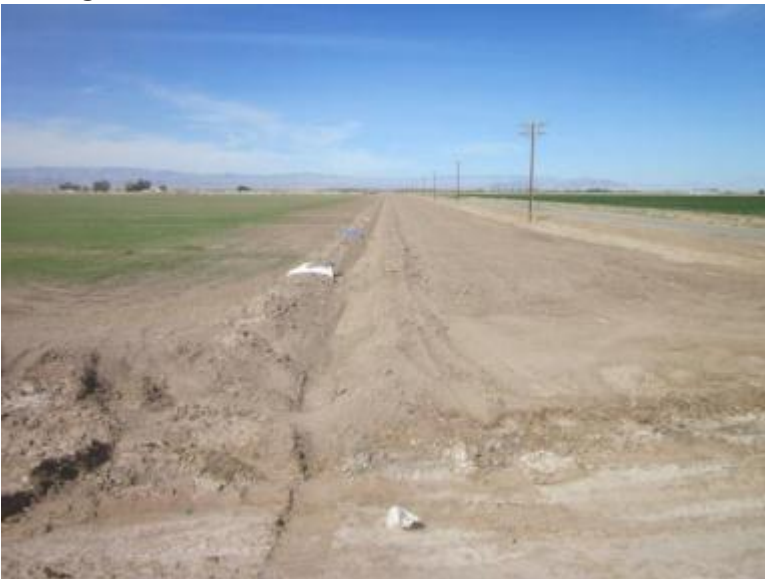
Drainage #27 – Photo 46

Mapbook Pages: D-1, D-2
 Photographs: 46, 47, 50, 51, 146, 147
 ACOE Jurisdiction: Potentially Jurisdictional
 CDFG Jurisdiction: Potentially Jurisdictional
 Feature Type: Drain
 Riparian Vegetation: Yes
 Substrate: Earthen

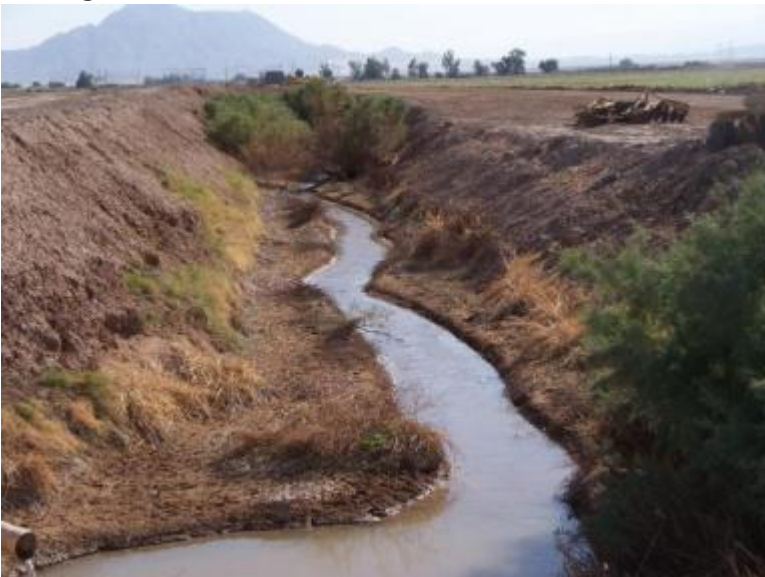
Drainage #29 – Photo 49

Mapbook Pages: D-1, D-2
 Photographs: 49
 ACOE Jurisdiction: Not Jurisdictional
 CDFG Jurisdiction: Not Jurisdictional
 Feature Type: Tail Ditch
 Riparian Vegetation: None
 Substrate: Earthen

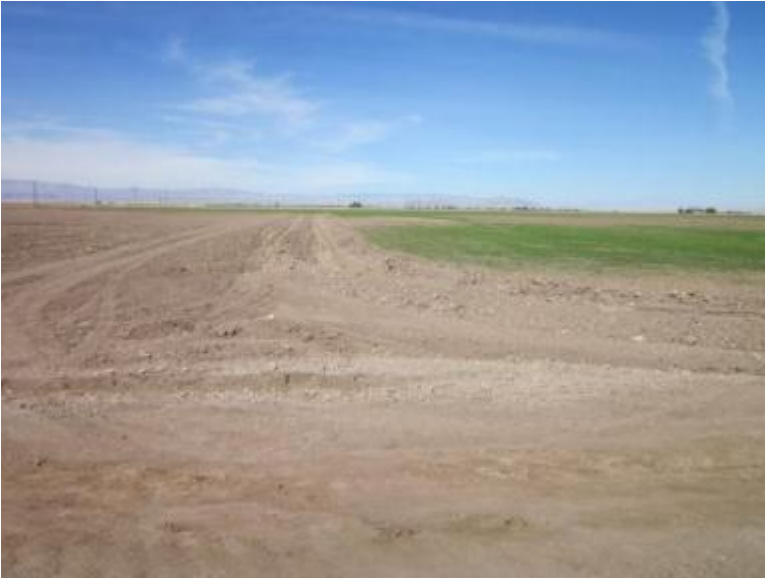
Drainage #30 – Photo 52

Mapbook Pages: E-1
 Photographs: 52, 53
 ACOE Jurisdiction: Not Jurisdictional
 CDFG Jurisdiction: Not Jurisdictional
 Feature Type: Head Ditch
 Riparian Vegetation: None
 Substrate: Concrete

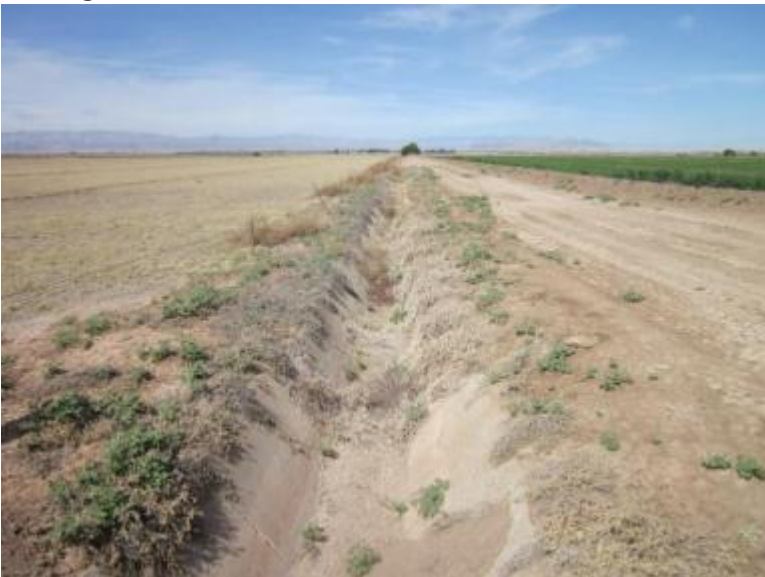
Drainage #31 – Photo 54

Mapbook Pages: D-1, D-2
 Photographs: 54, 55
 ACOE Jurisdiction: Not Jurisdictional
 CDFG Jurisdiction: Not Jurisdictional
 Feature Type: Head Ditch
 Riparian Vegetation: None
 Substrate: Concrete

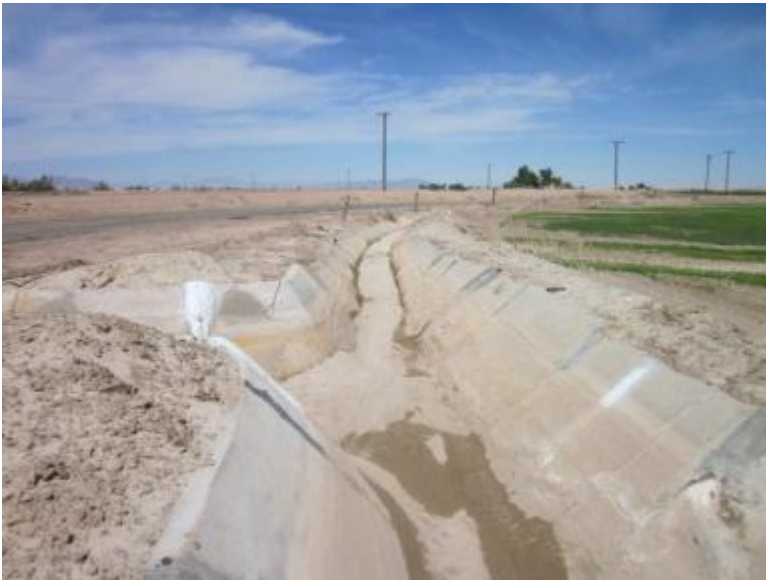
Drainage #32 – Photo 57

Mapbook Pages: D-1
 Photographs: 57
 ACOE Jurisdiction: Not Jurisdictional
 CDFG Jurisdiction: Not Jurisdictional
 Feature Type: Head Ditch
 Riparian Vegetation: None
 Substrate: Concrete

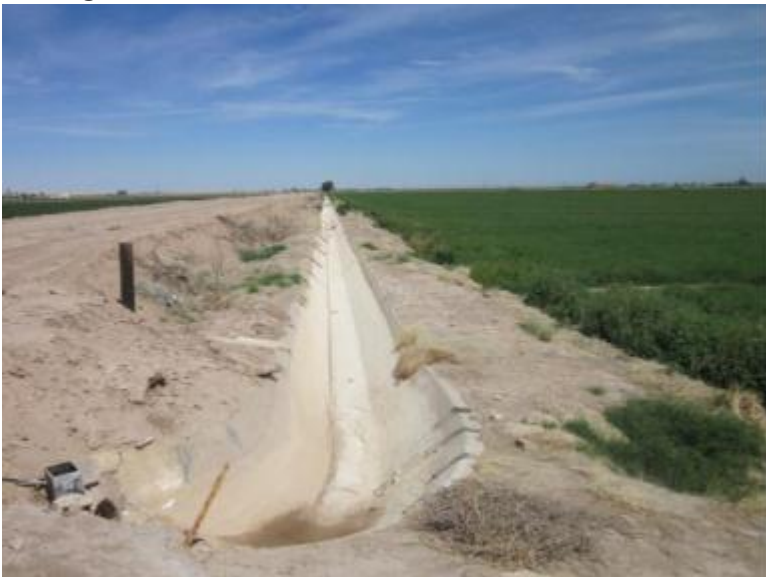
Drainage #33 – Photo 56

Mapbook Pages: D-1, D-2, D-3
 Photographs: 56
 ACOE Jurisdiction: Potentially Jurisdictional
 CDFG Jurisdiction: Potentially Jurisdictional
 Feature Type: Canal
 Riparian Vegetation: None
 Substrate: Concrete

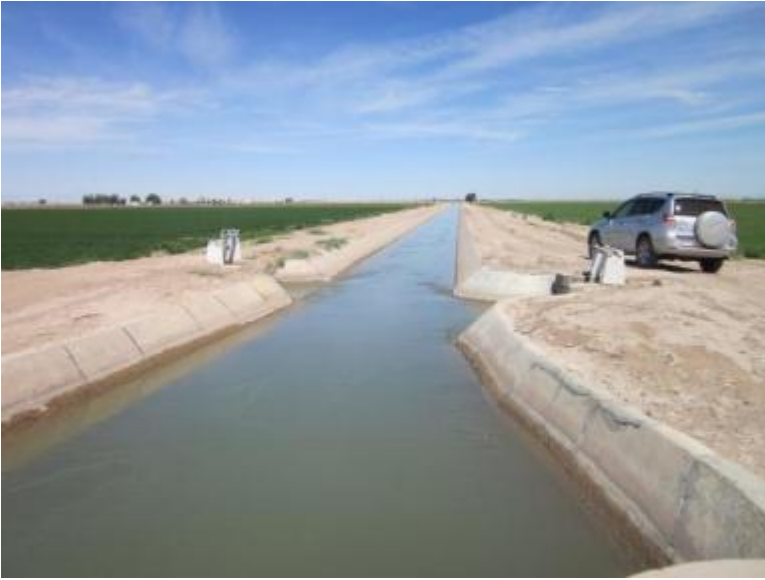
Drainage #34 – Photo 60

Mapbook Pages: D-1
 Photographs: 60
 ACOE Jurisdiction: Not Jurisdictional
 CDFG Jurisdiction: Not Jurisdictional
 Feature Type: Tail Ditch
 Riparian Vegetation: None
 Substrate: Earthen

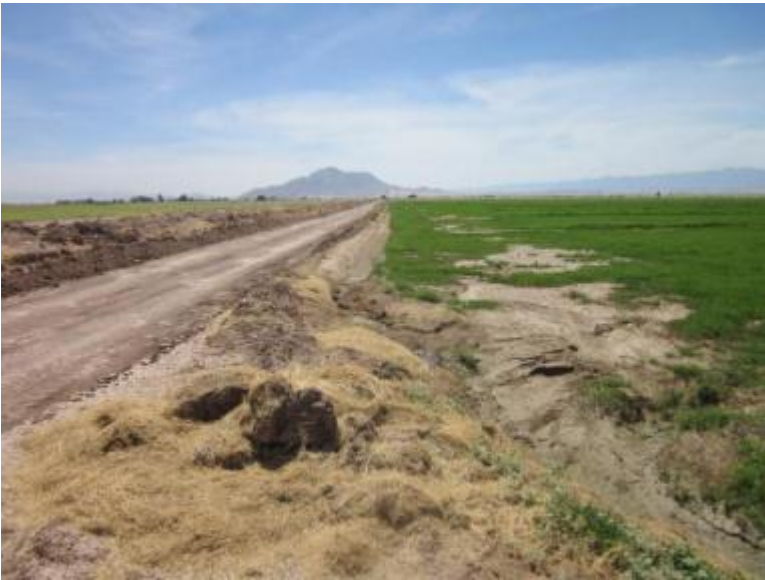
Drainage #35 – Photo 61

Mapbook Pages: C-2
 Photographs: 61
 ACOE Jurisdiction: Not Jurisdictional
 CDFG Jurisdiction: Not Jurisdictional
 Feature Type: Tail Ditch
 Riparian Vegetation: None
 Substrate: Earthen

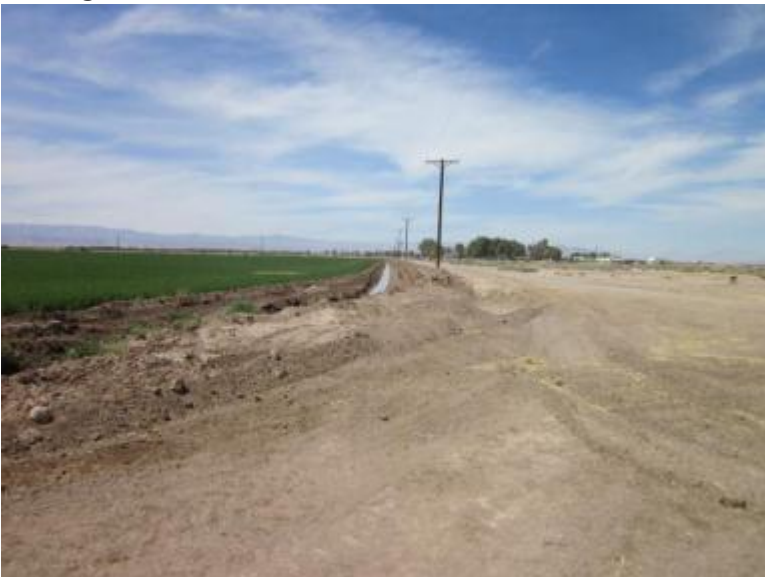
Drainage #36 – Photo 62

Mapbook Pages: C-2
 Photographs: 62
 ACOE Jurisdiction: Not Jurisdictional
 CDFG Jurisdiction: Not Jurisdictional
 Feature Type: Head Ditch
 Riparian Vegetation: None
 Substrate: Concrete

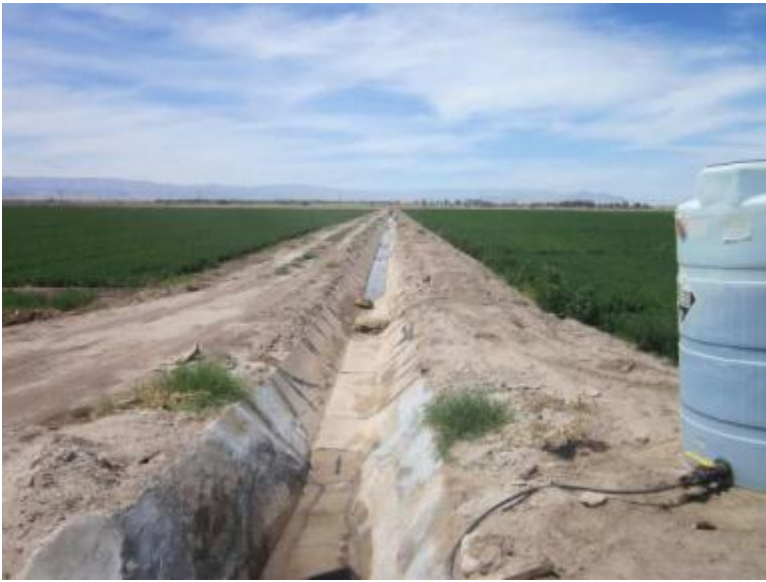
Drainage #37 – Photo 63

Mapbook Pages: C-2, C-3
 Photographs: 63
 ACOE Jurisdiction: Not Jurisdictional
 CDFG Jurisdiction: Not Jurisdictional
 Feature Type: Tail Ditch
 Riparian Vegetation: None
 Substrate: Earthen

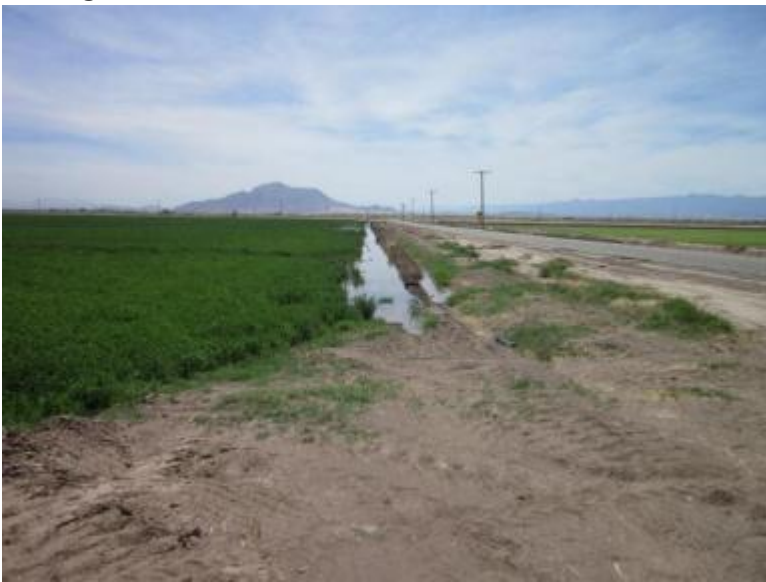
Drainage #38 – Photo 65

Mapbook Pages: D-1
 Photographs: 65

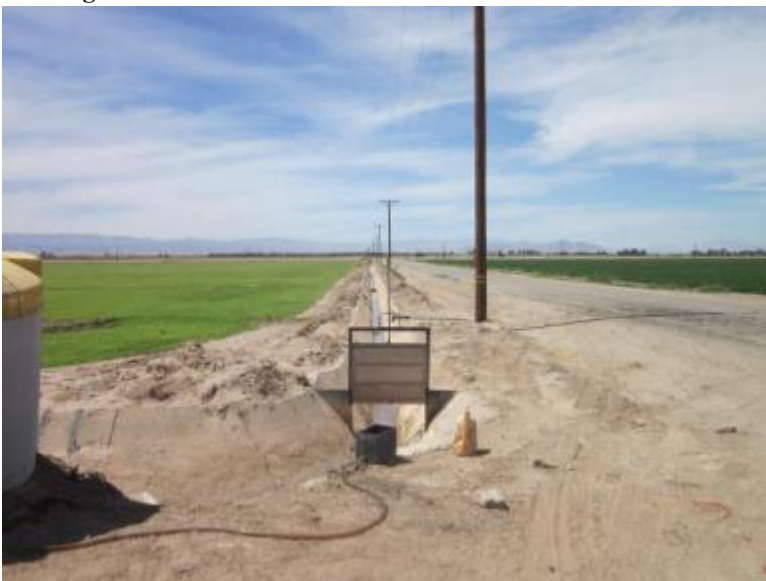
Drainage #39 – Photo 64

Mapbook Pages: C-3, D-1
Photographs: 64
ACOE Jurisdiction: Not Jurisdictional
CDFG Jurisdiction: Not Jurisdictional
Feature Type: Head Ditch
Riparian Vegetation: None
Substrate: Concrete

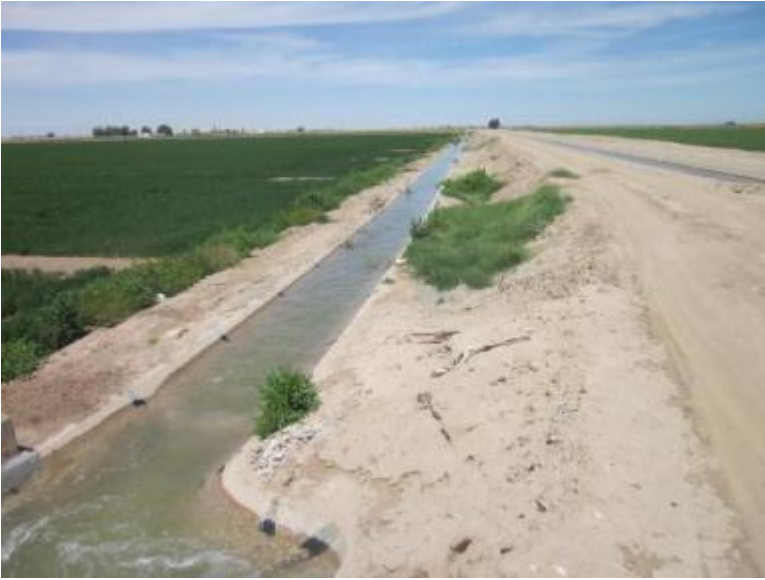
Drainage #40 – Photo 66

Mapbook Pages: D-1, D-2
Photographs: 66
ACOE Jurisdiction: Not Jurisdictional
CDFG Jurisdiction: Not Jurisdictional
Feature Type: Head Ditch
Riparian Vegetation: None
Substrate: Concrete/Earthen

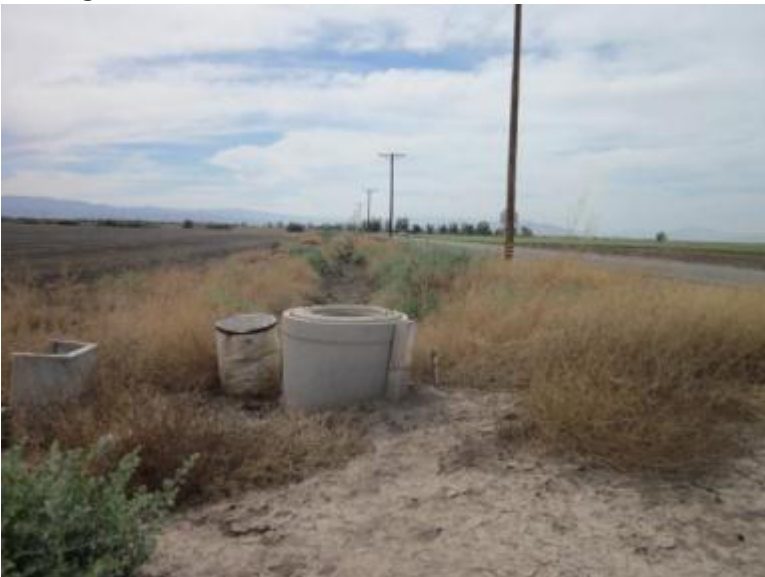
Drainage #53 – Photo 81

Mapbook Pages: C-2
Photographs: 81
ACOE Jurisdiction: Not Jurisdictional
CDFG Jurisdiction: Not Jurisdictional
Feature Type: Tail Ditch
Riparian Vegetation: Limited
Substrate: Earthen

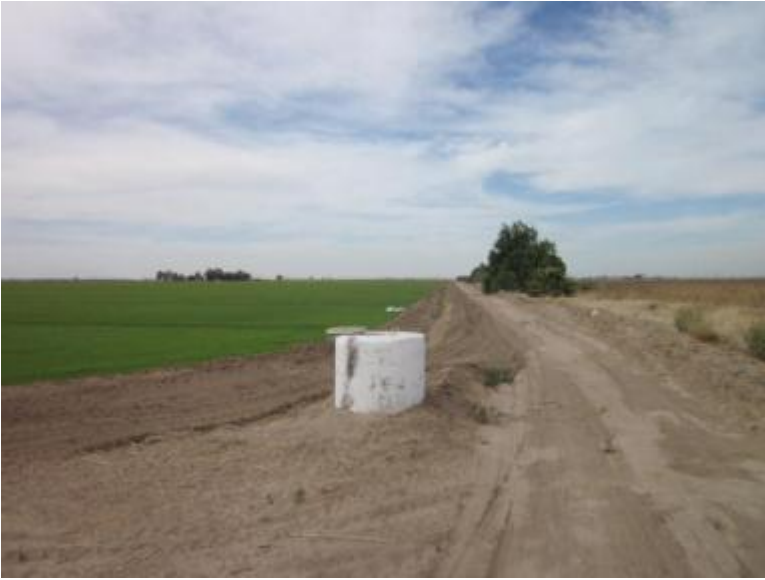
Drainage #54 – Photo 82

Mapbook Pages: C-2, C-3
Photographs: 82
ACOE Jurisdiction: Not Jurisdictional
CDFG Jurisdiction: Not Jurisdictional

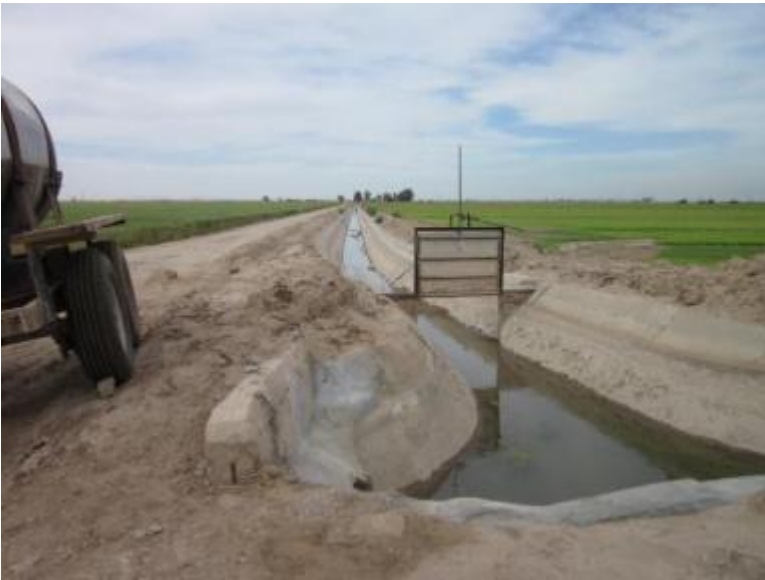
Drainage #55 – Photo 83

Mapbook Pages: C-1, C-2, C-3
Photographs: 83, 86
ACOE Jurisdiction: Not Jurisdictional
CDFG Jurisdiction: Not Jurisdictional
Feature Type: Head Ditch
Riparian Vegetation: None
Substrate: Concrete

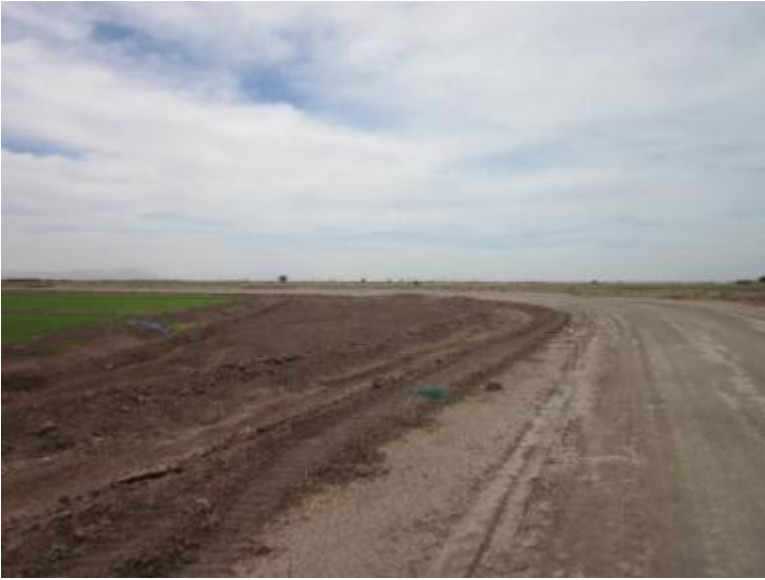
Drainage #56 – Photo 84

Mapbook Pages: C-1, C-2
Photographs: 84, 143
ACOE Jurisdiction: Not Jurisdictional
CDFG Jurisdiction: Not Jurisdictional
Feature Type: Tail Ditch
Riparian Vegetation: None
Substrate: Earthen

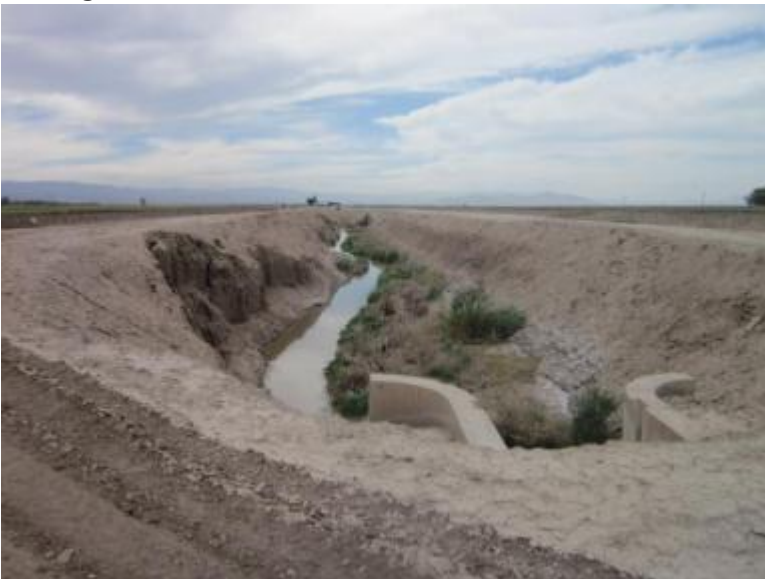
Drainage #57 – Photo 85

Mapbook Pages: C-1, C-2
 Photographs: 85
 ACOE Jurisdiction: Potentially Jurisdictional
 CDFG Jurisdiction: Potentially Jurisdictional
 Feature Type: Drain
 Riparian Vegetation: Yes
 Substrate: Earthen

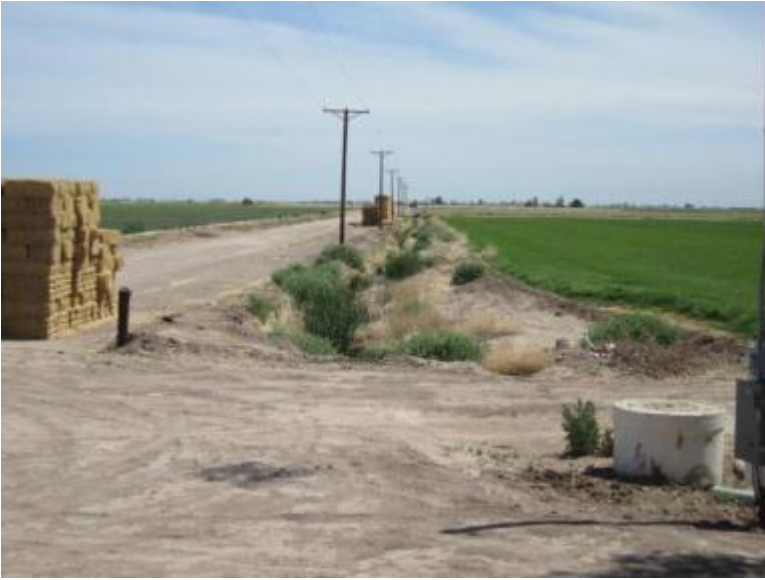
Drainage #58 – Photo 58

Mapbook Pages: C-2, D-1
 Photographs: 58, 59, 88, 145
 ACOE Jurisdiction: Potentially Jurisdictional
 CDFG Jurisdiction: Potentially Jurisdictional
 Feature Type: Drain
 Riparian Vegetation: Yes
 Substrate: Earthen

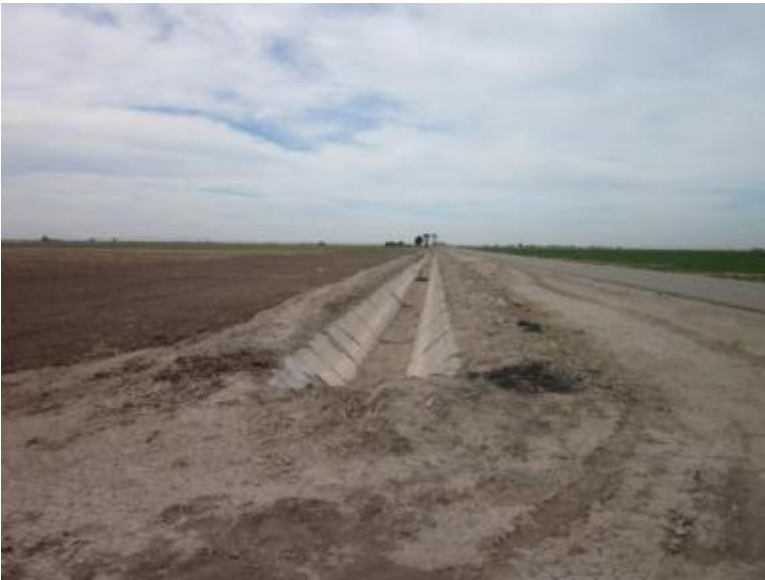
Drainage #59 – Photo 89

Mapbook Pages: C-1, C-2
 Photographs: 89
 ACOE Jurisdiction: Not Jurisdictional
 CDFG Jurisdiction: Not Jurisdictional
 Feature Type: Head Ditch
 Riparian Vegetation: None
 Substrate: Concrete

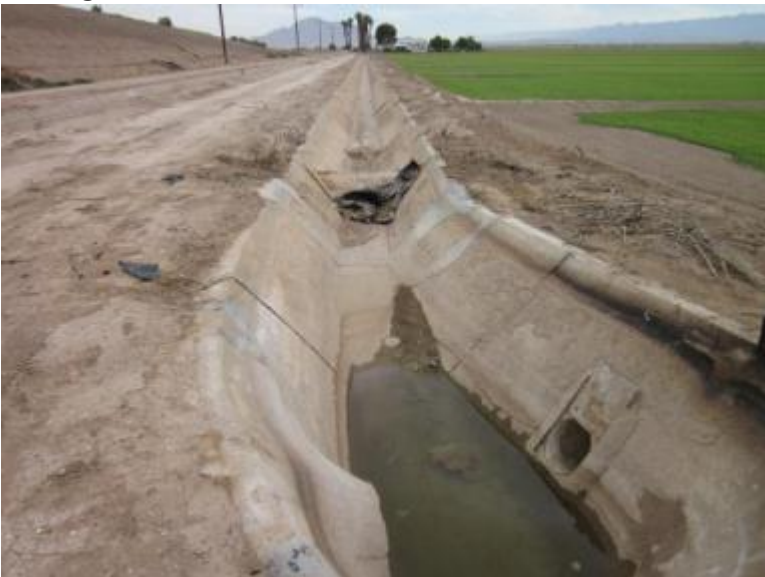
Drainage #60 – Photo 92

Mapbook Pages: C-1
 Photographs: 92
 ACOE Jurisdiction: Not Jurisdictional
 CDFG Jurisdiction: Not Jurisdictional
 Feature Type: Head Ditch
 Riparian Vegetation: None
 Substrate: Concrete

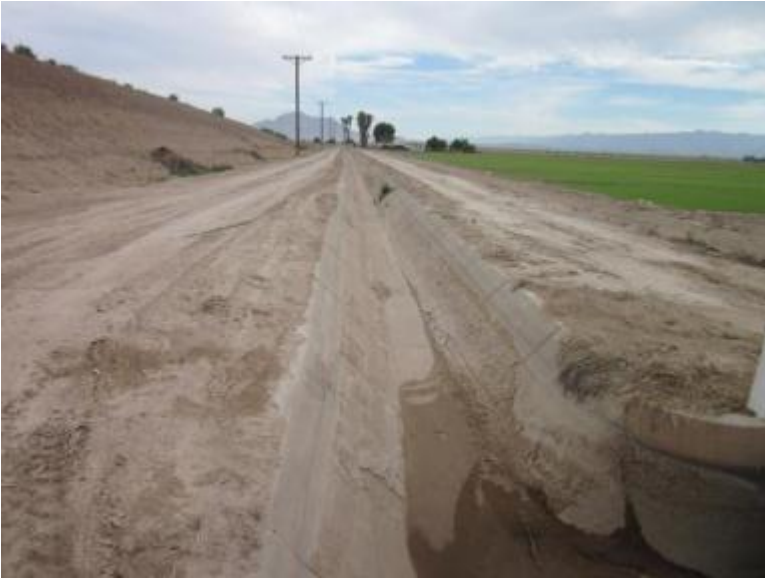
Drainage #61 – Photo 90

Mapbook Pages: C-1
 Photographs: 90
 ACOE Jurisdiction: Potentially Jurisdictional
 CDFG Jurisdiction: Potentially Jurisdictional
 Feature Type: Lateral Canal
 Riparian Vegetation: None
 Substrate: Concrete

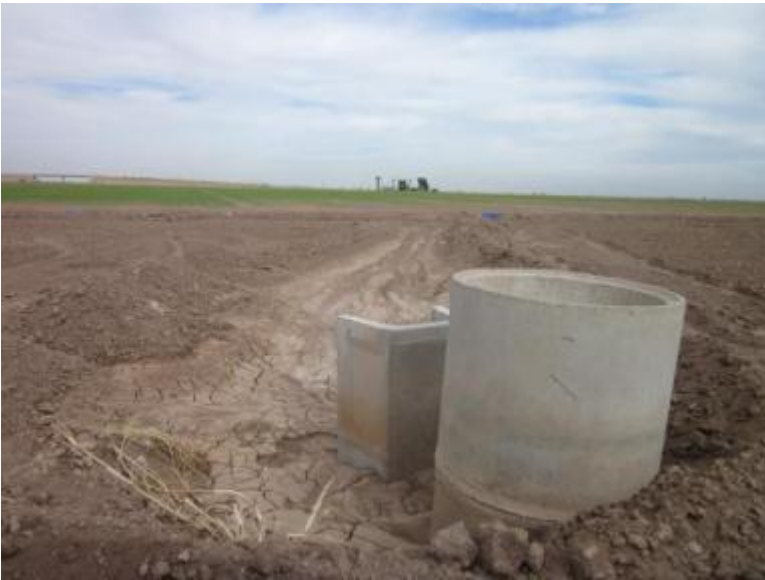
Drainage #62 – Photo 93

Mapbook Pages: C-1, C-2
 Photographs: 93
 ACOE Jurisdiction: Not Jurisdictional
 CDFG Jurisdiction: Not Jurisdictional

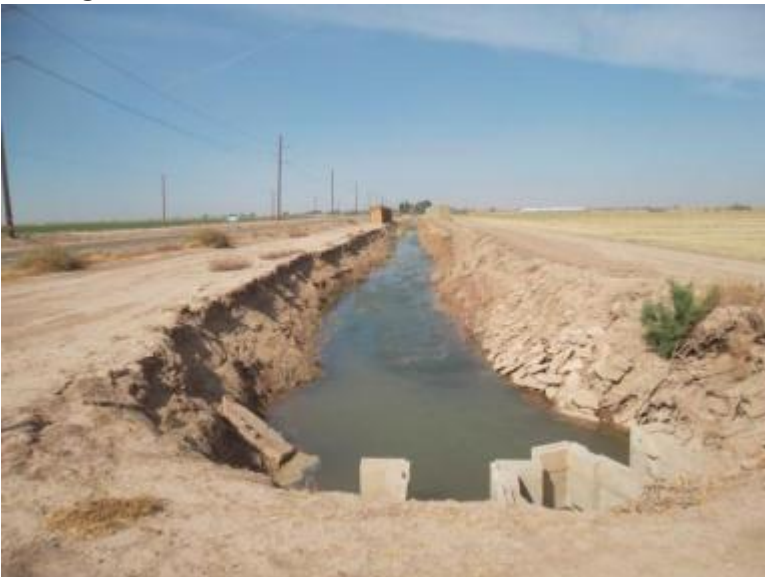
Drainage #64 – Photo 95

Mapbook Pages: F-1, F-2
Photographs: 95, 96
ACOE Jurisdiction: Potentially Jurisdictional
CDFG Jurisdiction: Potentially Jurisdictional
Feature Type: Drain
Riparian Vegetation: Yes
Substrate: Earthen

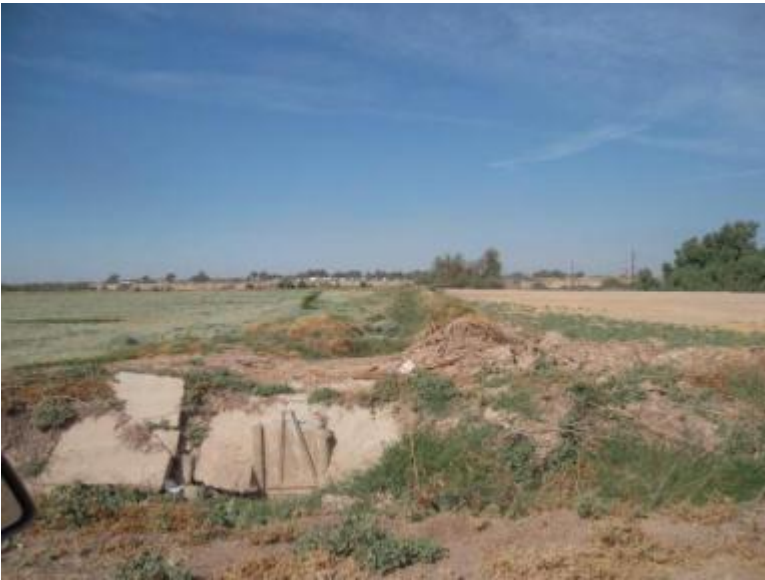
Drainage #65 – Photo 97

Mapbook Pages: F-1
Photographs: 97
ACOE Jurisdiction: Not Jurisdictional
CDFG Jurisdiction: Not Jurisdictional
Feature Type: Head Ditch
Riparian Vegetation: None
Substrate: Concrete

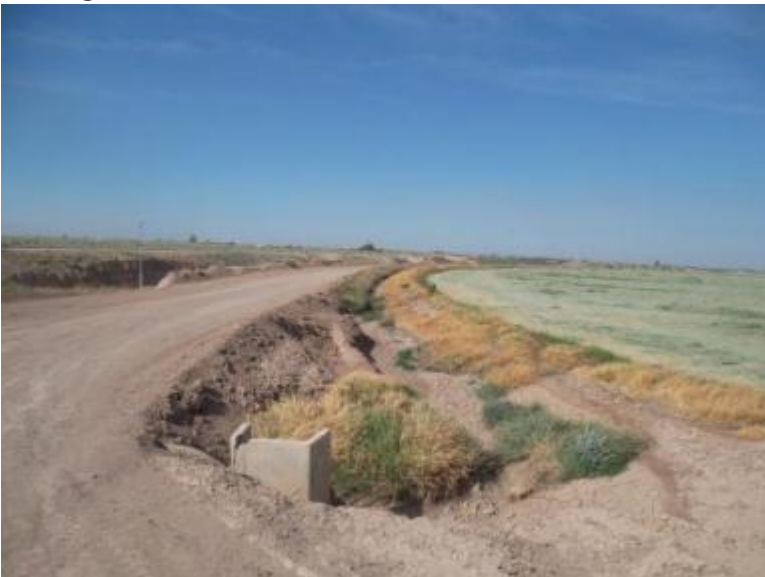
Drainage #66 – Photo 98

Mapbook Pages: E-1
 Photographs: 98
 ACOE Jurisdiction: Not Jurisdictional
 CDFG Jurisdiction: Not Jurisdictional
 Feature Type: Tail Ditch
 Riparian Vegetation: None
 Substrate: Earthen

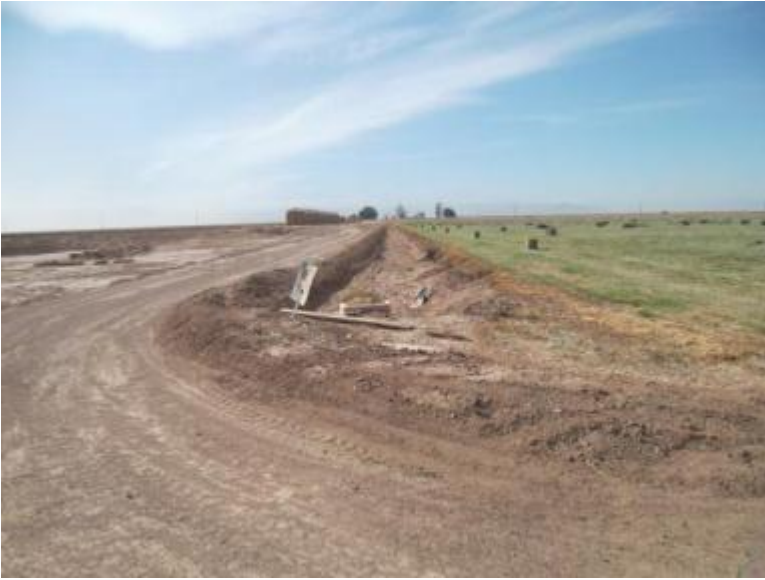
Drainage #67 – Photo 99

Mapbook Pages: E-1
 Photographs: 99
 ACOE Jurisdiction: Not Jurisdictional
 CDFG Jurisdiction: Not Jurisdictional
 Feature Type: Tail Ditch
 Riparian Vegetation: None
 Substrate: Earthen

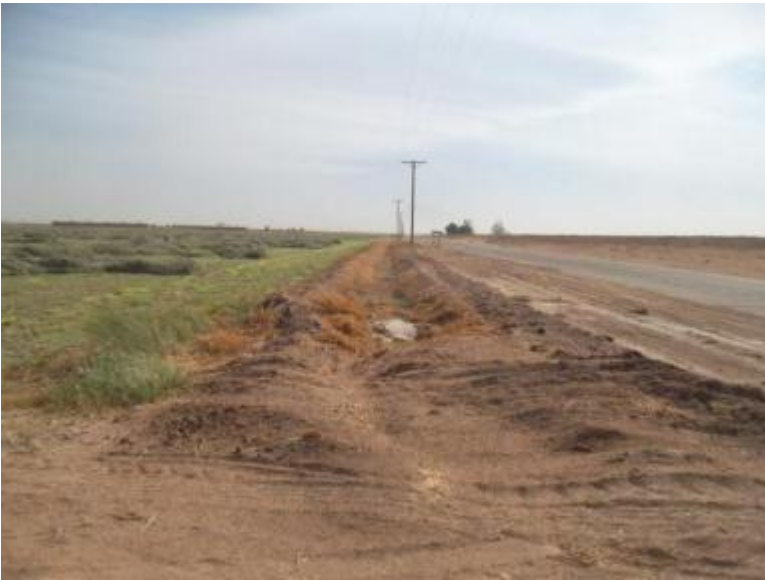
Drainage #68 – Photo 100

Mapbook Pages: E-1
 Photographs: 100
 ACOE Jurisdiction: Not Jurisdictional
 CDFG Jurisdiction: Not Jurisdictional
 Feature Type: Tail Ditch
 Riparian Vegetation: None
 Substrate: Earthen

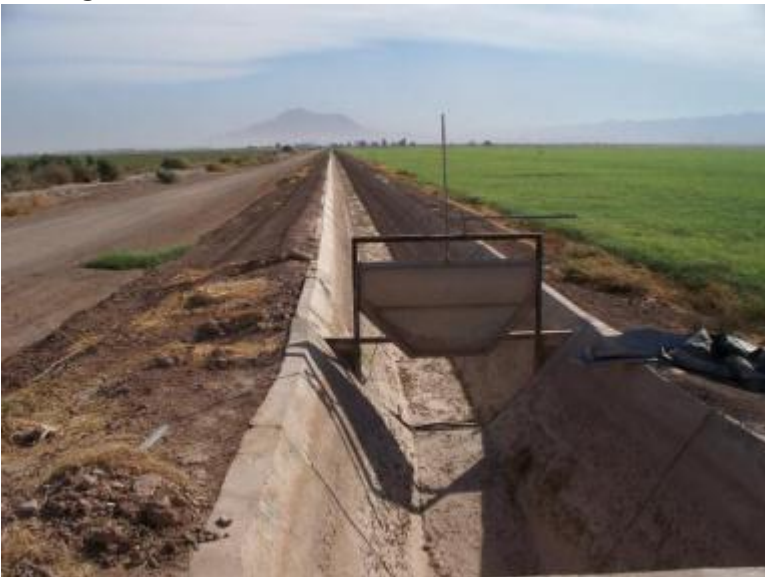
Drainage #72 – Photo 104

Mapbook Pages: D-1
 Photographs: 104
 ACOE Jurisdiction: Not Jurisdictional
 CDFG Jurisdiction: Not Jurisdictional
 Feature Type: Head Ditch
 Riparian Vegetation: None
 Substrate: Concrete

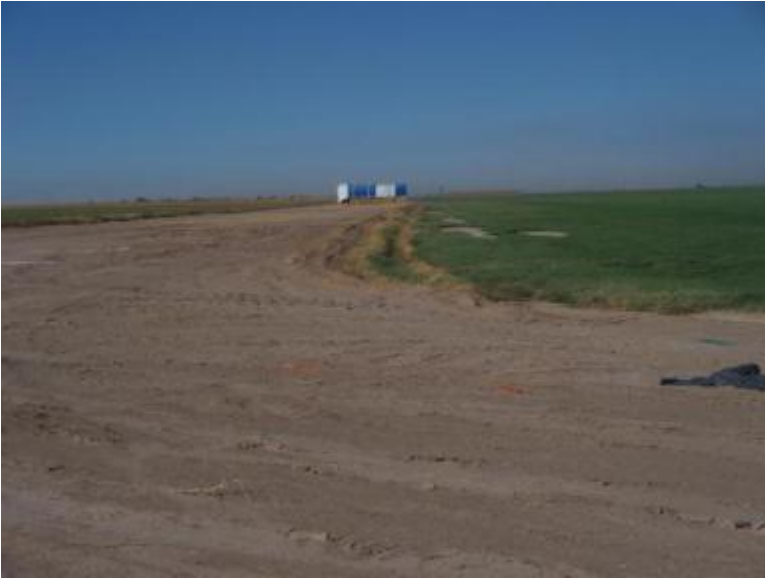
Drainage #73 – Photo 105

Mapbook Pages: D-1
 Photographs: 105
 ACOE Jurisdiction: Not Jurisdictional
 CDFG Jurisdiction: Not Jurisdictional
 Feature Type: Tail Ditch
 Riparian Vegetation: None
 Substrate: Earthen

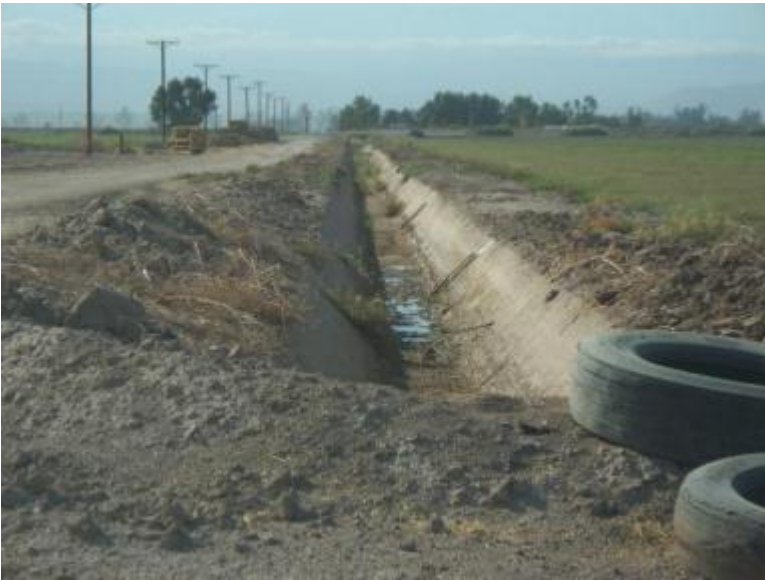
Drainage #74 – Photo 106

Mapbook Pages: D-1
 Photographs: 106
 ACOE Jurisdiction: Not Jurisdictional
 CDFG Jurisdiction: Not Jurisdictional
 Feature Type: Head Ditch
 Riparian Vegetation: None
 Substrate: Concrete

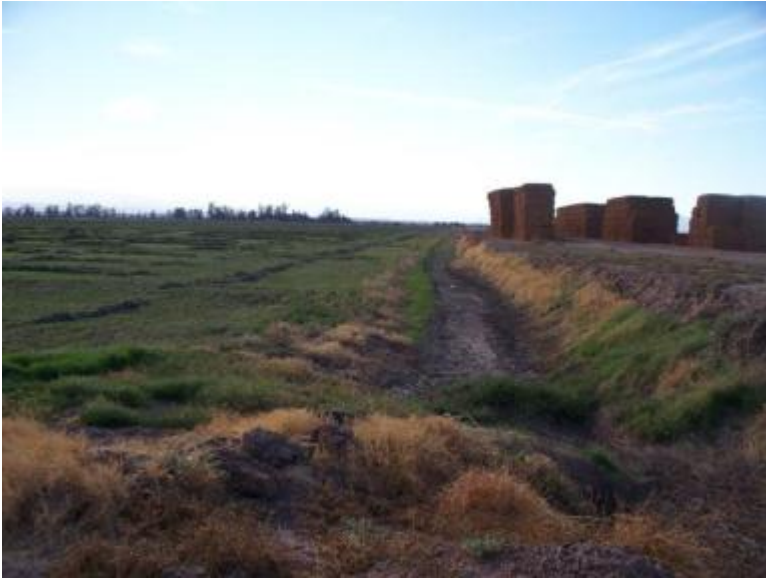
Drainage #80 – Photo 111

Mapbook Pages: B-2, C-2
 Photographs: 111
 ACOE Jurisdiction: Not Jurisdictional

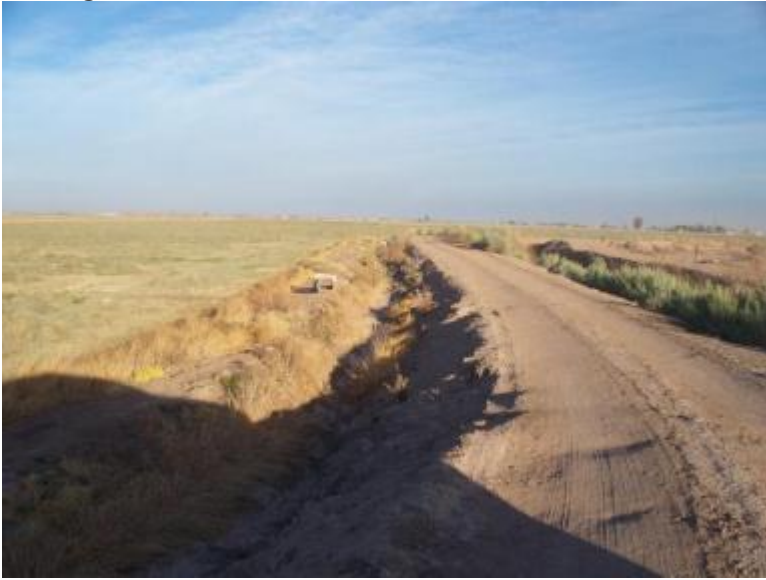
Drainage #98 – Photo 128

Mapbook Pages: D-2, E-2
 Photographs: 128
 ACOE Jurisdiction: Not Jurisdictional
 CDFG Jurisdiction: Not Jurisdictional
 Feature Type: Head Ditch
 Riparian Vegetation: None
 Substrate: Concrete/Earthen

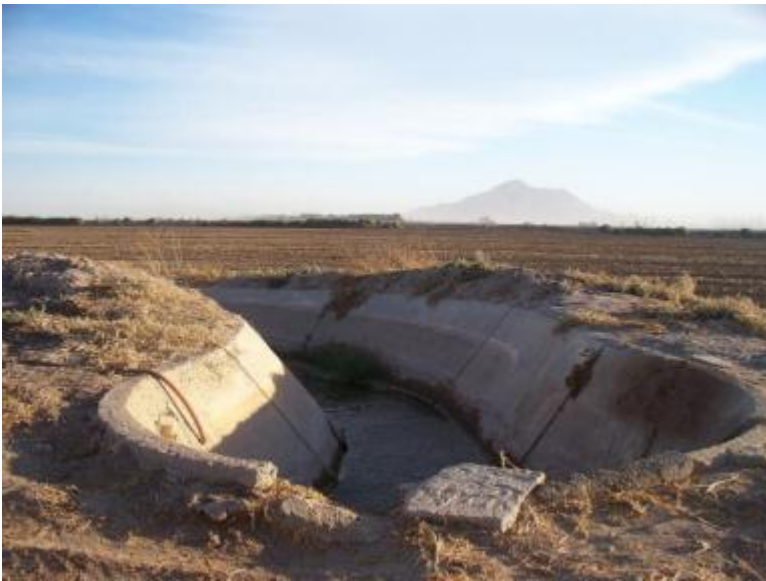
Drainage #99 – Photo 129

Mapbook Pages: E-2
 Photographs: 129
 ACOE Jurisdiction: Not Jurisdictional
 CDFG Jurisdiction: Not Jurisdictional
 Feature Type: Head Ditch
 Riparian Vegetation: None
 Substrate: Concrete

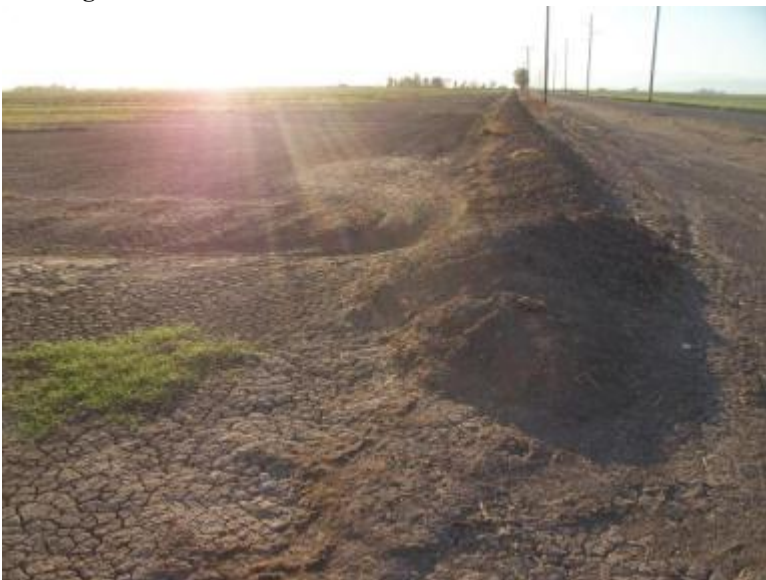
Drainage #100 – Photo 130

Mapbook Pages: E-2, F-2
 Photographs: 130
 ACOE Jurisdiction: Not Jurisdictional
 CDFG Jurisdiction: Not Jurisdictional
 Feature Type: Tail Ditch
 Riparian Vegetation: None
 Substrate: Earthen

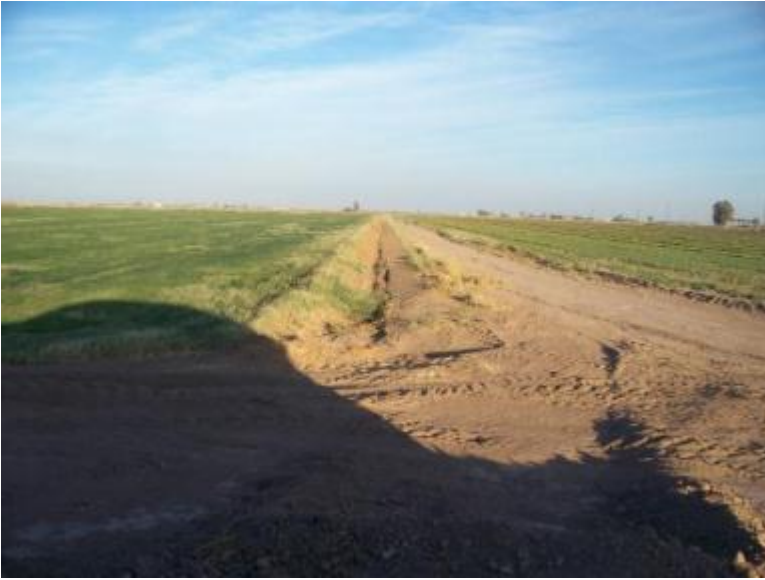
Drainage #101 – Photo 131

Mapbook Pages: E-2
 Photographs: 131
 ACOE Jurisdiction: Not Jurisdictional
 CDFG Jurisdiction: Not Jurisdictional
 Feature Type: Tail Ditch
 Riparian Vegetation: None
 Substrate: Earthen

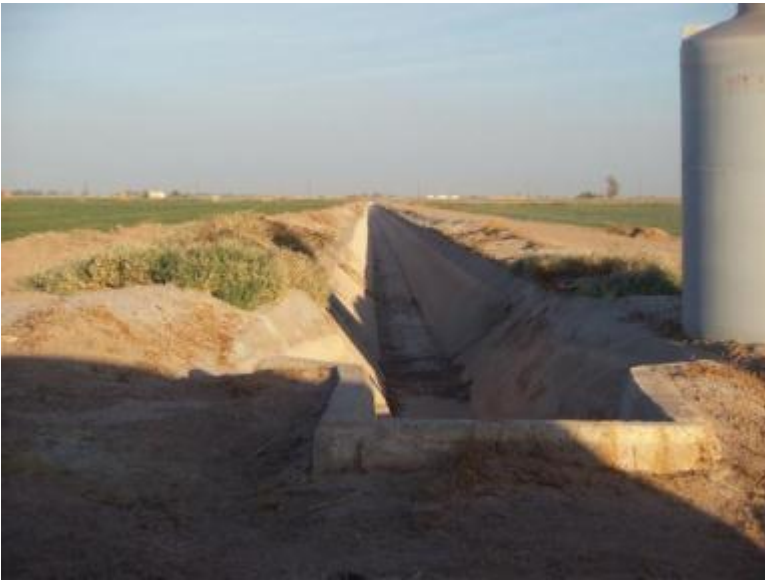
Drainage #102 – Photo 132

Mapbook Pages: E-2
 Photographs: 132
 ACOE Jurisdiction: Not Jurisdictional

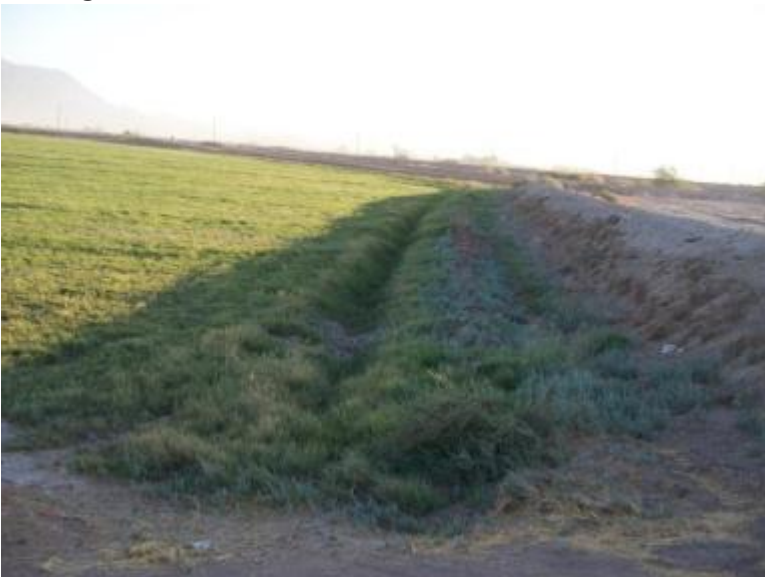
Drainage #103 – Photo 133

Mapbook Pages: E-2
Photographs: 133
ACOE Jurisdiction: Not Jurisdictional
CDFG Jurisdiction: Not Jurisdictional
Feature Type: Tail Ditch
Riparian Vegetation: None
Substrate: Earthen

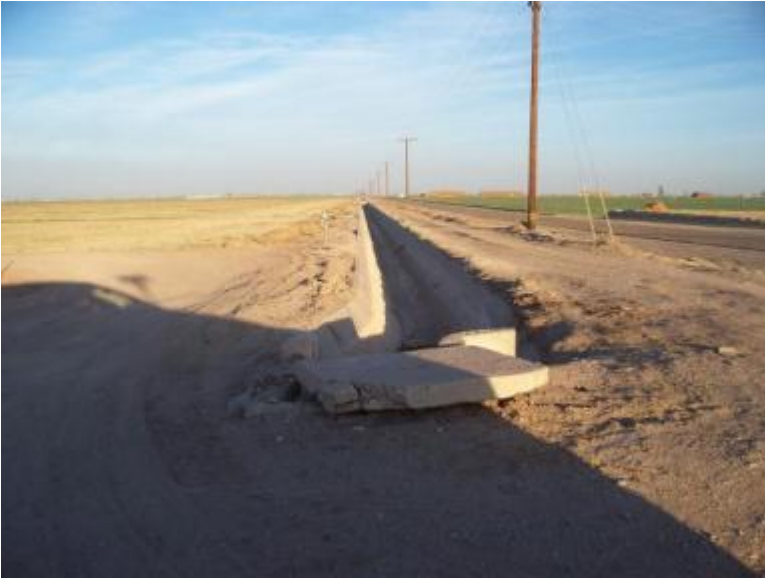
Drainage #104 – Photo 134

Mapbook Pages: E-2
Photographs: 134
ACOE Jurisdiction: Not Jurisdictional
CDFG Jurisdiction: Not Jurisdictional
Feature Type: Head Ditch
Riparian Vegetation: None
Substrate: Concrete

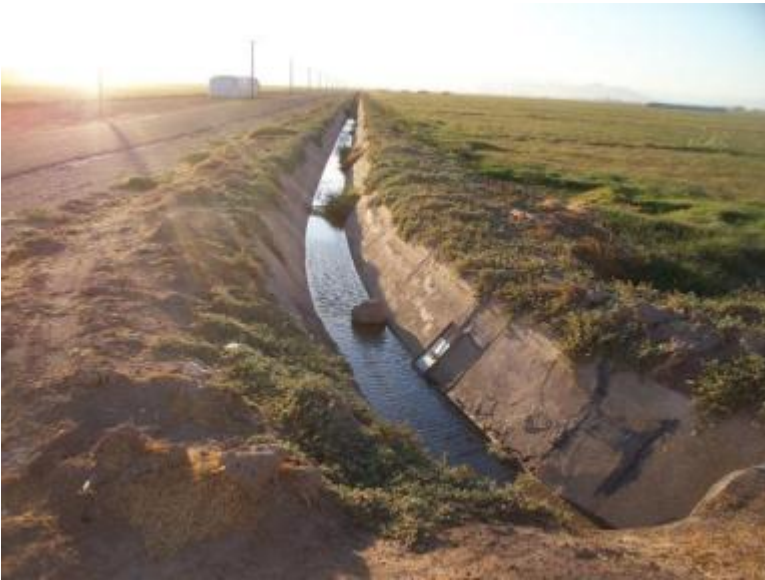
Drainage #105 – Photo 135

Mapbook Pages: D-2, E-2
 Photographs: 135
 ACOE Jurisdiction: Not Jurisdictional
 CDFG Jurisdiction: Not Jurisdictional
 Feature Type: Head Ditch
 Riparian Vegetation: None
 Substrate: Concrete
