Jurisdictional Features

Table 1 - Summary of Potential Federally Jurisdictional Waters

Photographs

Campo Verde Solar Project Drainage Mapbook

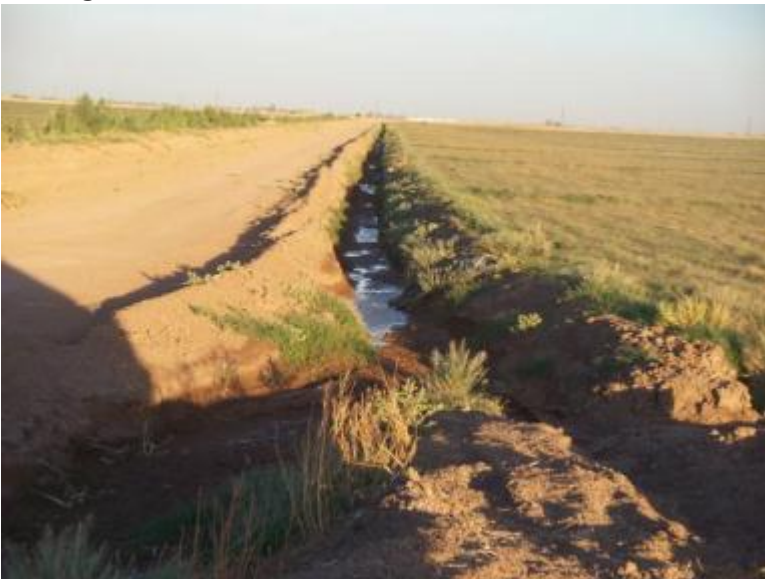
Drainage #106 – Photo 136

Mapbook Pages: D-1, E-1
 Photographs: 136
 ACOE Jurisdiction: Not Jurisdictional
 CDFG Jurisdiction: Not Jurisdictional
 Feature Type: Tail Ditch
 Riparian Vegetation: None
 Substrate: Earthen

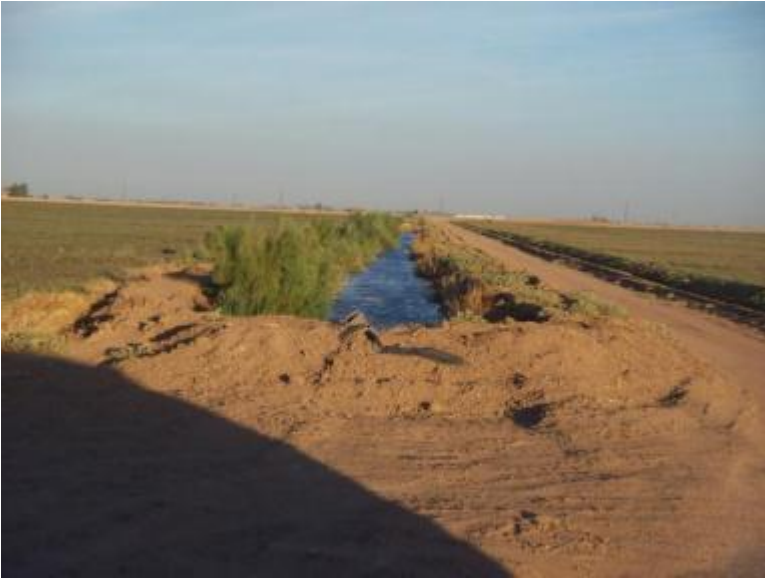
Drainage #107 – Photo 137

Mapbook Pages: D-1, E-1
 Photographs: 137
 ACOE Jurisdiction: Not Jurisdictional
 CDFG Jurisdiction: Potentially Jurisdictional
 Feature Type: Head Ditch
 Riparian Vegetation: Yes
 Substrate: Earthen

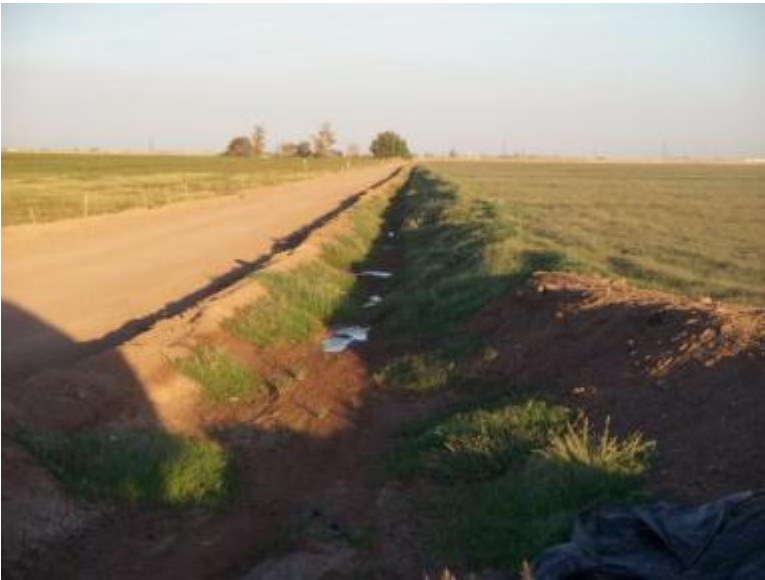
Drainage #108 – Photo 138

Mapbook Pages: D-1, E-1
 Photographs: 138
 ACOE Jurisdiction: Not Jurisdictional
 CDFG Jurisdiction: Not Jurisdictional
 Feature Type: Tail Ditch
 Riparian Vegetation: None
 Substrate: Earthen

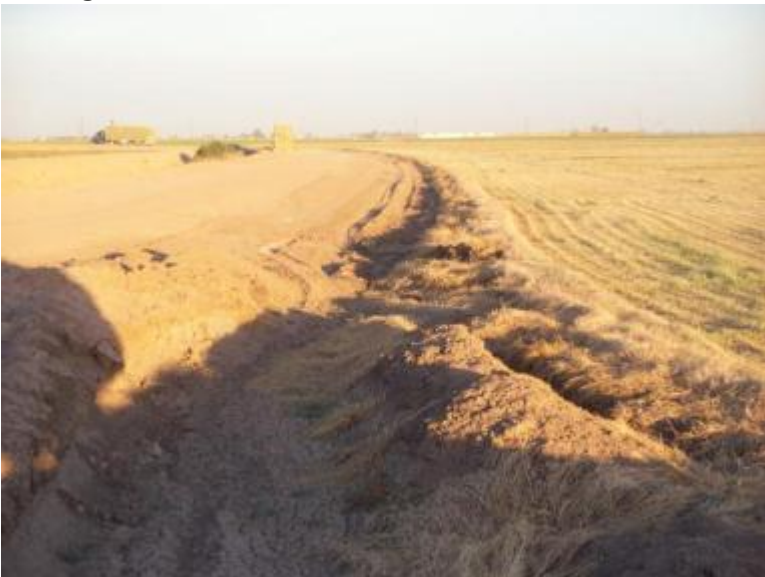
Drainage #109 – Photo 139

Mapbook Pages: E-1
 Photographs: 139
 ACOE Jurisdiction: Not Jurisdictional
 CDFG Jurisdiction: Not Jurisdictional
 Feature Type: Tail Ditch
 Riparian Vegetation: None
 Substrate: Earthen

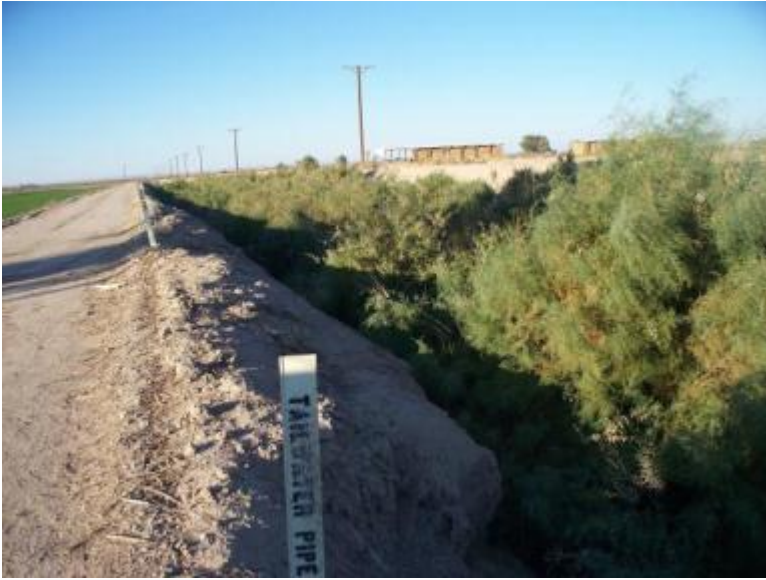
Drainage #110 – Photo 140

Mapbook Pages: B-1, B-2
 Photographs: 140
 ACOE Jurisdiction: Potentially Jurisdictional
 CDFG Jurisdiction: Potentially Jurisdictional
 Feature Type: Drain
 Riparian Vegetation: Yes
 Substrate: Earthen

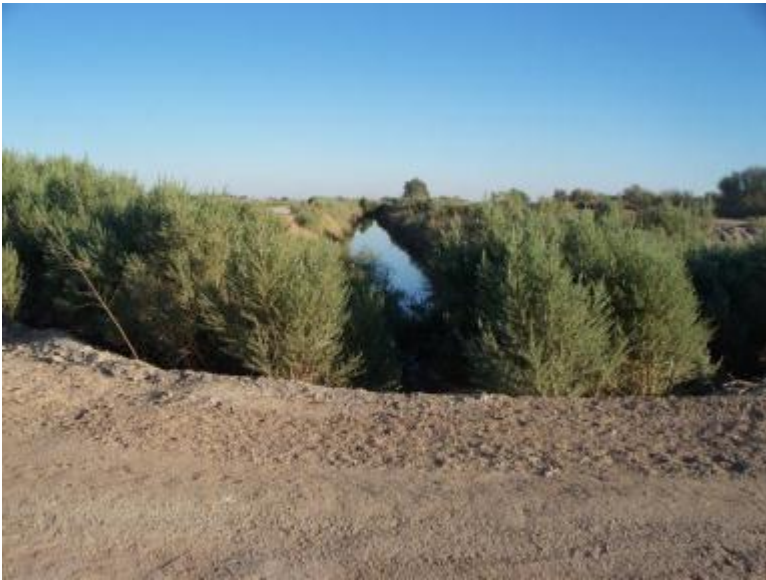
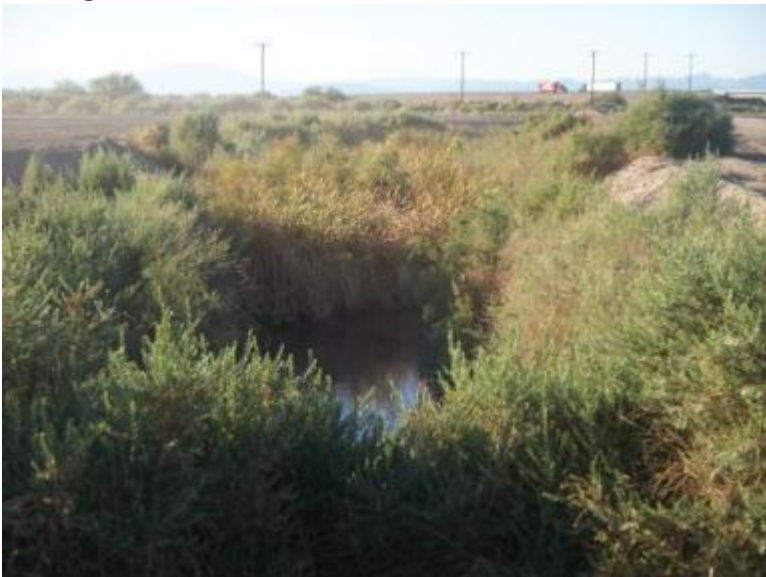
Drainage #111 – Photo 141

Mapbook Pages: A-1
 Photographs: 141, 142
 ACOE Jurisdiction: Potentially Jurisdictional
 CDFG Jurisdiction: Potentially Jurisdictional
 Feature Type: Drain
 Riparian Vegetation: Yes
 Substrate: Earthen

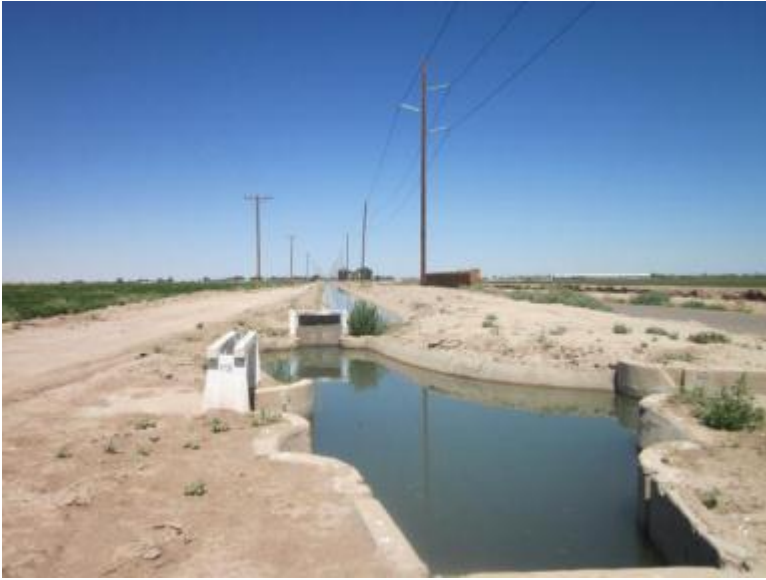
Drainage #113 – Photo 10

Mapbook Pages: F-1, F-2
 Photographs: 10
 ACOE Jurisdiction: Not Jurisdictional
 CDFG Jurisdiction: Not Jurisdictional
 Feature Type: Head Ditch
 Riparian Vegetation: None
 Substrate: Concrete

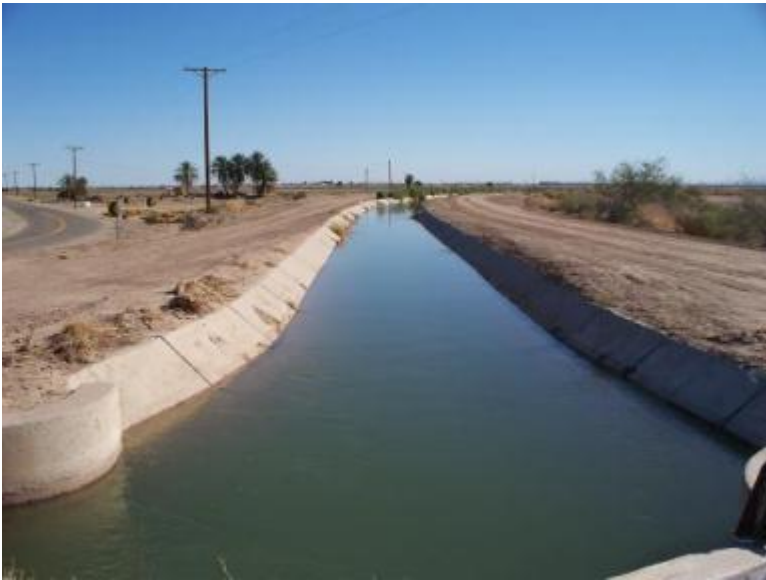
Drainage #114 – Photo 148

Mapbook Pages: A-1
 Photographs: 148
 ACOE Jurisdiction: Potentially Jurisdictional
 CDFG Jurisdiction: Potentially Jurisdictional
 Feature Type: Canal
 Riparian Vegetation: None
 Substrate: Concrete

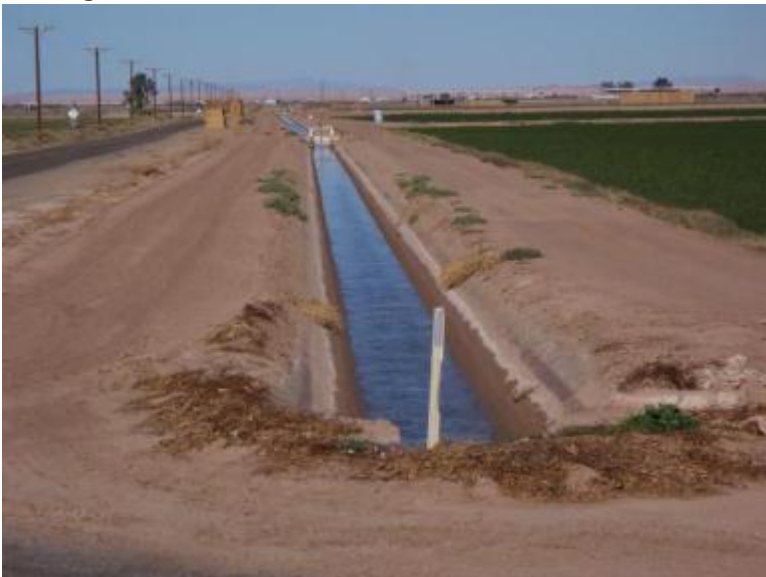
Drainage #115 – Photo 149

Mapbook Pages: B-1, B-2
 Photographs: 149
 ACOE Jurisdiction: Potentially Jurisdictional
 CDFG Jurisdiction: Potentially Jurisdictional
 Feature Type: Canal
 Riparian Vegetation: None
 Substrate: Concrete

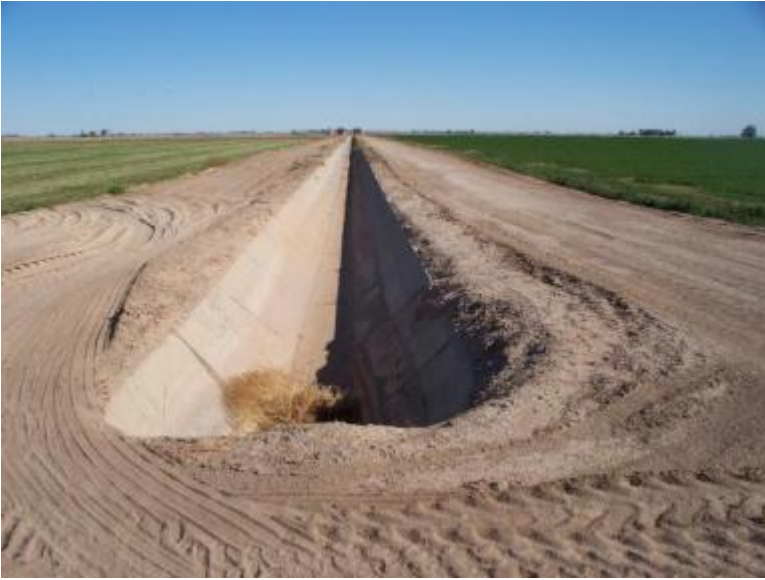
Drainage #116 – Photo 150

Mapbook Pages: B-1, B-2
 Photographs: 150
 ACOE Jurisdiction: Not Jurisdictional
 CDFG Jurisdiction: Not Jurisdictional
 Feature Type: Lateral Canal
 Riparian Vegetation: None
 Substrate: Concrete

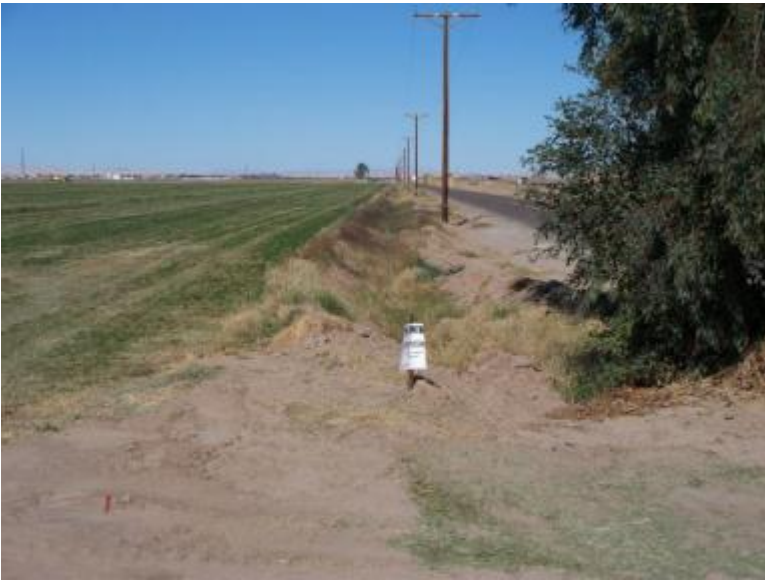
Drainage #118 – Photo 152

Mapbook Pages: B-2
 Photographs: 152
 ACOE Jurisdiction: Not Jurisdictional
 CDFG Jurisdiction: Not Jurisdictional
 Feature Type: Tail Ditch
 Riparian Vegetation: None
 Substrate: Earthen

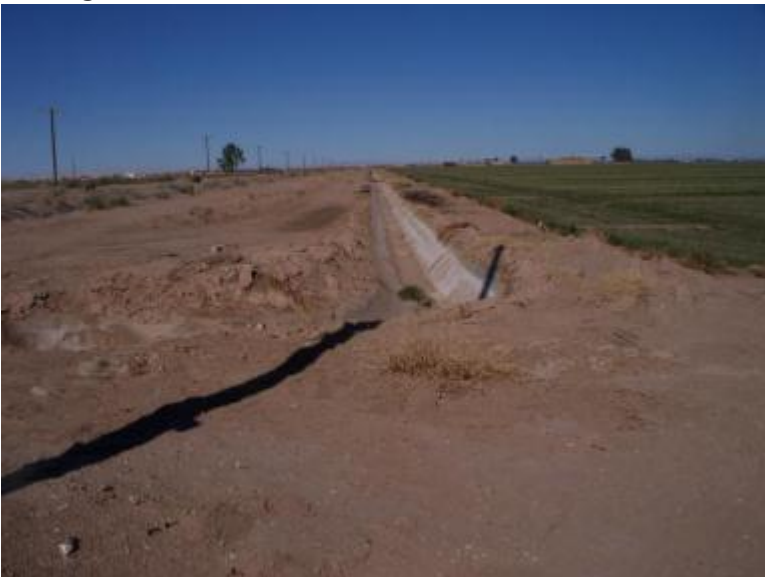
Drainage #119 – Photo 153

Mapbook Pages: B-1, B-2
 Photographs: 153
 ACOE Jurisdiction: Not Jurisdictional
 CDFG Jurisdiction: Not Jurisdictional
 Feature Type: Head Ditch
 Riparian Vegetation: None
 Substrate: Concrete

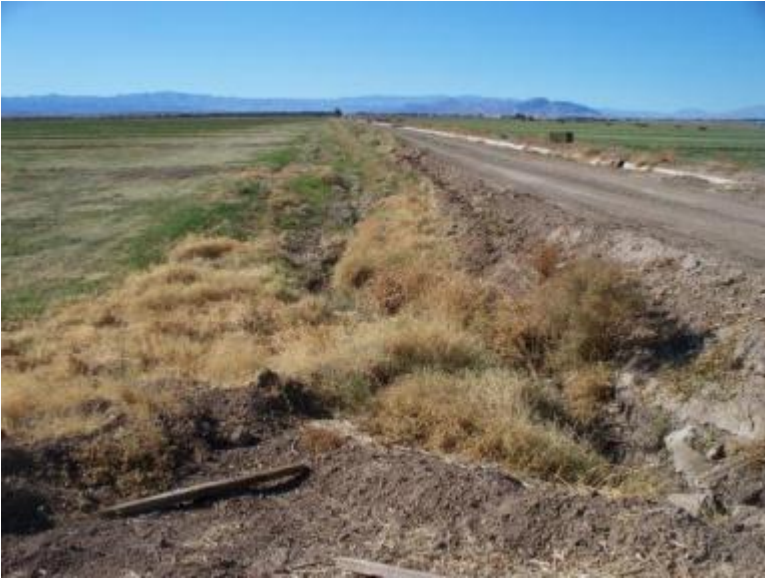
Drainage #121 – Photo 155

Mapbook Pages: B-1
 Photographs: 155
 ACOE Jurisdiction: Not Jurisdictional
 CDFG Jurisdiction: Not Jurisdictional
 Feature Type: Tail Ditch

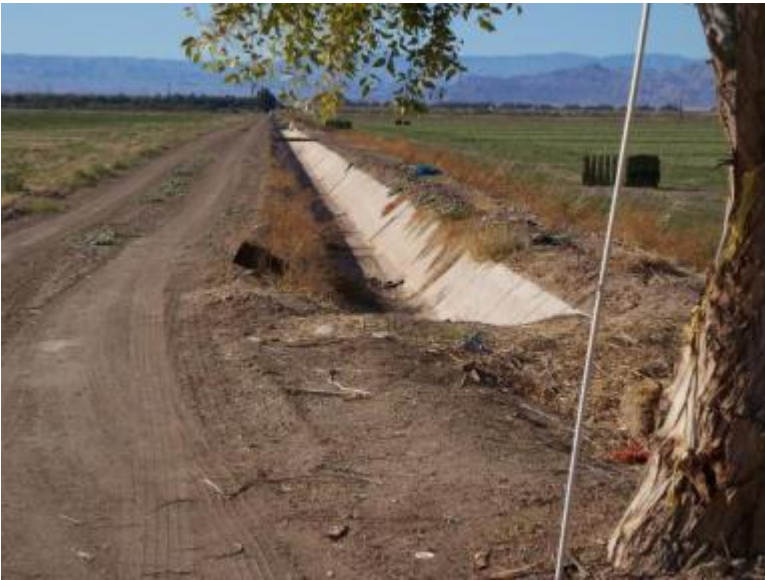
Drainage #122 – Photo 156

Mapbook Pages: B-1
Photographs: 156
ACOE Jurisdiction: Not Jurisdictional
CDFG Jurisdiction: Not Jurisdictional
Feature Type: Head Ditch
Riparian Vegetation: None
Substrate: Earthen/Concrete

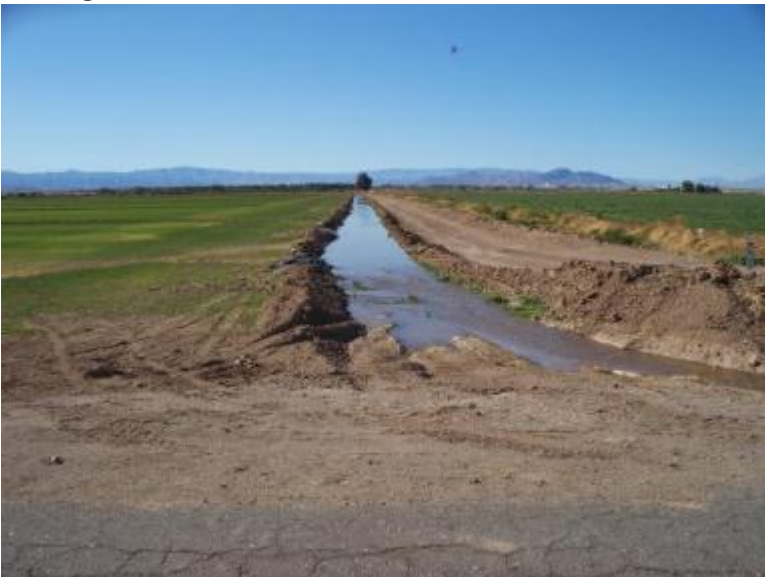
Drainage #123 – Photo 157

Mapbook Pages: B-1
Photographs: 157
ACOE Jurisdiction: Not Jurisdictional
CDFG Jurisdiction: Not Jurisdictional
Feature Type: Tail Ditch
Riparian Vegetation: None
Substrate: Earthen

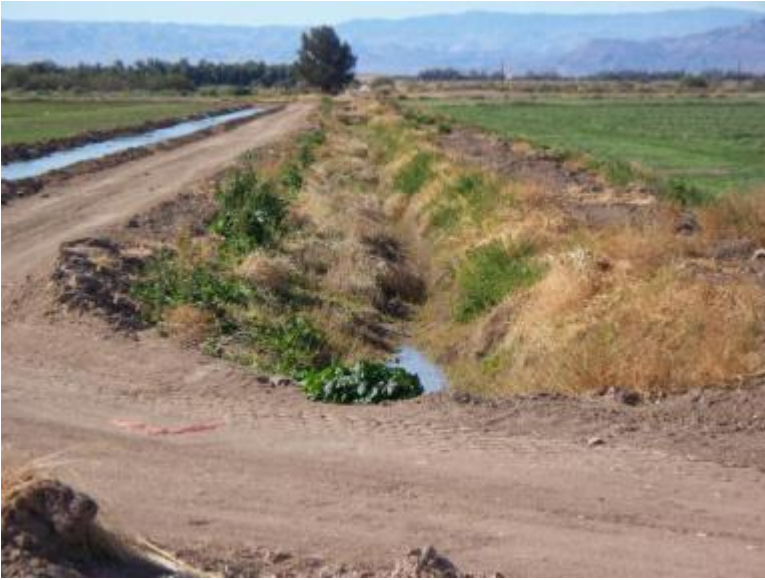
Drainage #124 – Photo 158

Mapbook Pages: A-1, B-1
 Photographs: 158
 ACOE Jurisdiction: Not Jurisdictional
 CDFG Jurisdiction: Not Jurisdictional
 Feature Type: Head Ditch
 Riparian Vegetation: None
 Substrate: Earthen

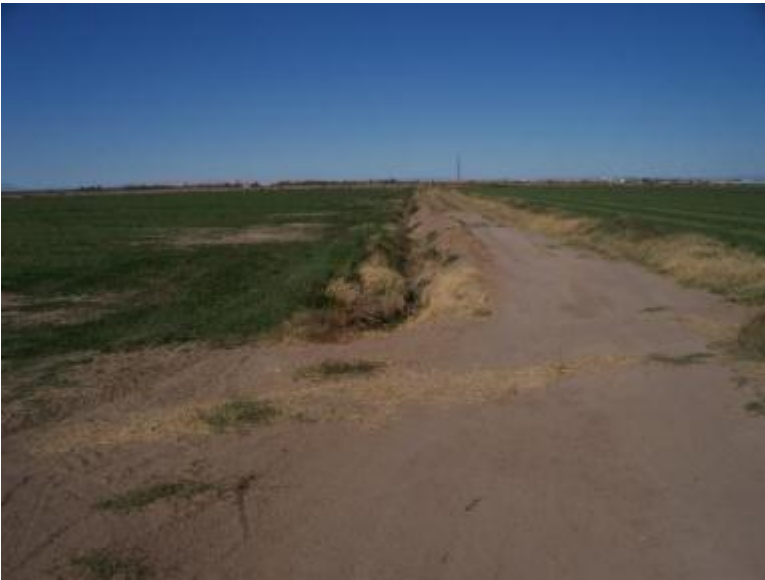
Drainage #125 – Photo 159

Mapbook Pages: B-1
 Photographs: 159
 ACOE Jurisdiction: Not Jurisdictional
 CDFG Jurisdiction: Not Jurisdictional
 Feature Type: Tail Ditch
 Riparian Vegetation: None
 Substrate: Earthen

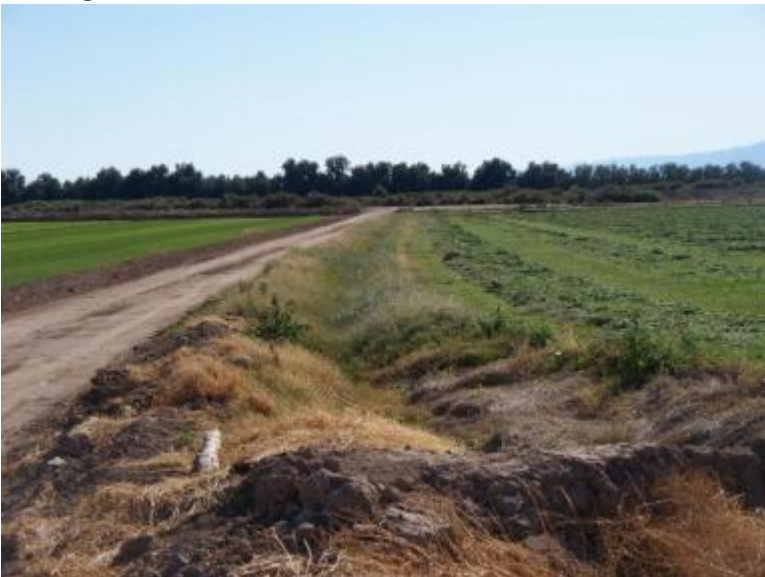
Drainage #126 – Photo 160

Mapbook Pages: B-1
 Photographs: 160
 ACOE Jurisdiction: Not Jurisdictional
 CDFG Jurisdiction: Not Jurisdictional
 Feature Type: Tail Ditch
 Riparian Vegetation: None
 Substrate: Earthen

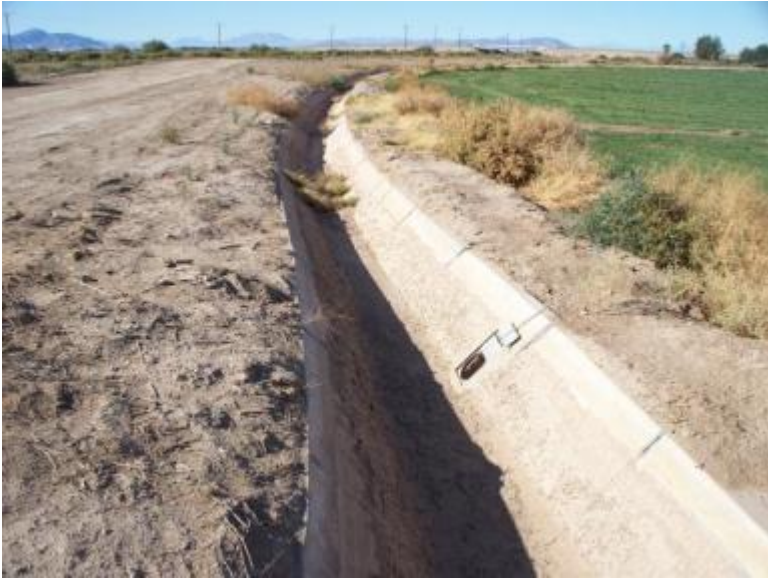
Drainage #127 – Photo 161

Mapbook Pages: A-1
Photographs: 161
ACOE Jurisdiction: Not Jurisdictional
CDFG Jurisdiction: Not Jurisdictional
Feature Type: Head Ditch
Riparian Vegetation: None
Substrate: Concrete
