# **PHASE I ENVIRONMENTAL SITE ASSESSMENT**

**FOR THE  
FIRST SOLAR CAMPO VERDE PROJECT SITE**

**IMPERIAL COUNTY, CALIFORNIA**

April 20, 2012 (Updated)

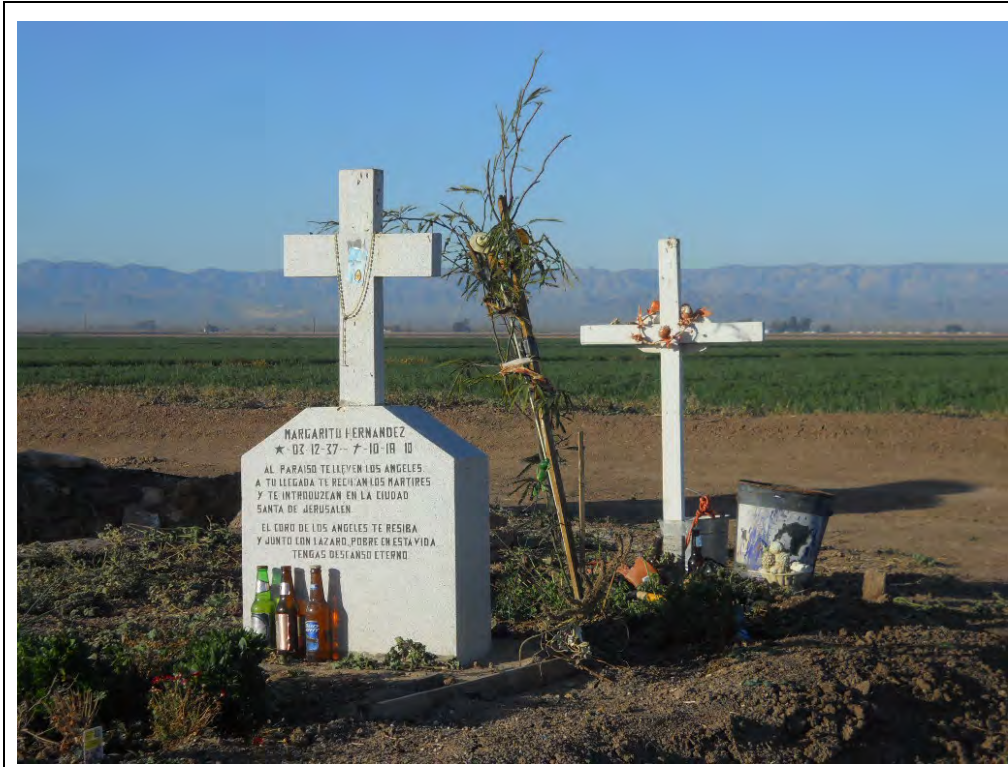
Photograph 3

APN: 051-310-40

View of monument facing west on western boundary of parcel.

A memorial consisting of a headstone, concrete footing, wooden cross, and other memorial material was observed on-site on the northwestern edge of APN 051-310-40. It is not known if there is anything buried associated with this memorial.

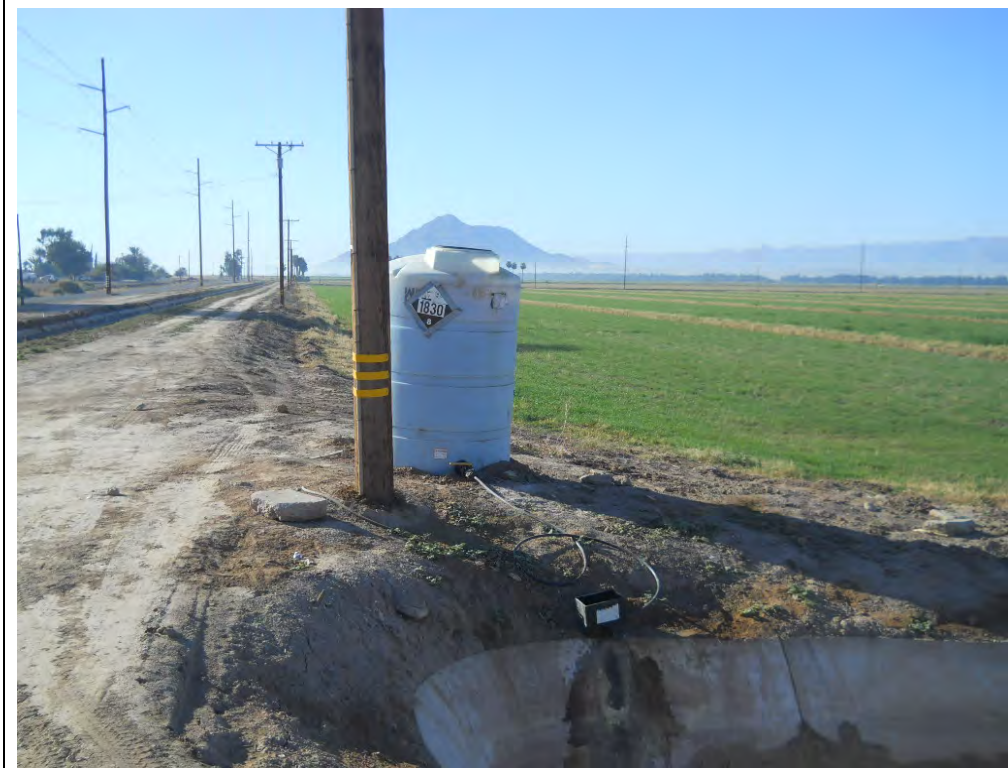
Photograph 4

View of AST and agricultural chemical application.

Several ASTs were observed on the property for storage of agricultural-related chemicals. These ASTs were observed adjacent to irrigation canals and appear to be used to add agriculture fertilizers directly into the irrigation canals for eventual soil treatment during irrigation/flooding of fields.

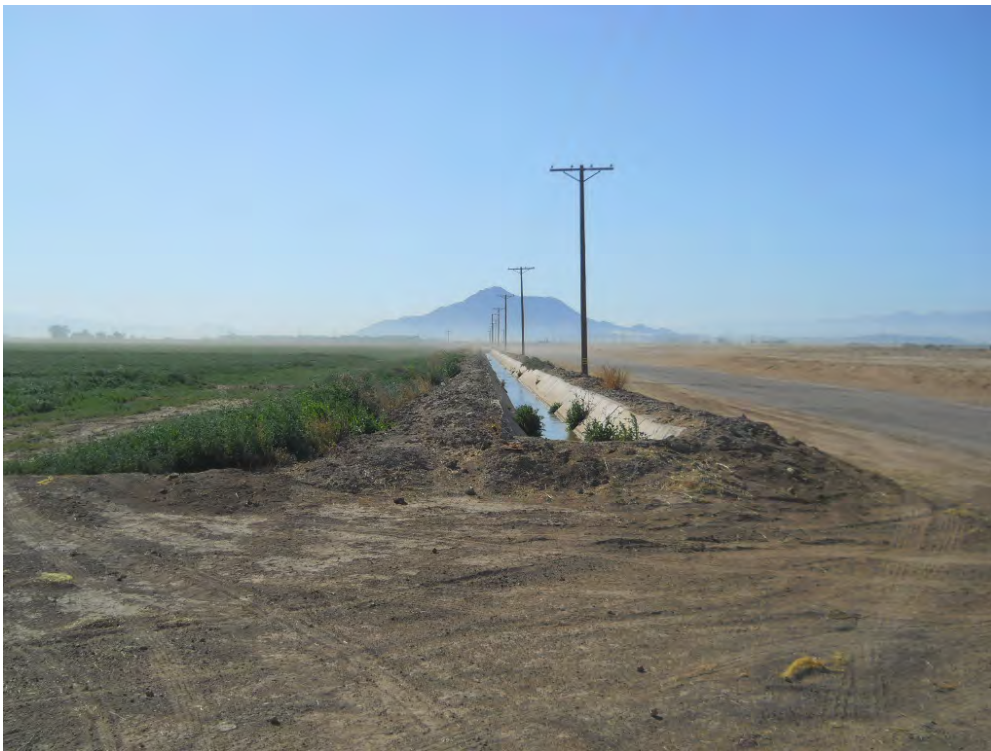
**Photograph 5**

APN: 051-310-56

Facing south along electric transmission lines from the north-west portion of the property.

Electricity transmission lines were observed on the property along the improved roads.

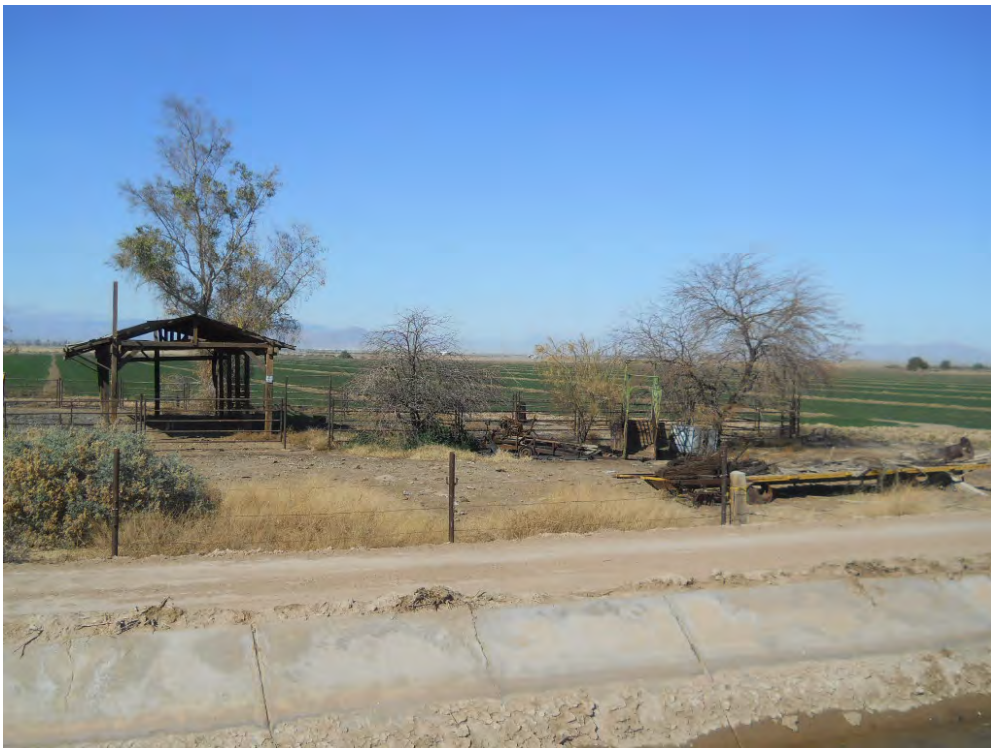
**Photograph 6**

Facing north toward shade structure and corral.

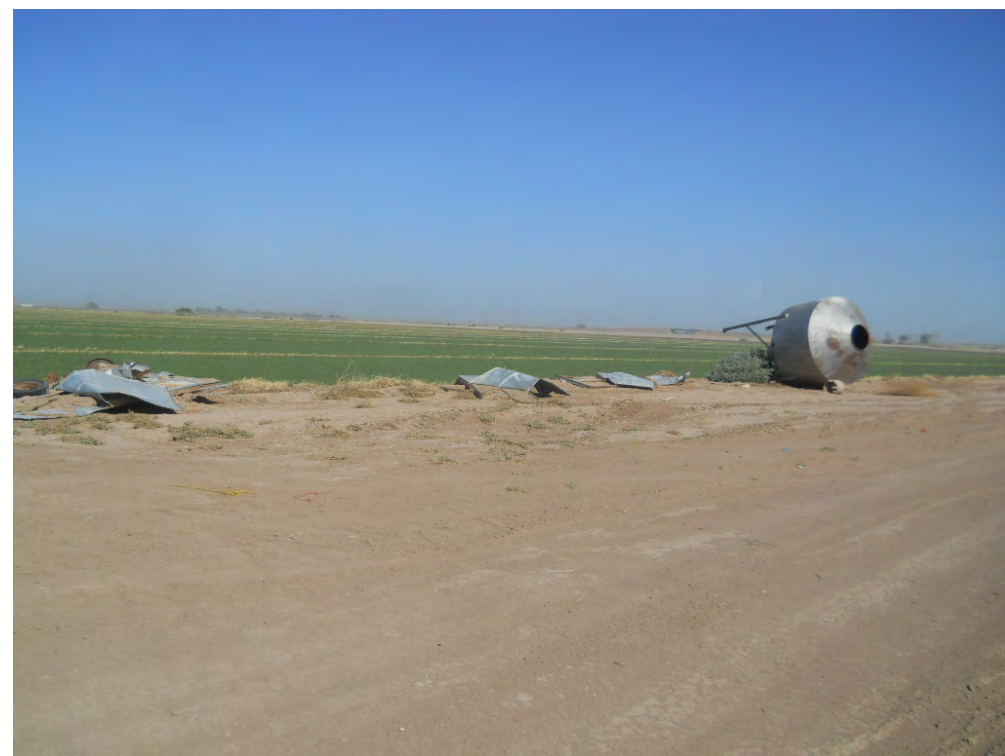
**Photograph 12**

Debris along Non-  
BLM Off-site Gen-  
Tie Alignment,  
facing northwest.

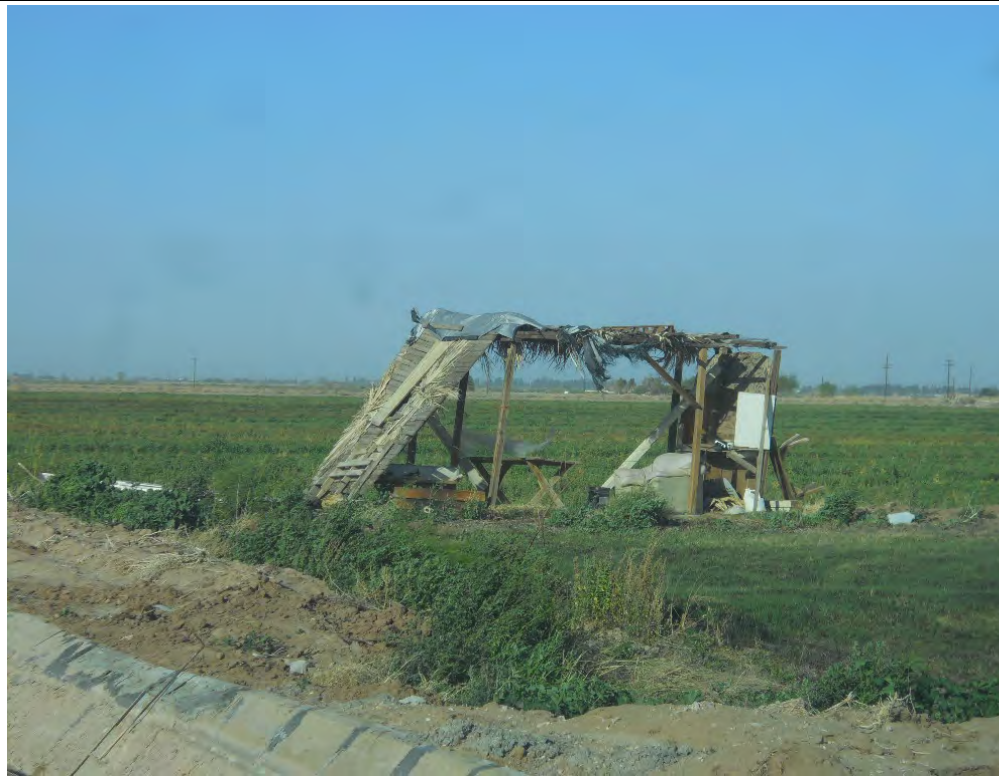
**Photograph 15**  
**Comments:**  
APN: 051-350-14  
View facing northwest toward shade/shelter structure in central portion of property.

Two structures were observed within APNs 051-330-19 and 051-350-14. One residential structure and two garage structures were observed on APN 051-350-012.

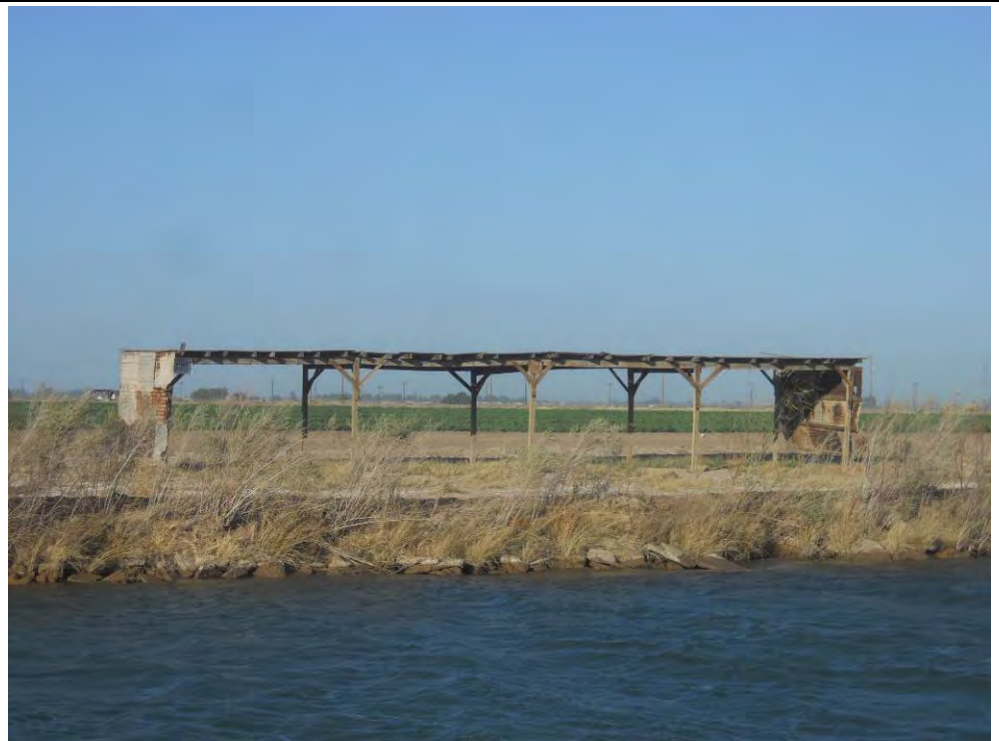
**Photograph 16**  
**Comments:**  
APN: 051-350-14  
View facing north of bee box shade structure on southern side of parcel.

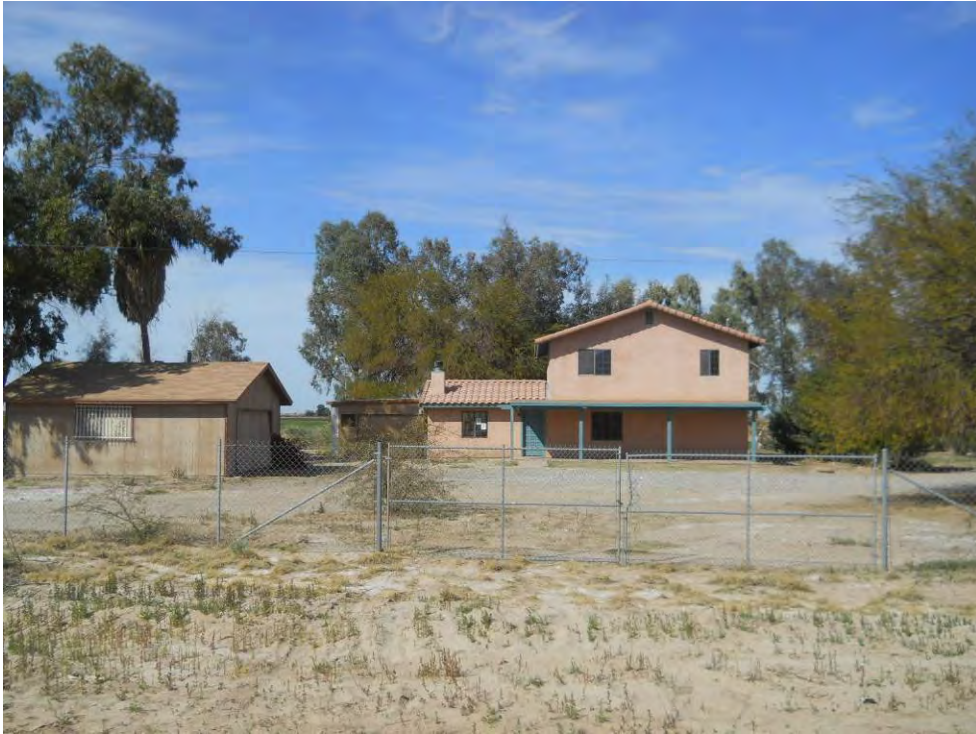
Photograph 17

APN: 051-350-12

View of residential structure and garage, facing north.

Small containers of hazardous materials such as paint were observed on APN 051-350-012. No staining was observed beneath the containers.

A lead-based paint (LBP) survey was not included in the Scope of Services performed for this Phase I ESA. Concern for LBP is primarily related to older structures. The residential structure and associated garages have the potential to contain LBP. In addition, equipment and canal lift gates observed on the property may contain LBP.

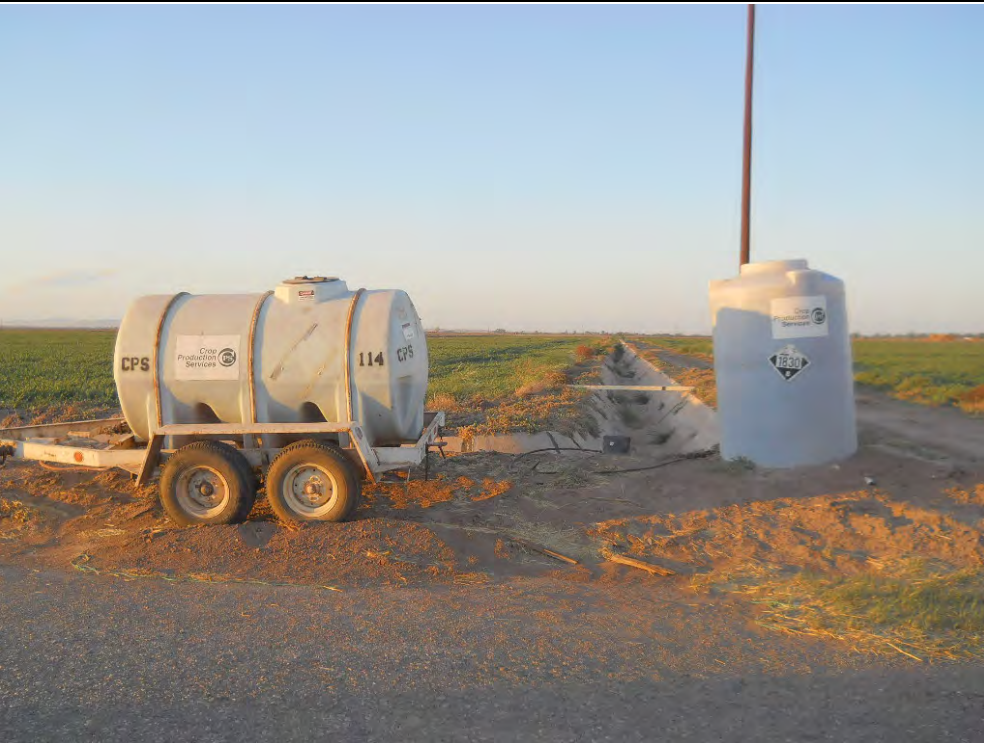
Photograph 18

View of agricultural ASTs.

Fifteen approximately 500-gallon plastic ASTs were observed throughout the property to contain sulfuric acid. They were observed during the site visit at the following locations:
