Appendix C. Habitat Assessment and Reporting Details

Appendix D. Breeding and Non-breeding Season Surveys and Reports

Appendix E. Example Components for Burrowing Owl Artificial Burrow and Exclusion Plans

The National Fish and Wildlife Forensics Laboratory was requested to determine cause of death for birds found at facilities that generate electricity from solar energy. Solar generating facilities can be classified into three major types: photovoltaic sites, trough systems and solar power towers. There is much written about these systems so this report will not include any technical details, but simply mention the differences and their potential impact on birds.

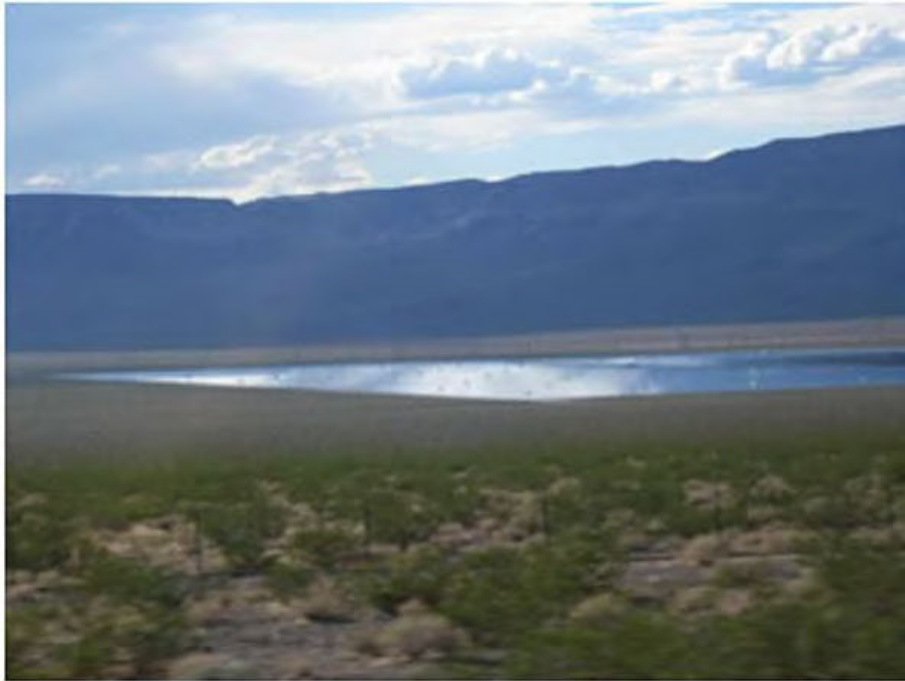
Polarized reflective glare | Photo © Basin and Range Watch

PV panels polarize the light they reflect, much like the surface of a body of water. The resemblance of the PV field pictured to a lake is remarkable, even in bright daylight that reveals the technological underpinnings of the site. For night-flying birds, especially on nights when a new or crescent moon doesn't provide much light, all the birds would have to go on would be the reflection of the stars in the PV panels. A large PV project would seem to offer an oasis for water birds in the desert, but coming in for a landing on such a "lake" could well prove routinely fatal, either at the moment of impact or after a disabled bird wanders off into the desert.

What would entice a water bird like a clapper rail or a grebe to a field of photovoltaic panels deep in the desert? A photo of the Copper Mountain PV facility in Nevada taken by the group Basin and Range Watch offers a suggestion:

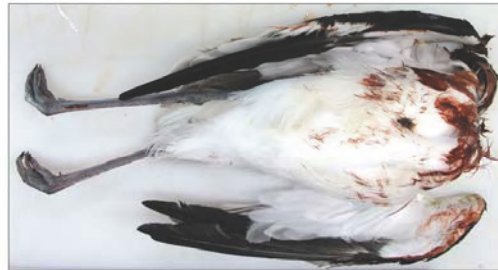
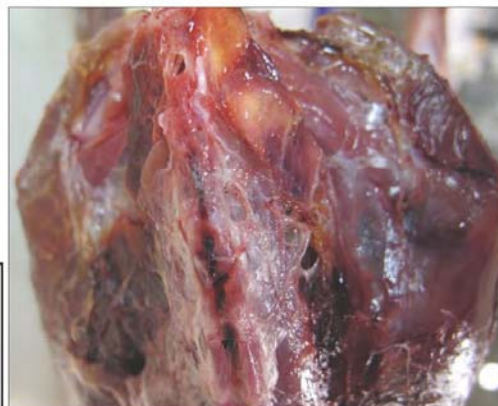
Figure 2: Predation trauma (top) resulting in traumatic amputation of the head and neck (American Avocet) and impact trauma (bottom) causing bruising of the keel ridge of the sternum (Brown Pelican).

Blunt force impact trauma was determined to have been the cause of death for 19 Desert Sunlight birds including two Western Grebes (*Aechmophorus occidentalis*) and one each of 16 other species. Impact (blunt force) trauma is diagnosed by the presence of fractures and internal and/or external contusions. In particular, bruising around the legs, wings and chest are consistent with crash-landings while fractures of the head and/or neck are consistent with high-velocity, frontal impact (such as may result from impacting a mirror).

Predation was the immediate cause of death for 15 birds. Lesions supporting the finding of predation included decapitation or missing parts of the body with associated hemorrhage (9/15), and lacerations of the skin and pectoral muscles. Eight of the predated birds from Desert Sunlight were

grebes, which are unable to easily take off from land. This suggests a link between predation and stranding and/or impact resulting from confusion of the solar panels with water (see Discussion).
