Document Name: APLIC: Suggested Practices for Raptor Protection on Power Lines: The State of the Art in 1996

**SUGGESTED PRACTICES FOR RAPTOR
PROTECTION ON POWER LINES:**

THE STATE OF THE ART IN 1996

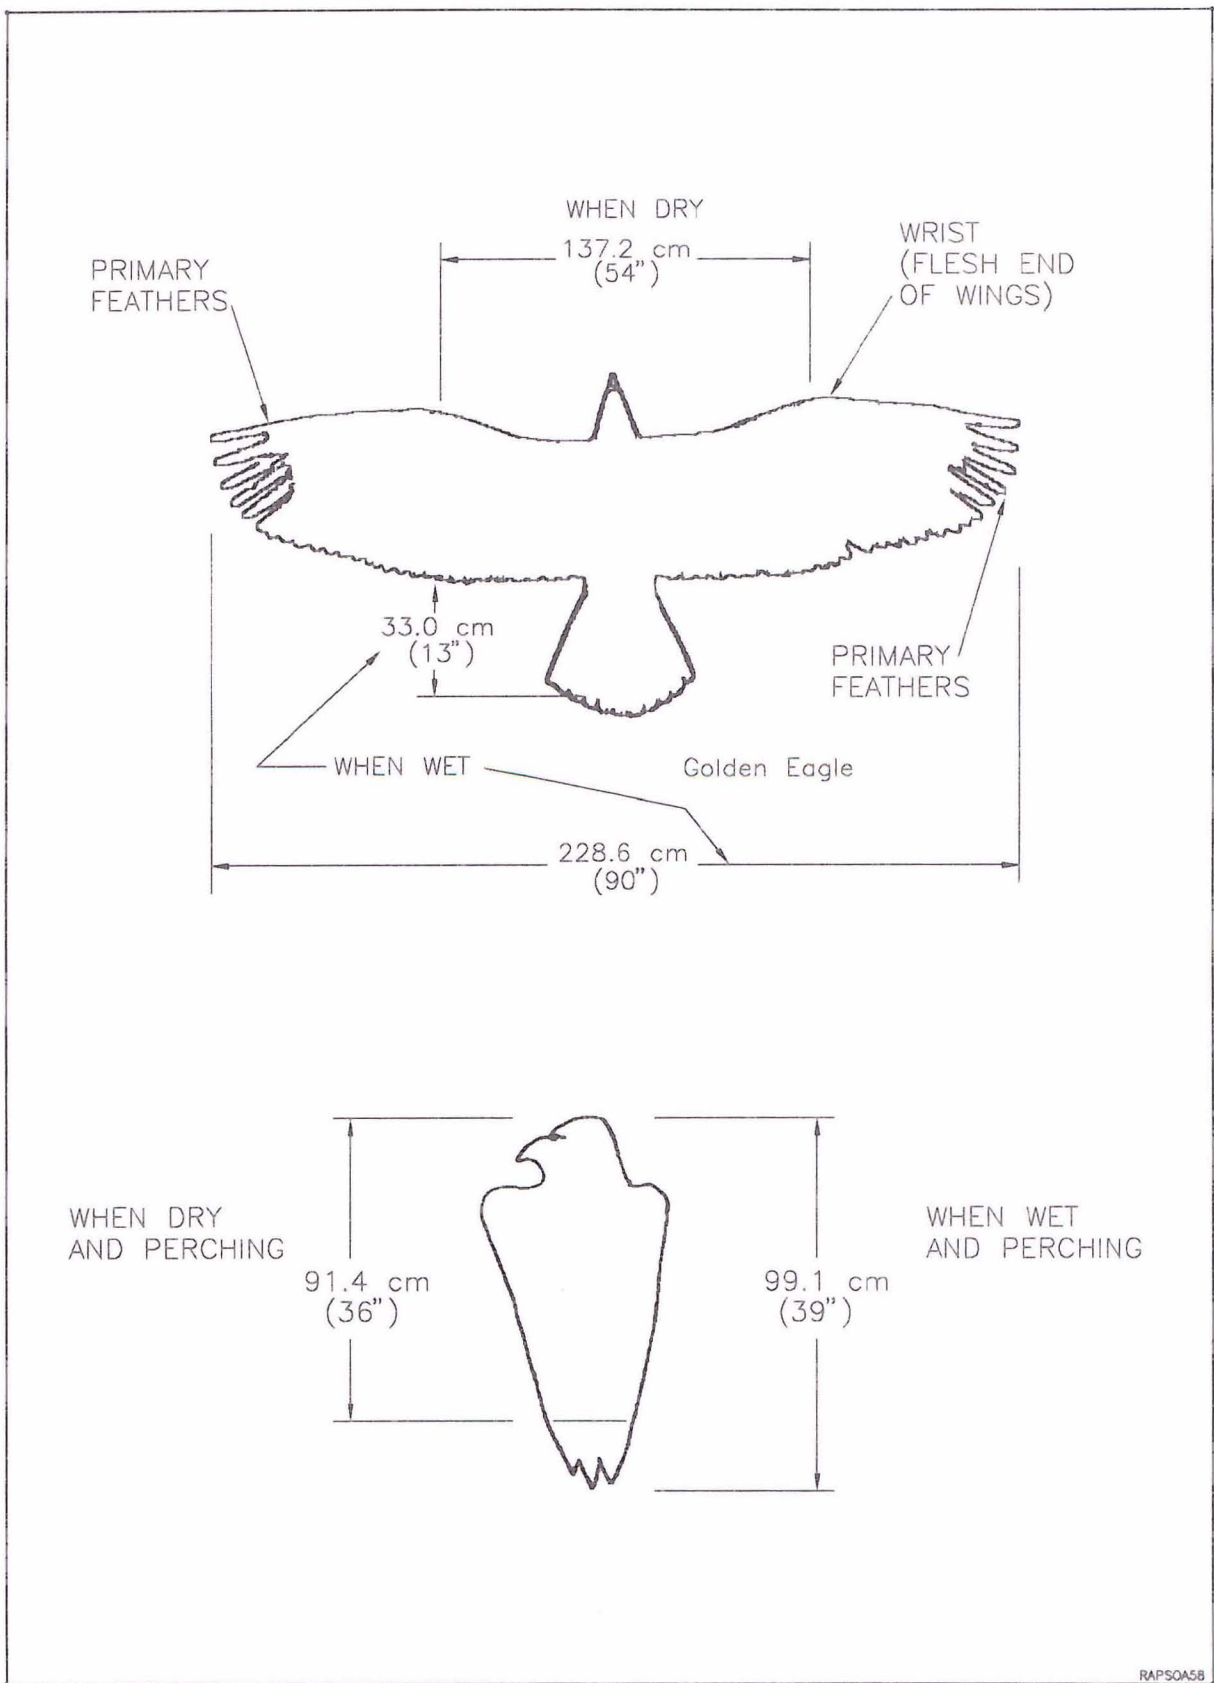
Figure 2. Critical dimensions of the golden eagle.

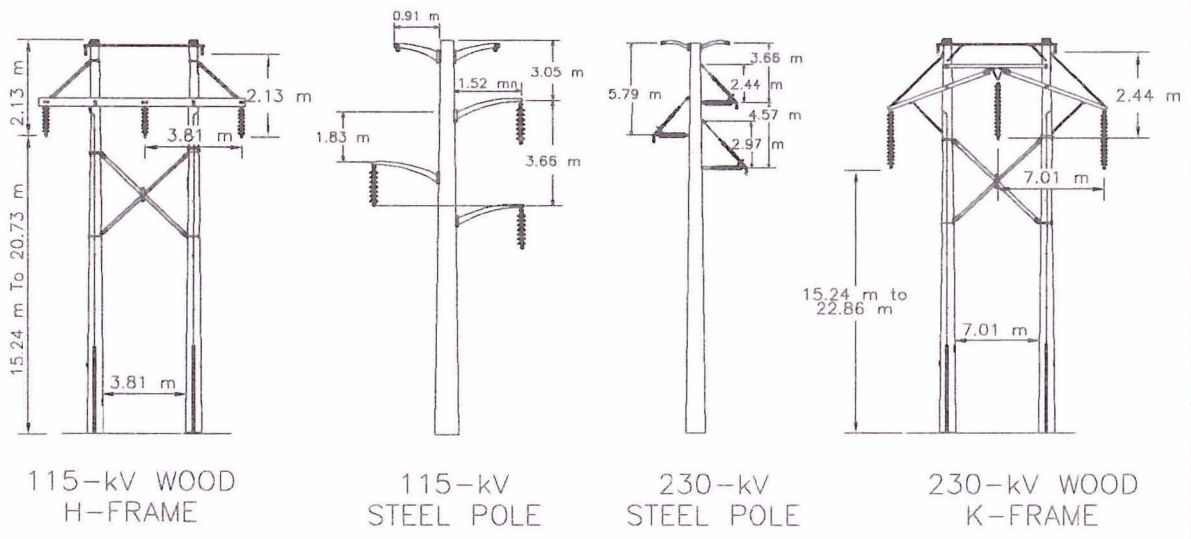
Figure 3. Examples of high-voltage transmission structures. Dimensions will vary with utility's specifications.

Transmission conductors are generally spaced 2.1 to 9.1 m (7 to 30 ft.) apart, and are supported on poles or towers (structures) that range from 15.2 m to 36.6 m (50 ft. to 120 ft.) in height (Figure 3). The conductors will generally be kept at least 6.4 m (21 ft.) above ground at the lowest point of sag. Where a circuit is one three-phase system, one tower can accommodate more than one circuit (see the double-circuit tower in Figure 3).

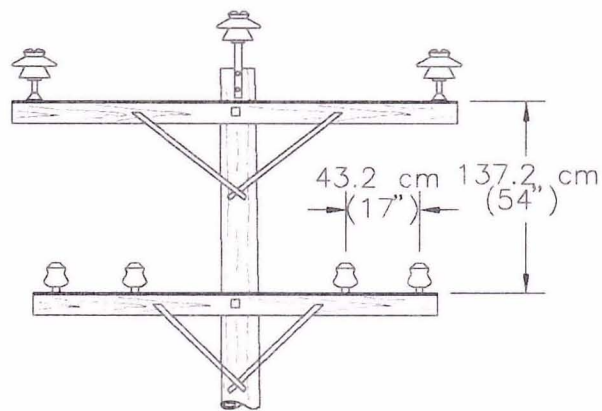
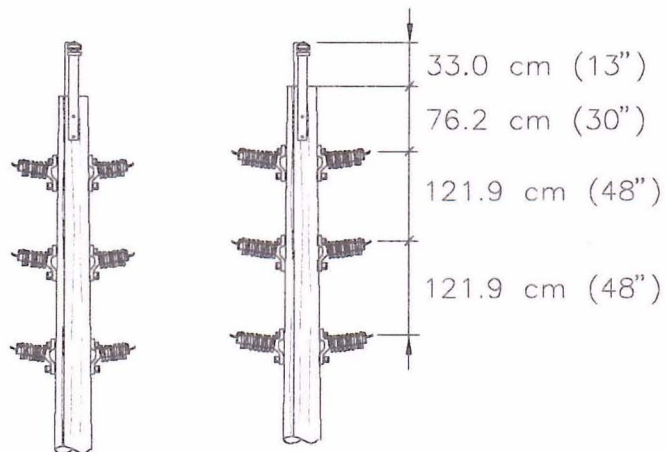
7.62-/25-kV
CROSSARM CONSTRUCTION
THREE-PHASE SINGLE-CIRCUIT

TYPICAL 69-kV/13-kV
UNDERBUILD CONFIGURATION

7.62-/13.2-kV 14.4-/25-kV
THREE-PHASE DOUBLE-CIRCUIT

Figure 4B. Examples of typical distribution configurations, continued.

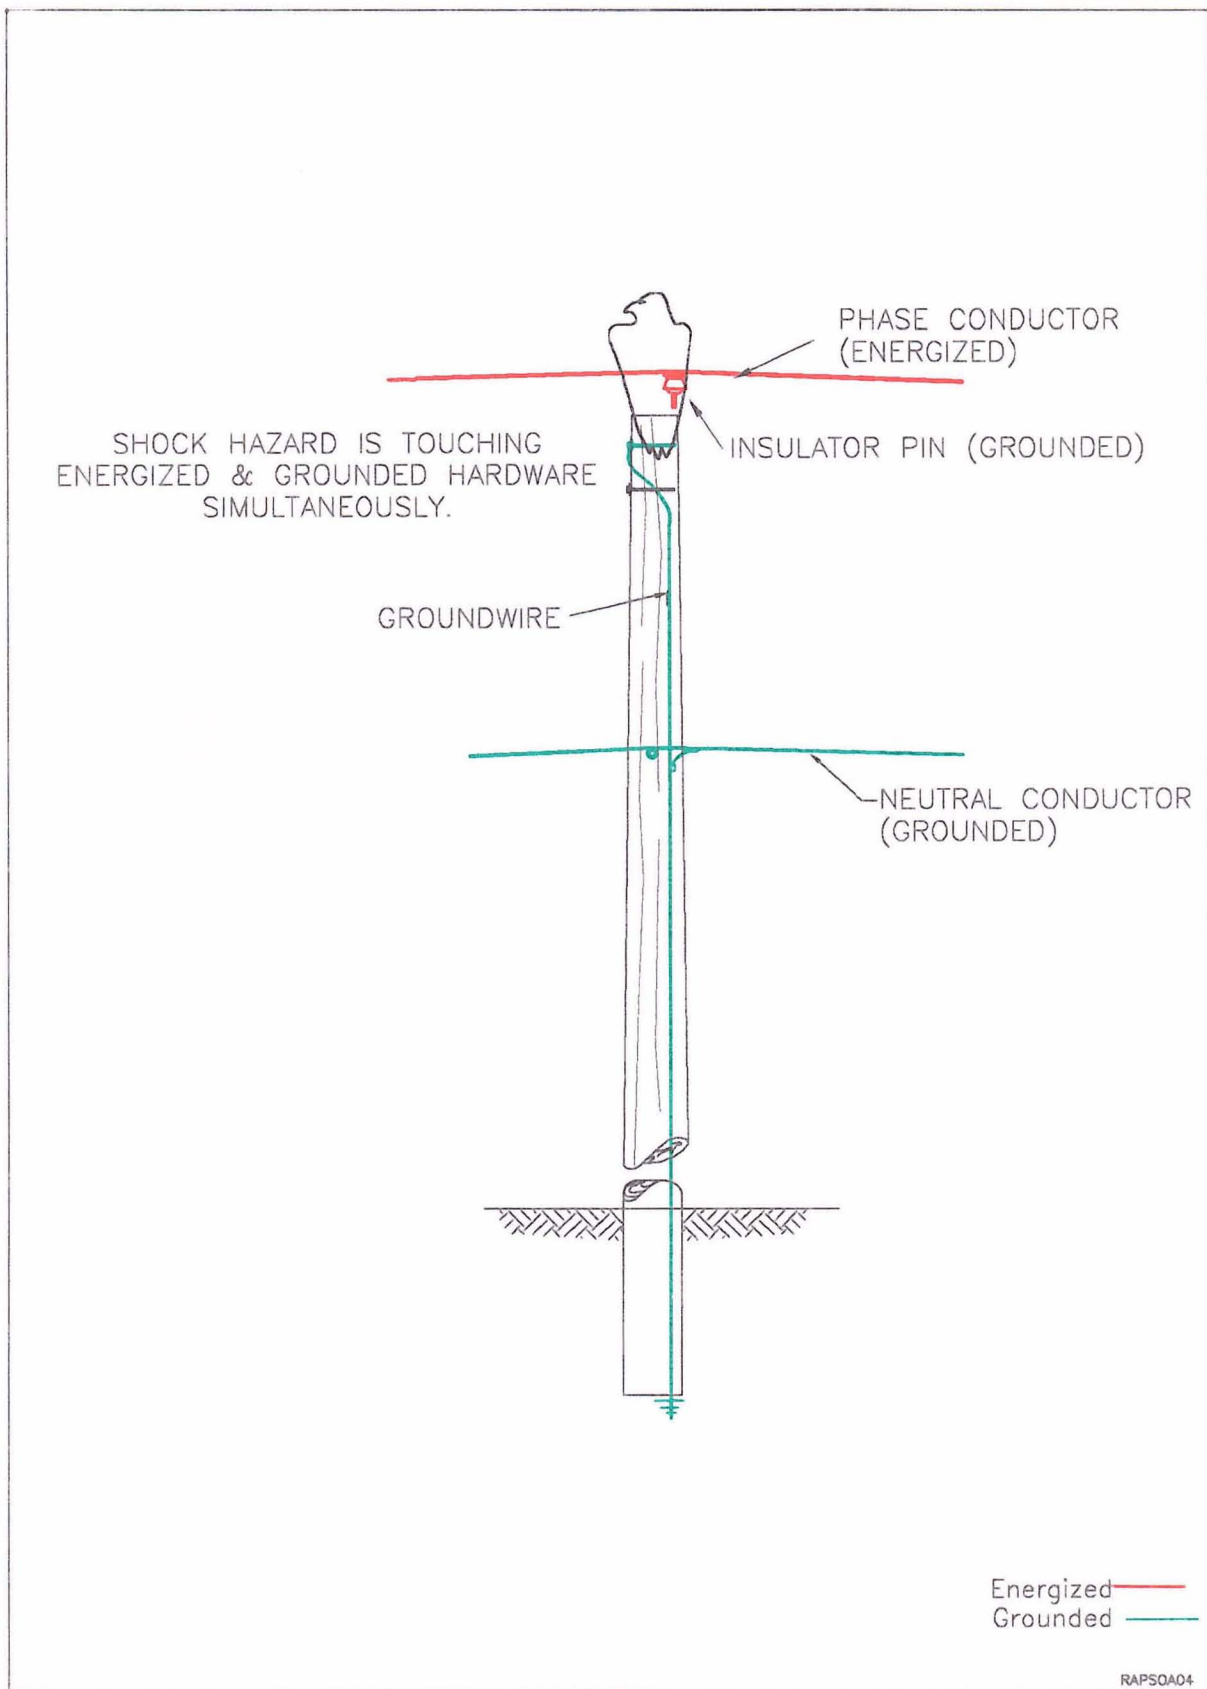
Figure 5. Problem single-phase configuration.
 (Refer to Figure 17 for recommended solution.)

In the early 1970's, most electrocuted eagles were found along two general types of pole lines: single-phase or three-phase (Olendorff et al. 1981). Figure 5 shows the first type, a single-phase line. (Note that in this and subsequent figures, *ground wires* are shown in green, and *energized wires* in red.) With this configuration, the tail feathers of an eagle perching on the pole top could touch the groundwire or grounded insulator pin, while the eagle's breast or other body parts contact the phase conductor. Either tail feathers or feet could contact the grounded insulator pin, and the breast the phase conductor. An eagle's tail feathers may reach more than 25.4 cm (10 in.) below its perch, spanning the distance. The design in Figure 5 killed 17 eagles in northeastern Colorado (Olendorff 1972a).

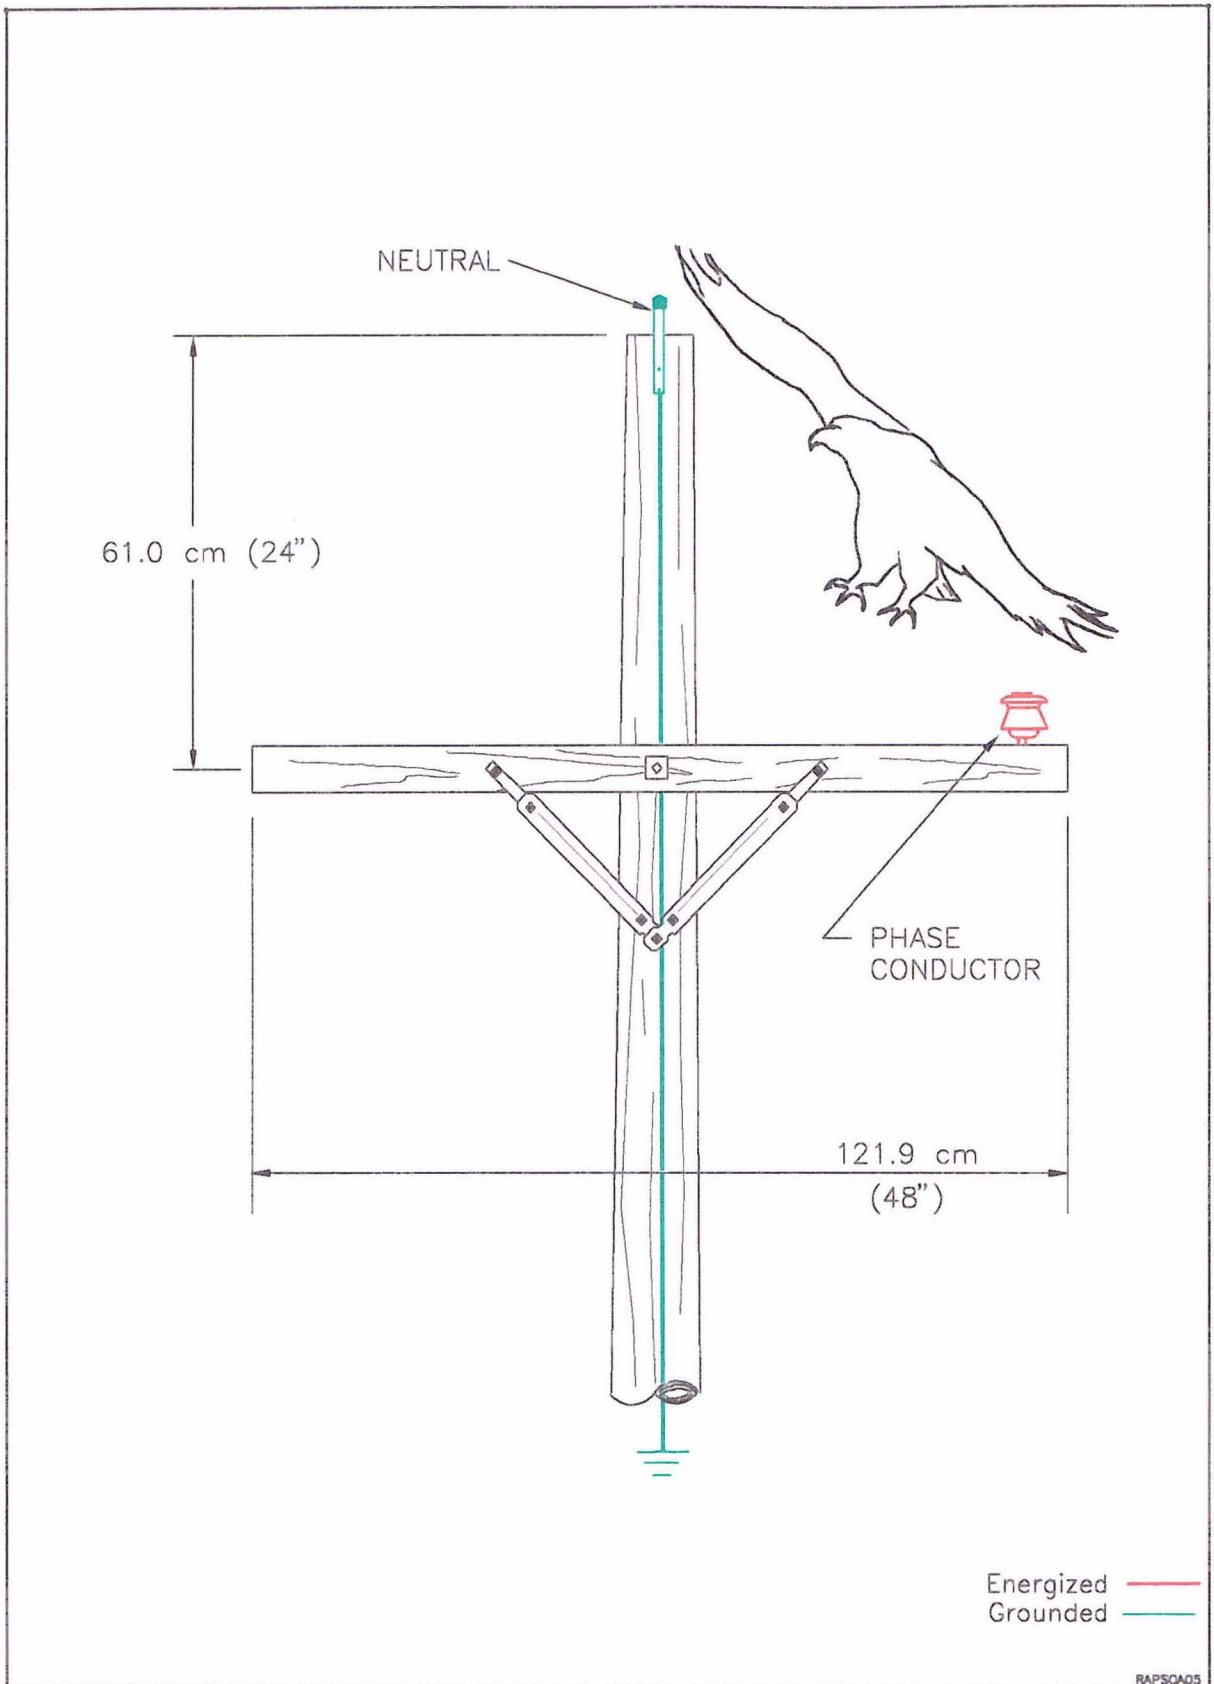
Figure 6. Problem single-phase configuration with crossarm.
(Refer to Figure 18 for recommended solution.)

Figure 6 shows another single-phase power line, where the overhead groundwire was mounted on top of the pole, while the energized conductor was supported on a 121.9-cm (48-in.) crossarm, 61.0 cm (24 in.) below the top of the pole. When the raptor tried to perch on the conductor end of the crossarm, the distance between the phase conductor and the ground was less than the wingspread, and the bird was electrocuted. Seventeen dead eagles were also found below such a configuration along a 24-km (15-mi.) stretch of distribution line in central Wyoming in 1992 (PacifiCorp, unpubl. data). In both designs, phase-to-ground contact caused electrocutions.

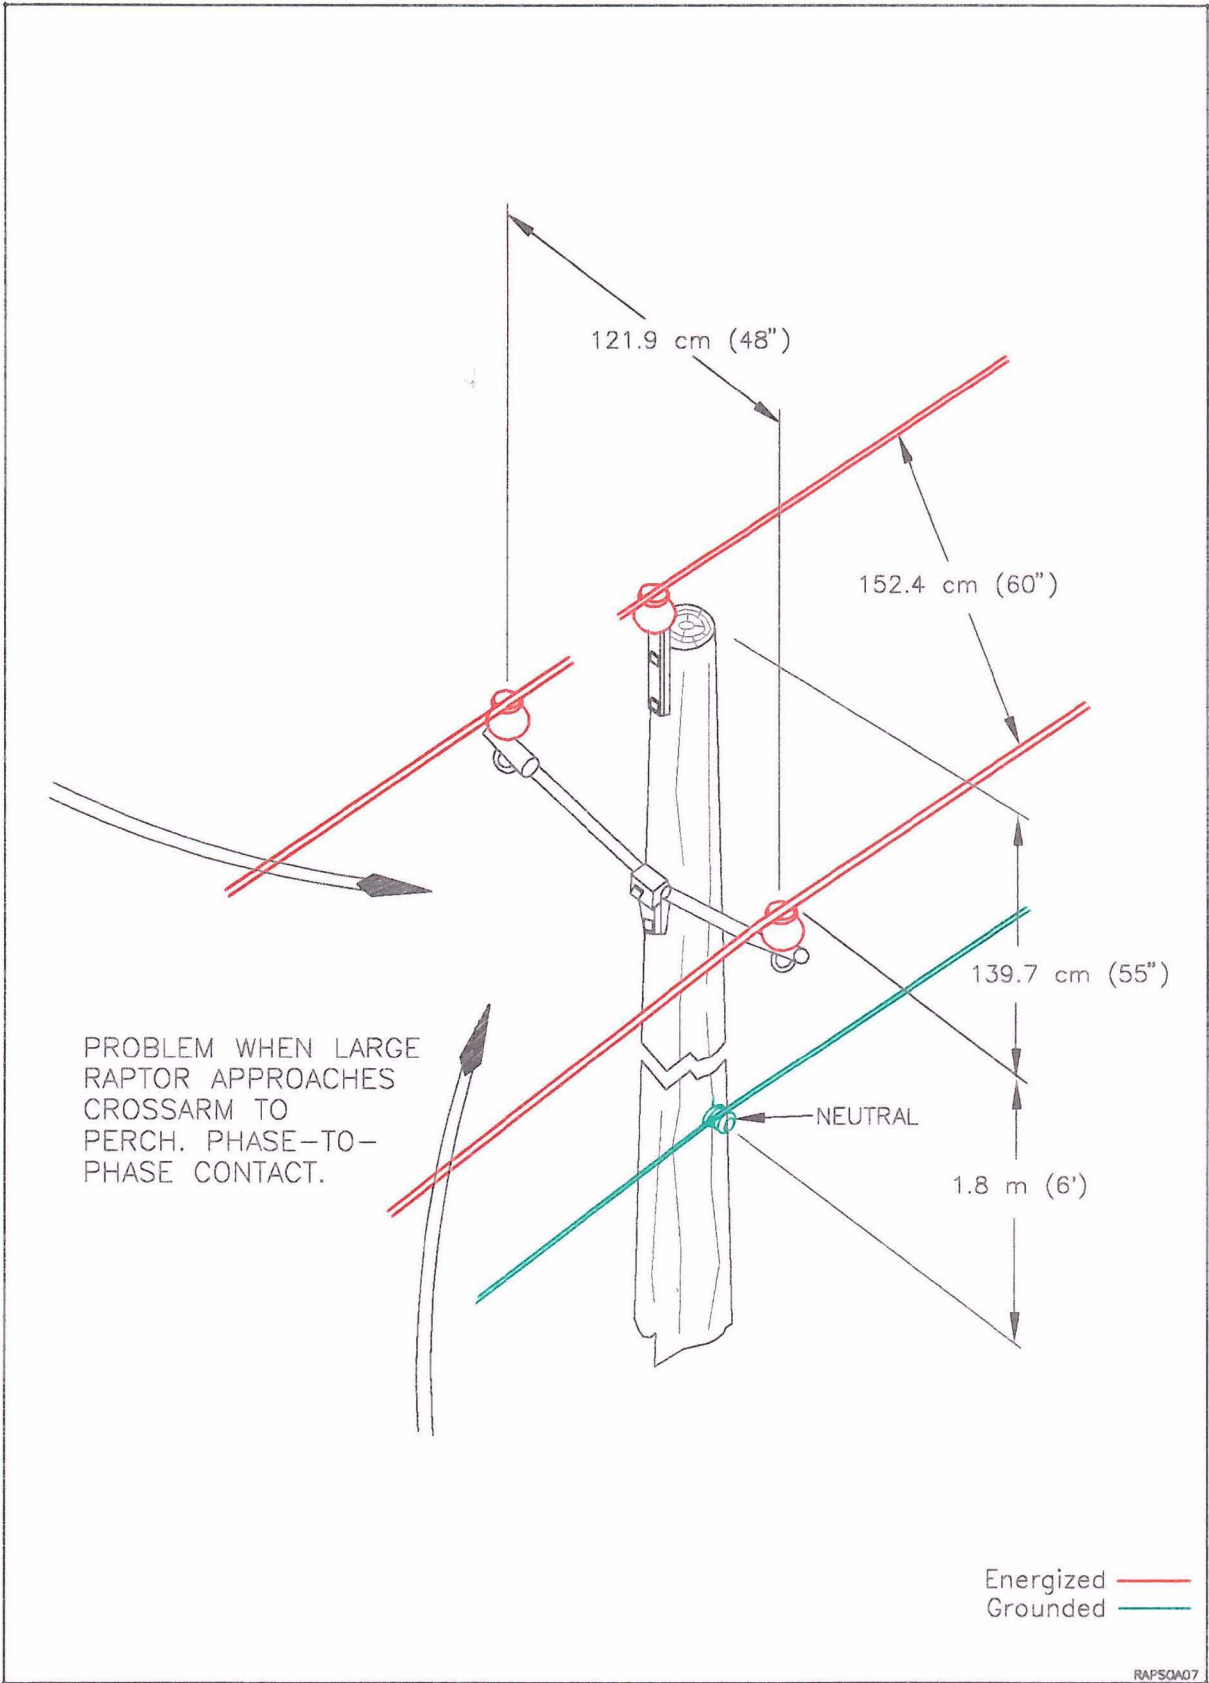
Figure 8. Problem compact three-phase design.
 (Refer to Figures 33 & 34 for recommended increase in phase spacing.)

Other three-phase designs have also been found hazardous. The three-phase design shown in Figure 8 is generally safe for raptor perching (Olendorff et al. 1981). However, recent field observations (PacifiCorp, unpubl. data) have indicated that larger raptors may be electrocuted when flying in to perch on the short fiberglass arms that support the phase conductors.

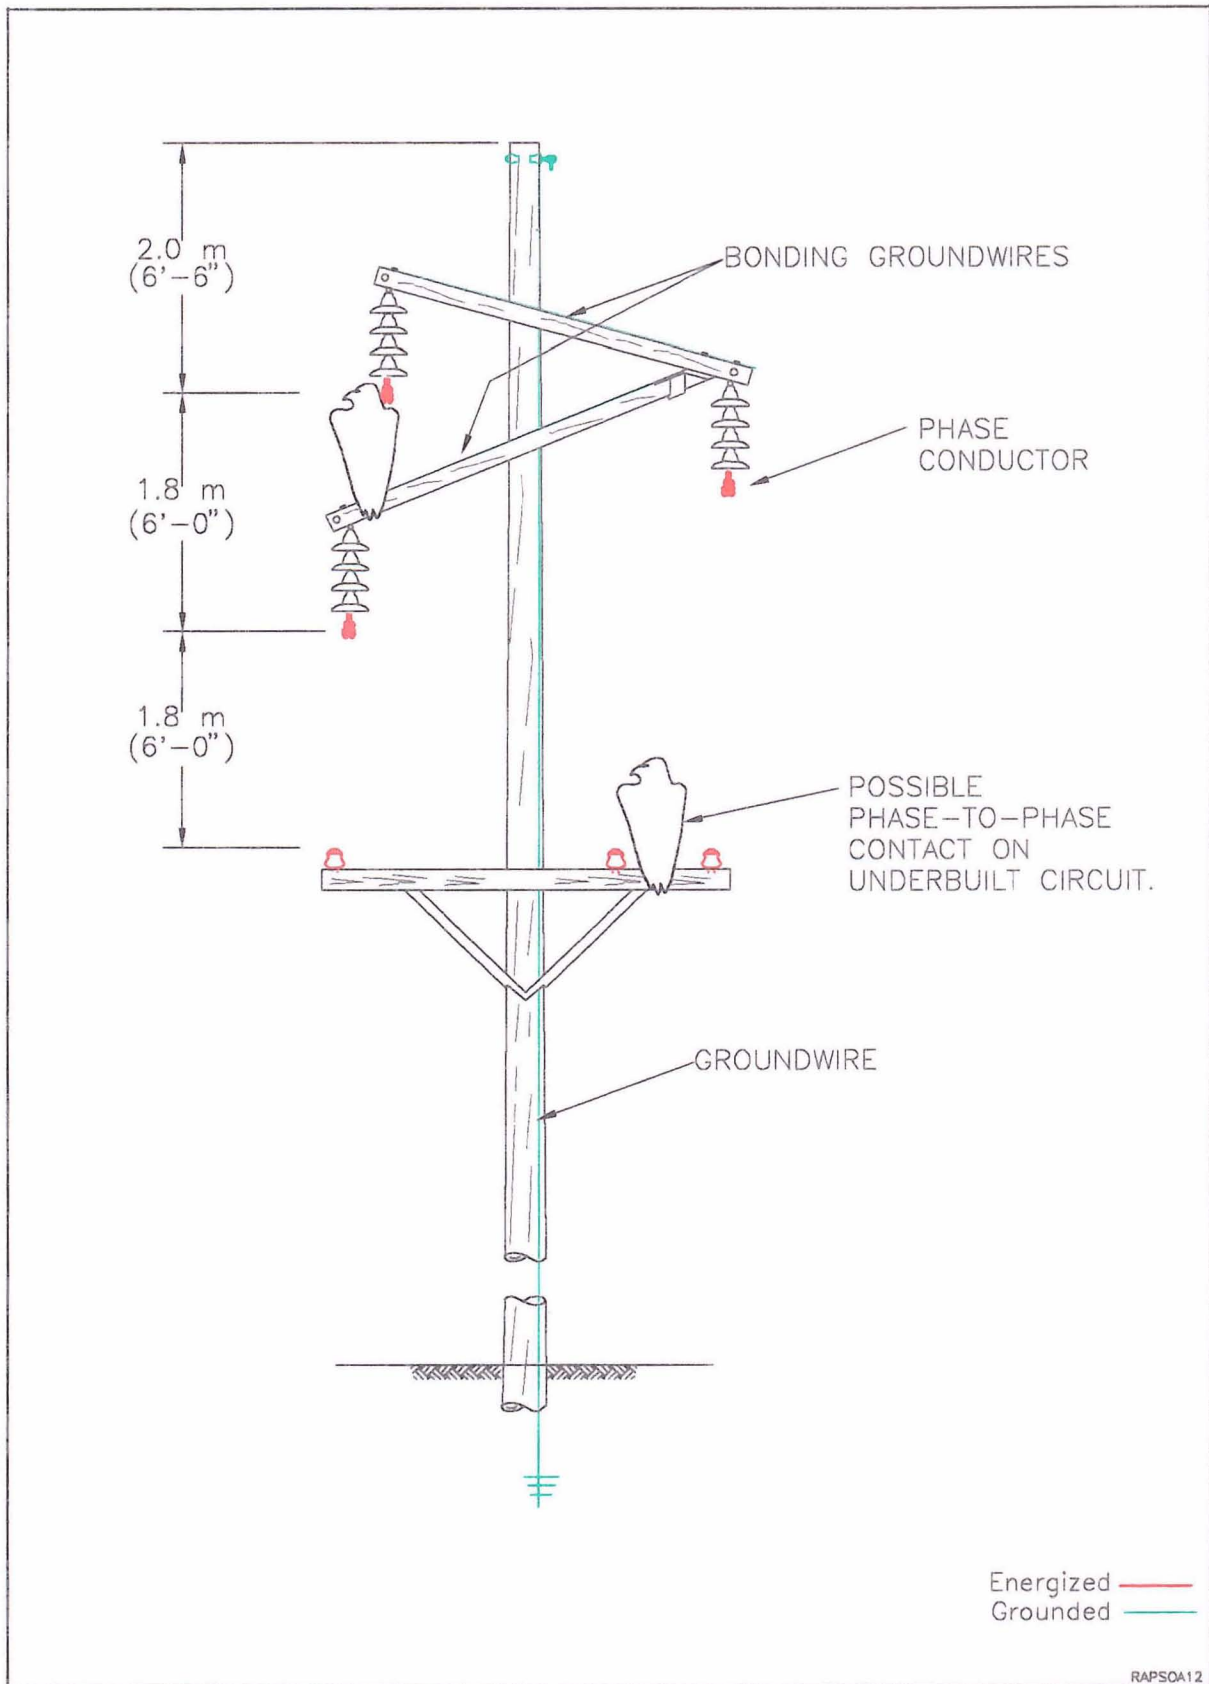
Figure 13. Problem wishbone design with underbuild.
 (Refer to Figure 28 for recommended solution.)

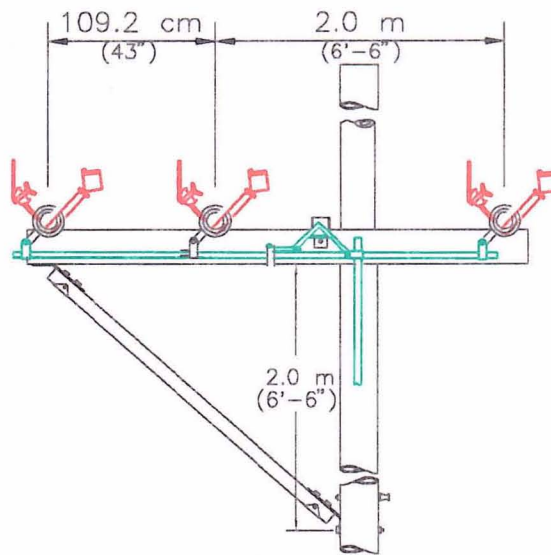
POLE-TOP CONFIGURATION

12.5-kV OFFSET CONFIGURATION

12.5-kV STAGGERED CONFIGURATIONS

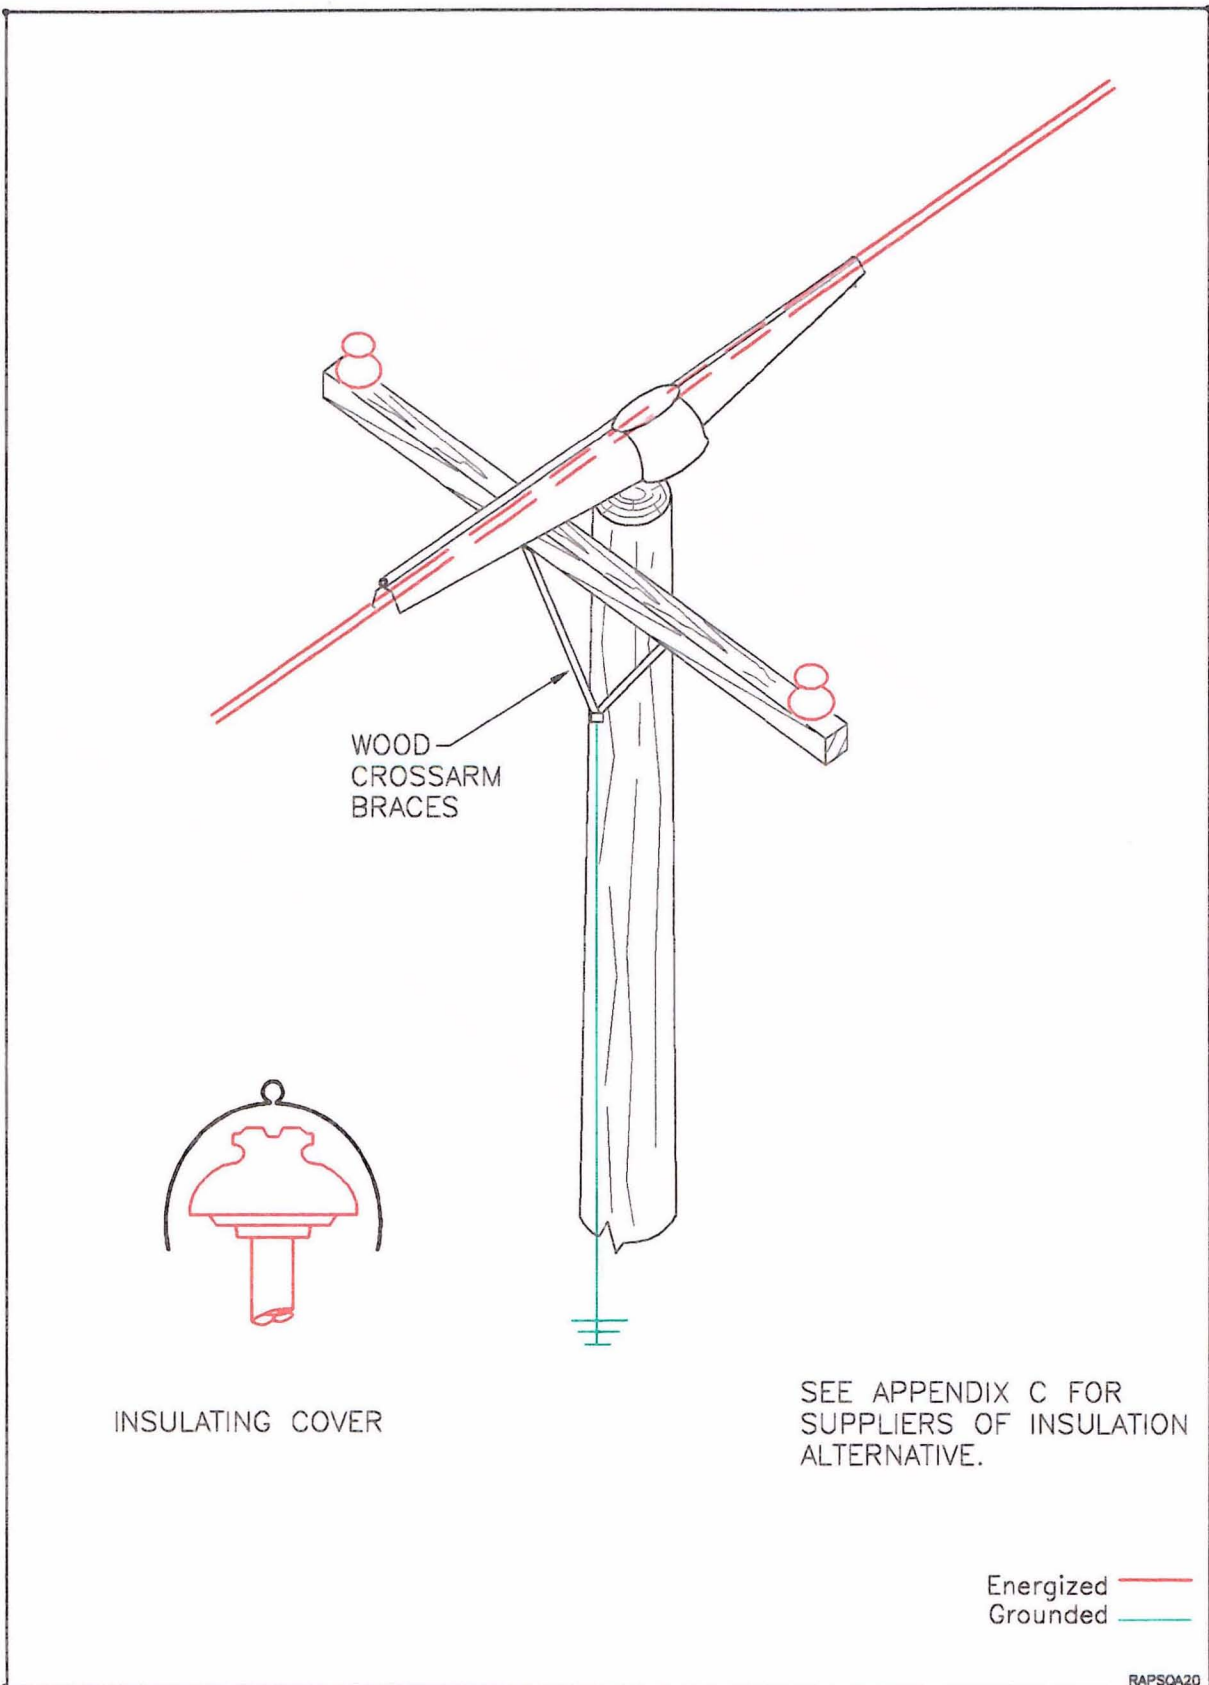
Figure 21. Conductor insulation alternative.
(Refer to Figure 7.)

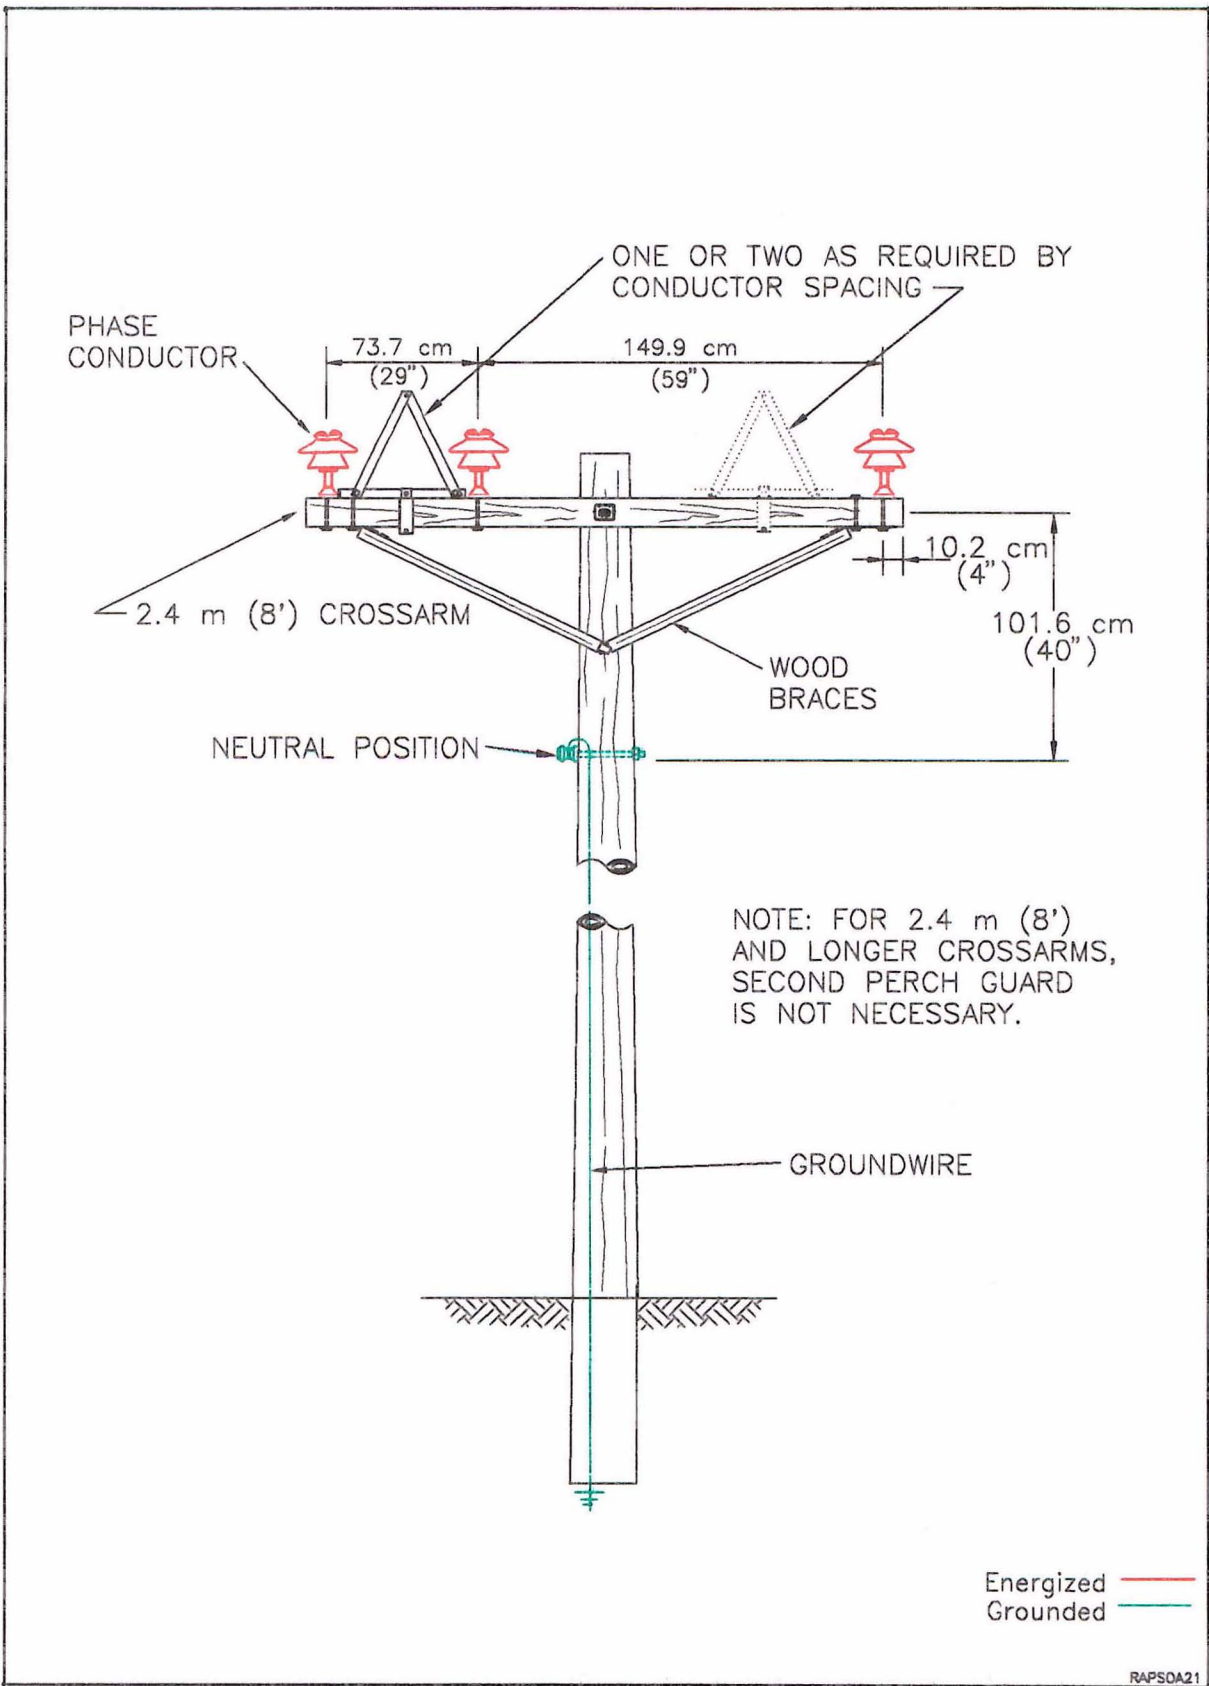
Figure 22. Perch guards.
 (Refer to Figure 7.)

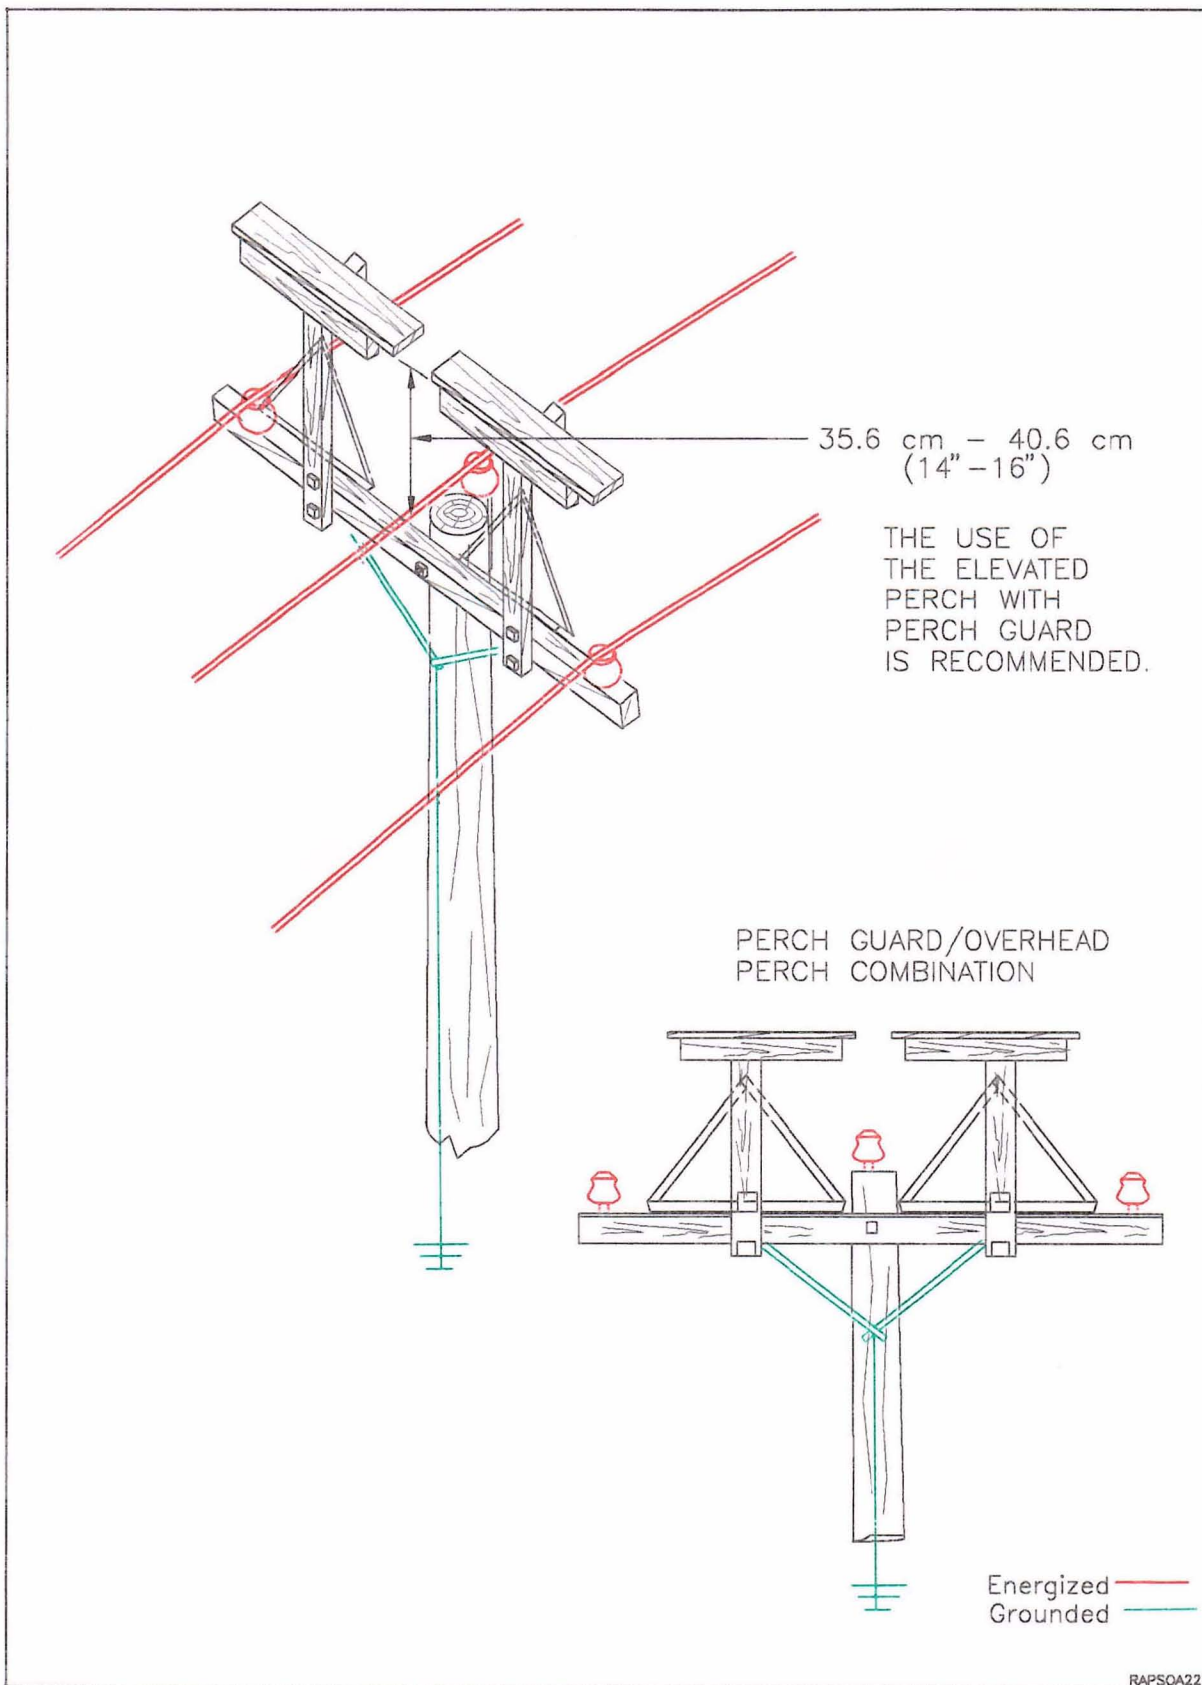
Figure 23. Elevated perch with perch guard construction.
(Refer to Figure 7.)

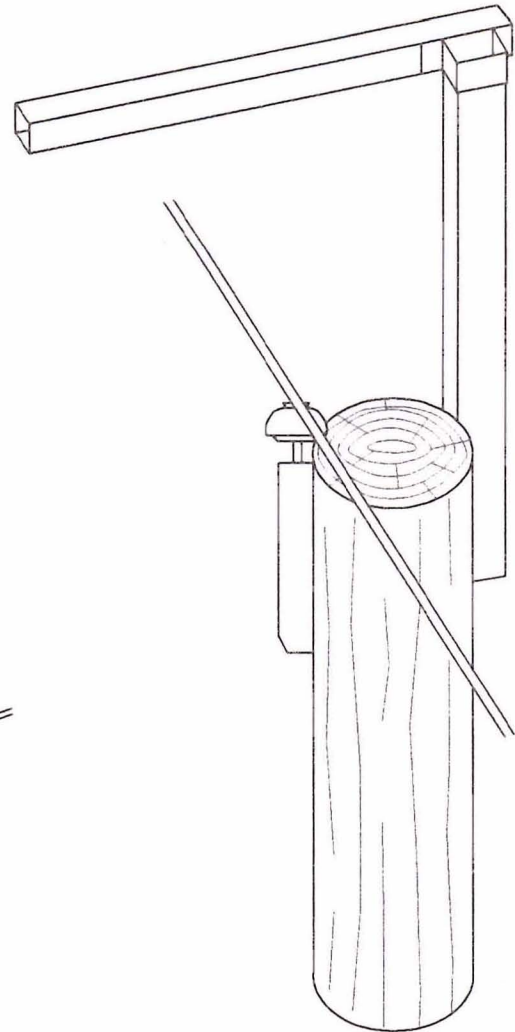
ALL HARDWARE AND MOUNTING HOLES ARE PROVIDED FOR EITHER POSITION.

HOLES ARE PROVIDED FOR USING THE SAME POLE THROUGH-BOLTS USED FOR MOUNTING THE POLE-TOP PIN.

POSITION 2:
PARALLEL
TO LINE

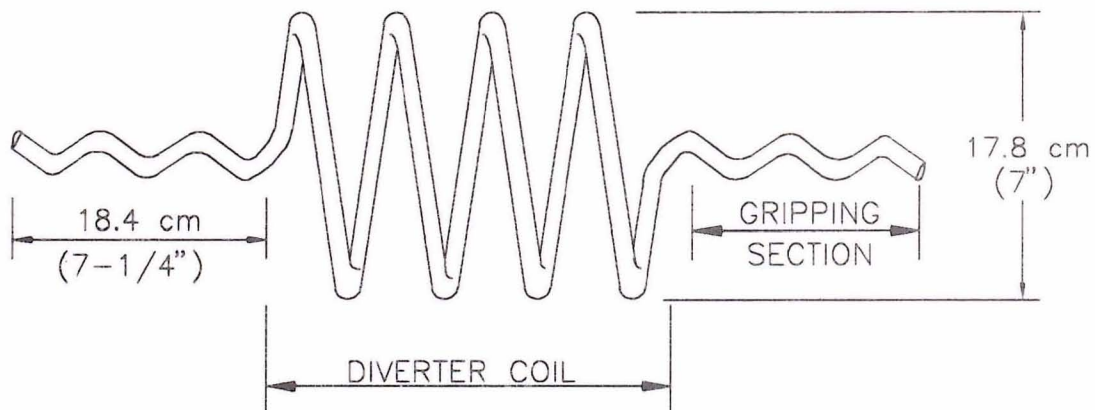
DULMISON SWAN FLIGHT DIVERTER

1. OVERALL LENGTH: APPROX 17.8 cm (7")
2. ROD DIA: 1.0 cm (0.375")
3. ENDS ARE SANDED.
4. MANUFACTURED FROM GREY OR YELLOW HIGH IMPACT P.V.C.
