# Brawley Solar Project – Geotechnical Feasibility Study

Ormat Nevada, Inc.

**Subject: Geotechnical Feasibility Study Applicability**

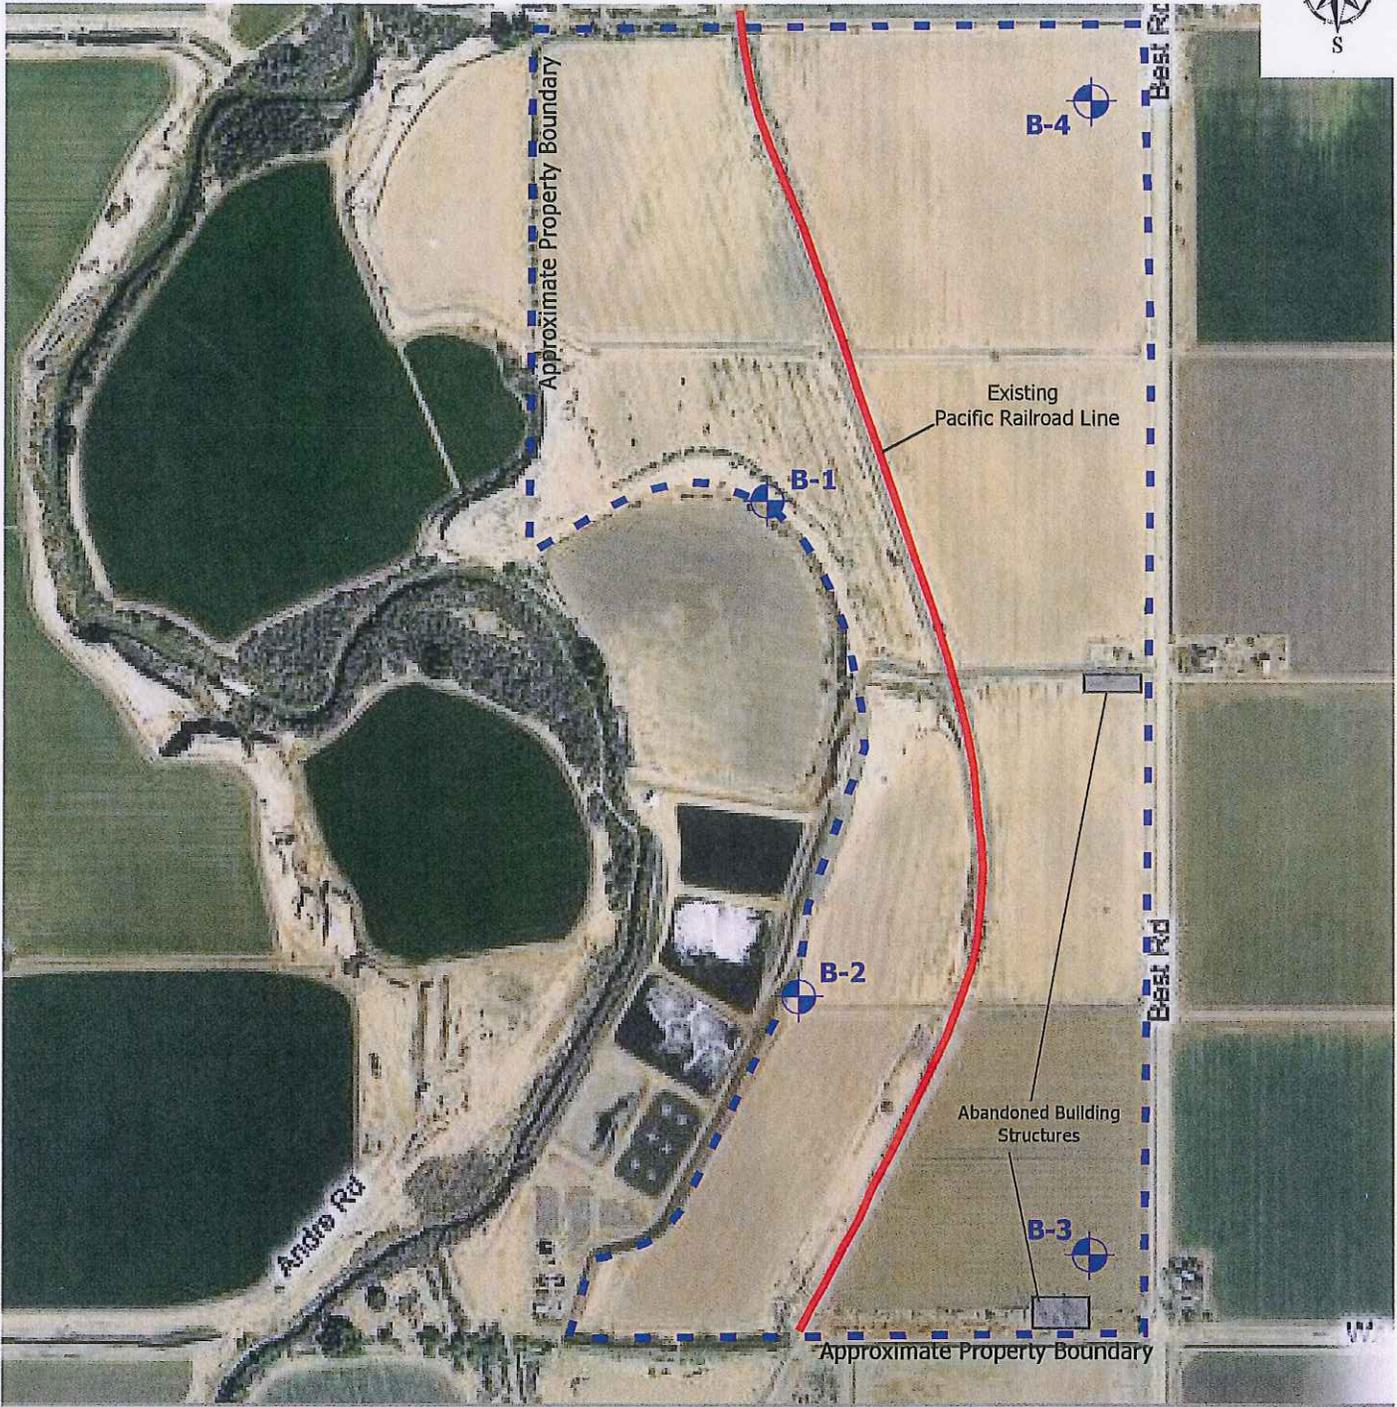
**Fig. 2**

Approximate Geotechnical Boring Location

Our site reconnaissance and subsurface exploration program was performed under the direction of an engineering geologist from Petra on December 2, 2010. The exploration involved the excavation of four 8-inch diameter exploratory hollow-stem auger borings to a maximum depth of approximately 51.5 below existing grade (Borings B-1 through B-4). Earth materials encountered within the exploratory borings were classified and logged by an engineering geologist in accordance with the visual-manual procedures of the Unified Soil Classification System. The approximate locations of the exploratory borings are shown on Figure 2 and descriptive logs are presented in Appendix A.
